Geothermal features annual monitoring report – June 2021

August 2021

Document #: 21036557

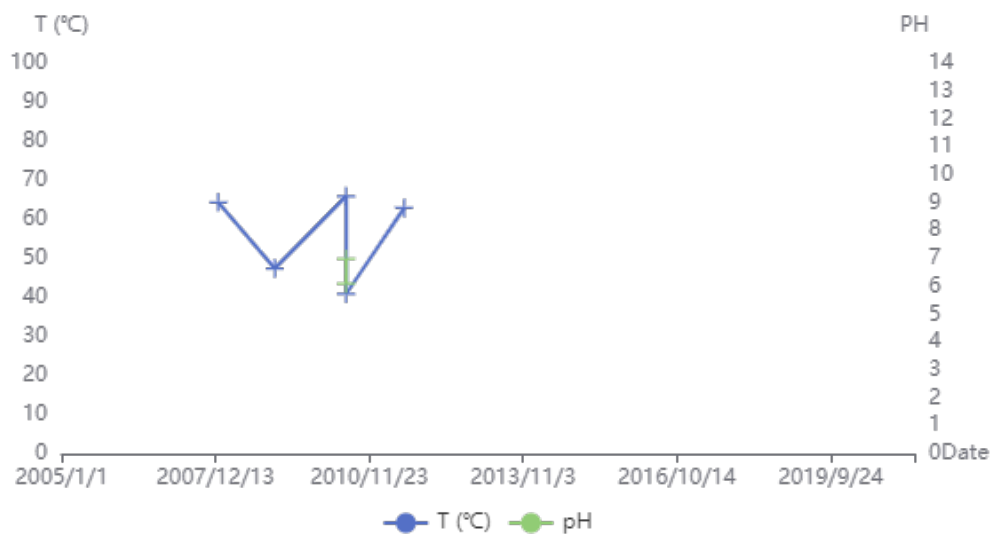
T5 Tirohanga Rd - Crater 3: Temperature and pH for 2005/1/1 - 2021/5/1

Date	pH	Temp °C	Level (m)	Flow (l/s)	Clarity	Colour	Ebullition
2007/04/01				None	nd	nd	nd
Comments	Two mud pools located at site. E2763448 N6295832. <i>Water level: nd</i>						
2008/01/01		64.4	2.0	None	Muddy	Grey	nd
Comments	Surrounding weeds flattened and covered in mud. <i>Water level: Below surface</i>						
2009/02/01		47.5		None	nd	Grey	nd
Comments	Pool is overflowing. Area of steaming ground and burnt vegetation beside the pool. <i>Water level: nd</i>						
2010/06/14		7.0	66.0	None	Murky	Brown	Calm
Comments	Water level covering ground between the pools in a 0.6 m wide channel. <i>Water level: Overflowing</i>						
2010/06/14		6.1	41.0	<2.0	Murky	Brown	Calm
Comments	Water level covering ground between the pools in a 0.6 m wide channel. <i>Water level: Overflowing</i>						
2011/07/24		63.0	1.5	>0.5	Murky	Brown	Calm
Comments	<i>Water level: Below rim</i>						
2021/04/29		62.3	0.3	Nd	Muddy	Brown – Light	Constant on multiple spots.

Comments	Floating black raft structures similar to bacterial mats or sulphur globules observed. Small pool flows into the larger pool and has stronger ebullition. <i>Water Level: Has been decreasing, lowest ever observed by Richard Setters (Steam field coordinator, Mercury)</i>

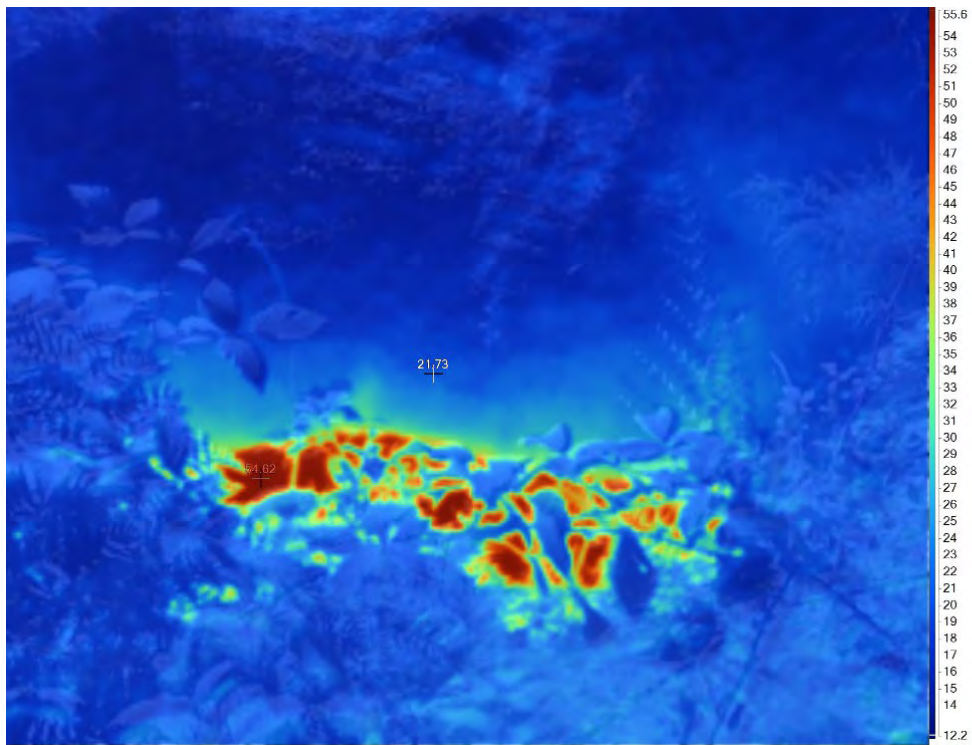
Fig. 1 Infrared image of Crater 8. Taken on 2021-04-29

- Feature could only be observed behind a vegetation cover for safety measures. As a result, direct temperature and pH measurements cannot be obtained.
- Temperature measurements decreased significantly between 2007 to 2011.

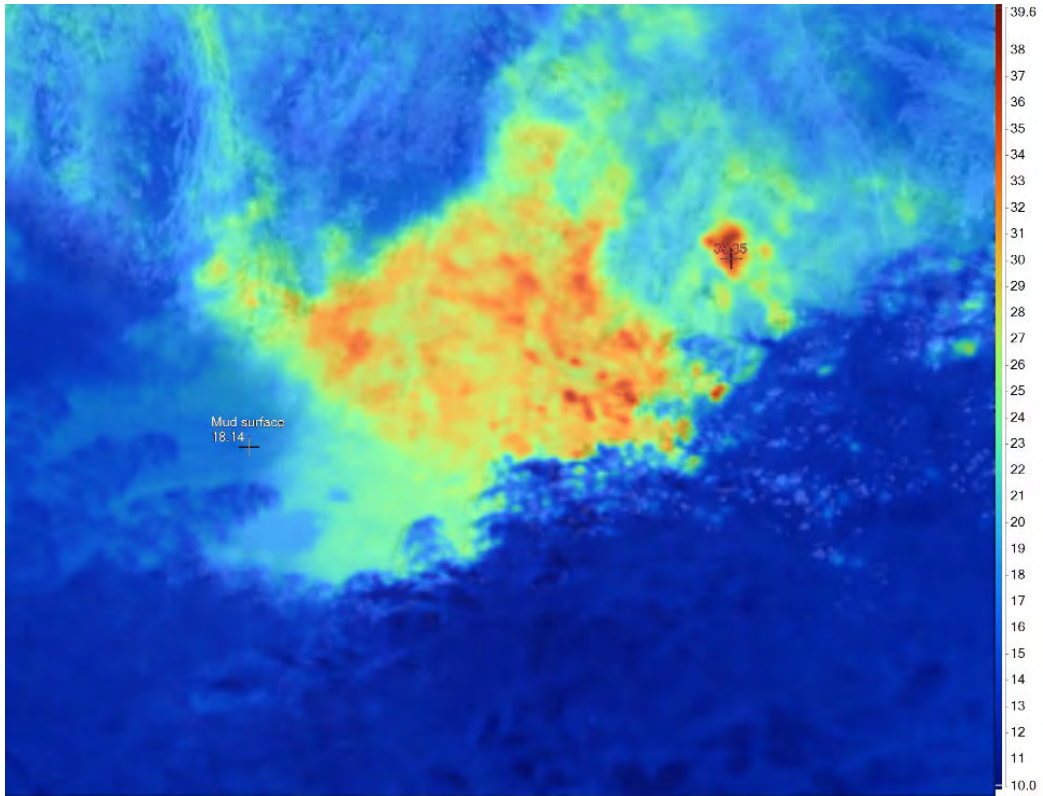
Fig. 1 Infrared image of Crater 7. Taken on 2021-04-29.

- Feature cannot be safely approached due to hazards. As a result, direct temperature and pH measurements cannot be obtained.
- Observations using an IR camera show that the rock wall next to the feature is much hotter than the mud surface.
- Temperature measurements decreased significantly between 2007 to 2011.

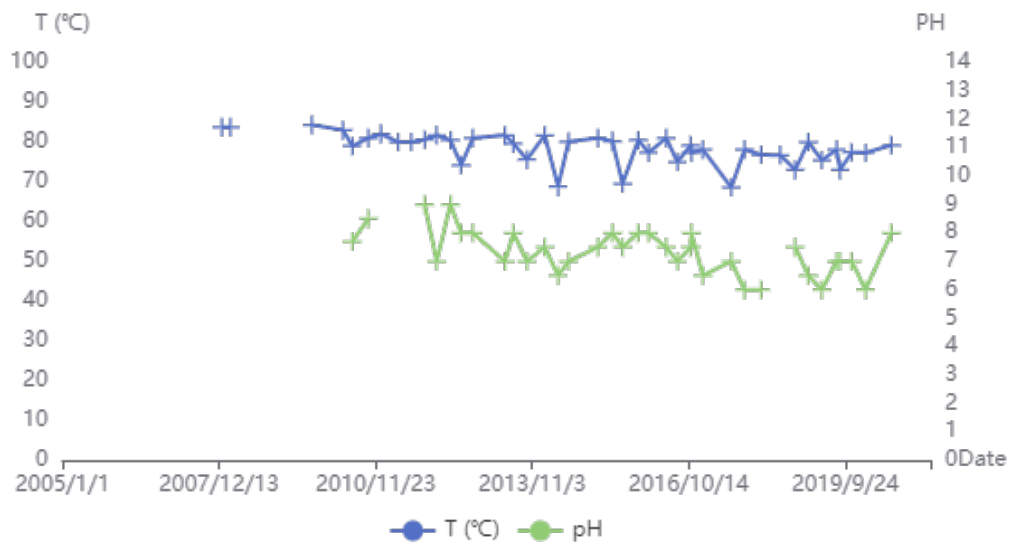
Map of Australia: Temperature and pH for 2005/1/1 - 2021/5/1

- The temperature at this pool regularly cycles between 80 °C and approximately 70 °C since early measurements were taken in 2008.
- pH measurement is observed to be inversely correlated to temperature, and ranges between pH 6 and 8, remaining near-neutral.
- In December 2020, the pool overflowed significantly and microbial mat communities formed in overflows above soil level. Silicification was ongoing, with some mats becoming partially silicified. In March 2021 the silicified mats are has become absent, but it is unknown if the process is natural or anthropogenic.

2021/04/30	7.0	77.8	0		Clear	Colourless	Constant weak ebullition from single part of the pool.
Comments	Pool no longer overflowing as observed on Dec 2020. Recent sinter deposits are damaged and algal communities are gone. Areas of increased temperatures around pool now cool.

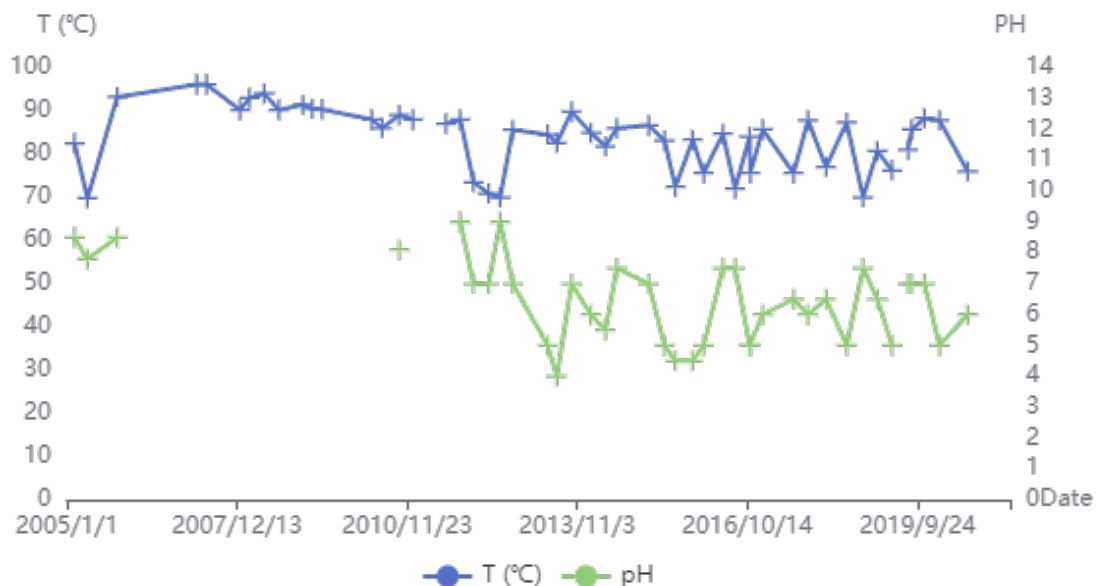
Diamond Geyser: Temperature and pH for 2005/1/1 - 2021/5/1

- Temperature conditions at Diamond Geyser have been constantly ranging between 70 and 90 °C.
- pH measurements have a great variation between pH 3 and 9. This could be affected by water accumulating at the surface of geyser vent being affected by the subaerial environment when the feature is not overflowing, with dissolved H₂S oxidising to H₂SO₄.
- This feature regularly erupts and overflow to the distal apron. Microbial mats with bubblemat textures grow in the outflow along the intermediate and distal vent slope.

2020/12/04	6.0	81.0	0	>3.0	Clear	Blue – Grey	Constant low ebullition, focused at one point
Comments	Clarity: 3 m						
2021/03/26	6.0	88.9	0	Nd	Cloudy	Grey	Constant ebullition at 2 points
Comments	New but minor nodular sinter deposits observed.

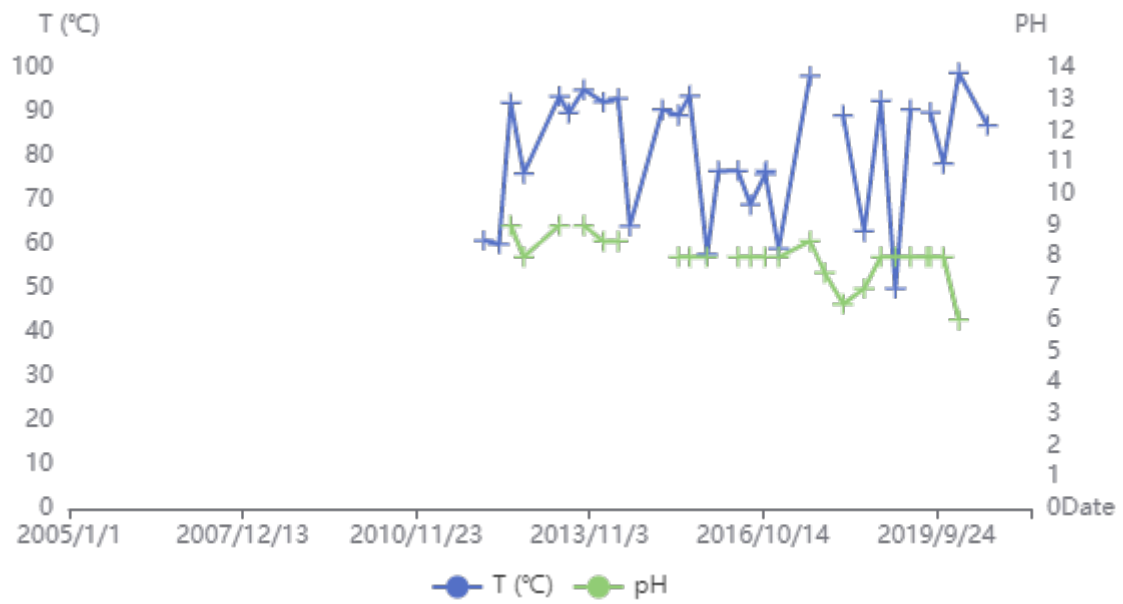
Bush Geyser: Temperature and pH for 2005/1/1 - 2021/5/1

Comments	Feature currently dry. Fresh nodular geysers observed proximal to vent. <i>pH:</i> from ex-situ sample in the slash zone <i>Infrared Temp:</i> Measured on the surface, water level not high enough <i>Water Level:</i> Not high enough to be observable						
2021/03/26		91.3	0	Nd			
Comments	Features around this geyser have expanded. Not currently erupting. <i>Ebullition:</i> Could only hear it

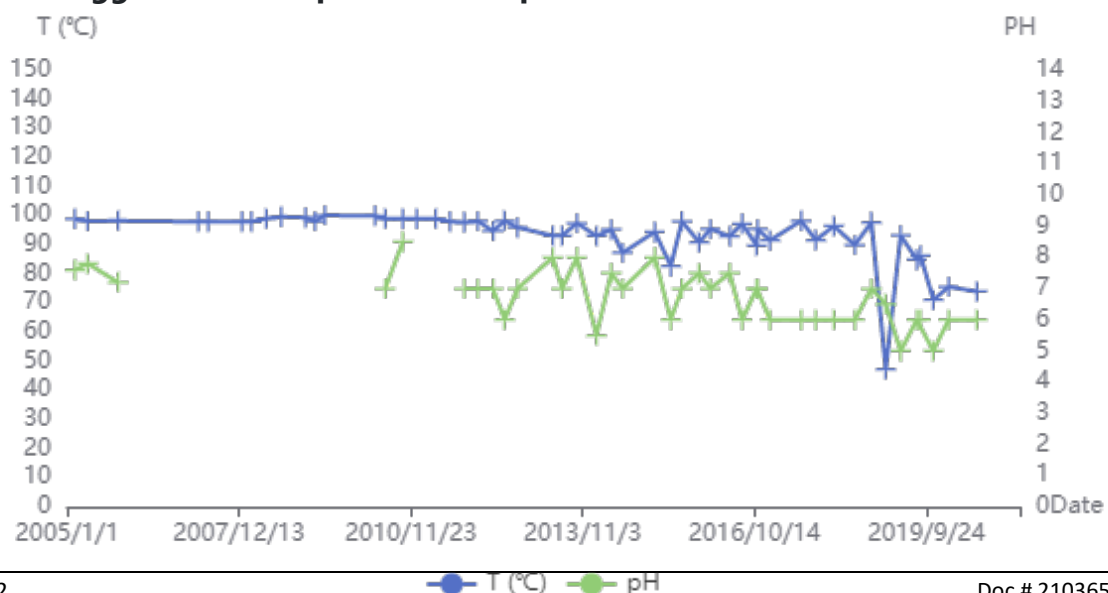
Fred & Maggie Pool: Temperature and pH for 2005/1/1 - 2021/5/1

- Temperature conditions remain relatively stable between 90 and 100 °C from 2005 to 2018. In early 2019, a temperature decrease was recorded, reaching a low of 47.3 °C, before recovering to historical levels in April 2019, and then decreasing again to today.
- pH measurements have constantly fluctuated between pH 5 and 8.
- The two pool basins have been observed to have no hydrological communication during low water levels.
- Spicular geyserrite textures were present above the pool rim in March 2019 (observed by author before working for WRC), but disappeared as of December 2020.

2020/02/11	6.0	75.6		<0.5	Clear	Colourless	Constant upwelling
Comments	Algae from the edge is ending up in the pool and floating within it.						
2020/08/06	6.0	74.0		<1.0	Clear	Colourless	Constant bubbles
Comments	<i>Ebullition:</i> Middle of pool						
2020/12/04	7.0	91.0	0	>3.0	Clear	Blue	High constant ebullition
Comments	Previously observed geyserrite rim now nonexistent. <i>Clarity:</i> 1.5 m						
2021/03/26	7.0	91.2	0	Nd	Clear	Colourless	Constant ebullition
Comments	Overflow of Wairere geyser now flows into this feature.

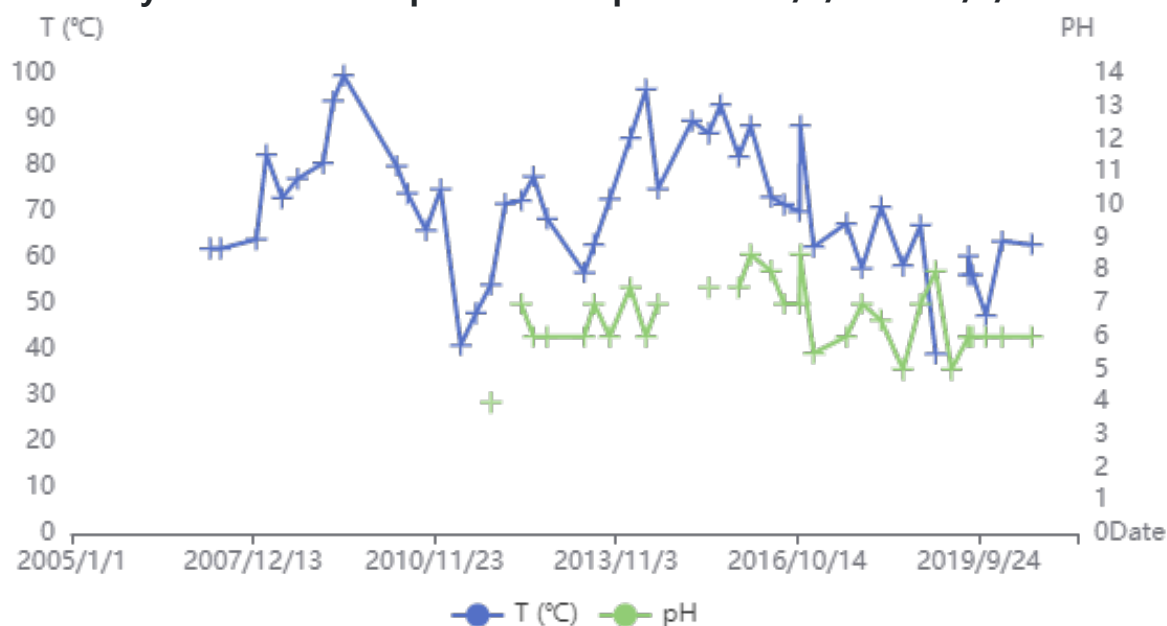
North Pool by Boardwalk: Temperature and pH for 2005/1/1 - 2021/5/1

- The temperature of this pool fluctuates from near-boiling conditions to as low as 40 °C. General temperature conditions have decreased since 2013, and from 2018 the feature has had relatively low water level or gone completely dry.
- pH conditions have ranged from 5 to 8 but have experienced more changes since 2015.

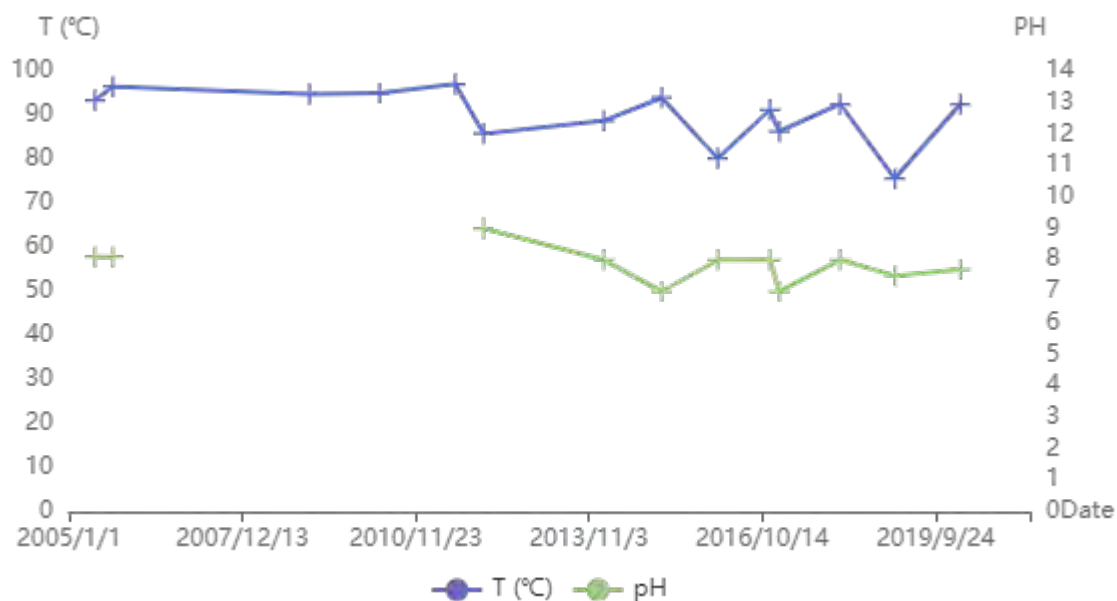
Hot Pool 3 at Reporoa: Temperature and pH for 2005/1/1 - 2021/5/1

Comments	Oily sheen observed on water surface around pool margins, provenance unknown.

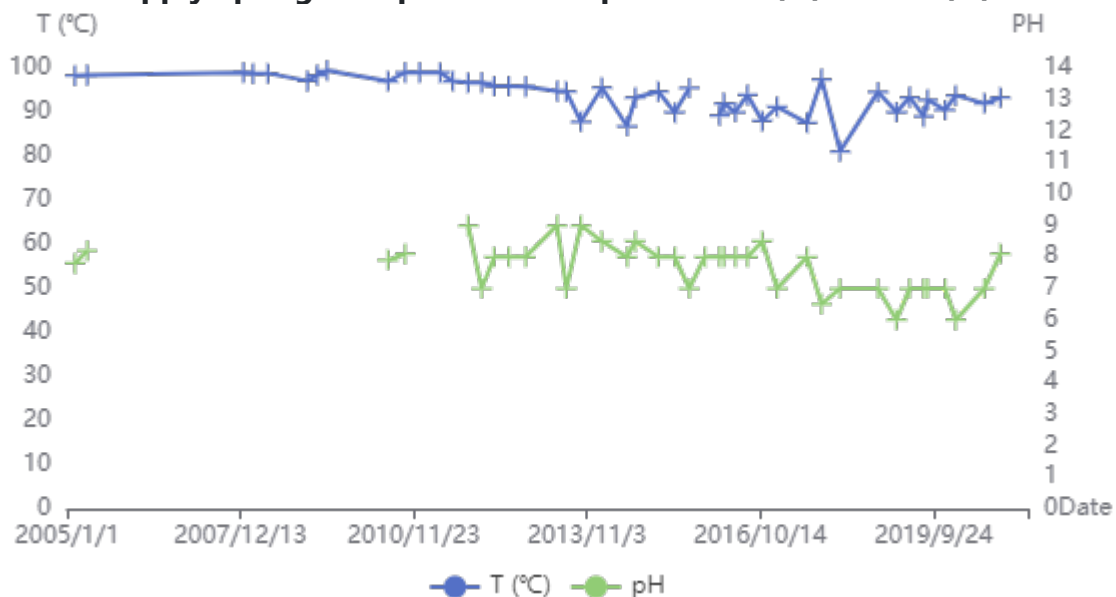
Hot Pools Supply Spring: Temperature and pH for 2005/1/1 - 2021/5/1

- The overall temperature trend since 2005 is minor but visible temperature decrease over time and stays above 90 °C.
- pH conditions often fluctuate but remain within near-neutral conditions.
- Fresh geysers form around the pool within the splash zone (Fig.8).
