IN THE MATTER of the hearing of submissions on The
Proposed Waikato Regional Plan Change 1 –
Waikato and Waipa River Catchments: Block
3

**STATEMENT OF EVIDENCE BY ANDREW BARBER
FOR HORTICULTURE NEW ZEALAND**

Erosion & Sediment Control Plan

Farm A

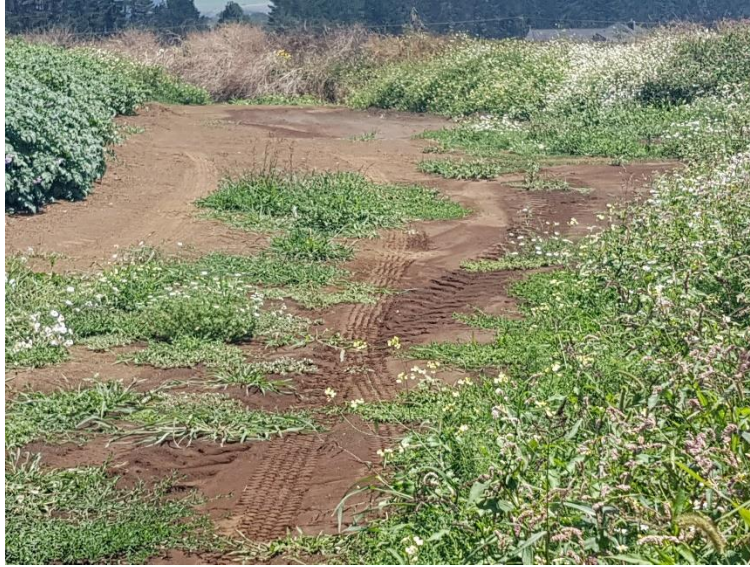
Paddock 605 with overland flow discharging into a drain without going through an SRP.

52. As can be seen in Table A2 (attached) the current E&S control practices (except 605) have achieved sediment losses of less than 1.0 t/ha (3rd column). The current mitigation measures have ensured that sediment loss is less than had the paddocks been in pasture where the average sediment loss would have been 2.9 t/ha (not shown).
53. Paddock 605 was ranked as the highest priority, which is then reflected in the action plan / construction schedule in Table 7. The benefit of the E&S Control Plan is that work can be staged over several years. In this case the construction of the new SRP4 is planned before April 2020. Work on other properties had a higher priority. A quicker temporary step was to construct a silt fence (see picture below).

1. A new SRP4 should be constructed in the north-western corner of paddock 605, with the existing pseudo-SRP being re-structured as a clean drain accepting the flow from paddocks 601 and 602. The spillways and snorkel from the new SRP should be directed into this drain. Prior to construction of this, a silt fence should be installed in the existing SRP4 as a temporary measure

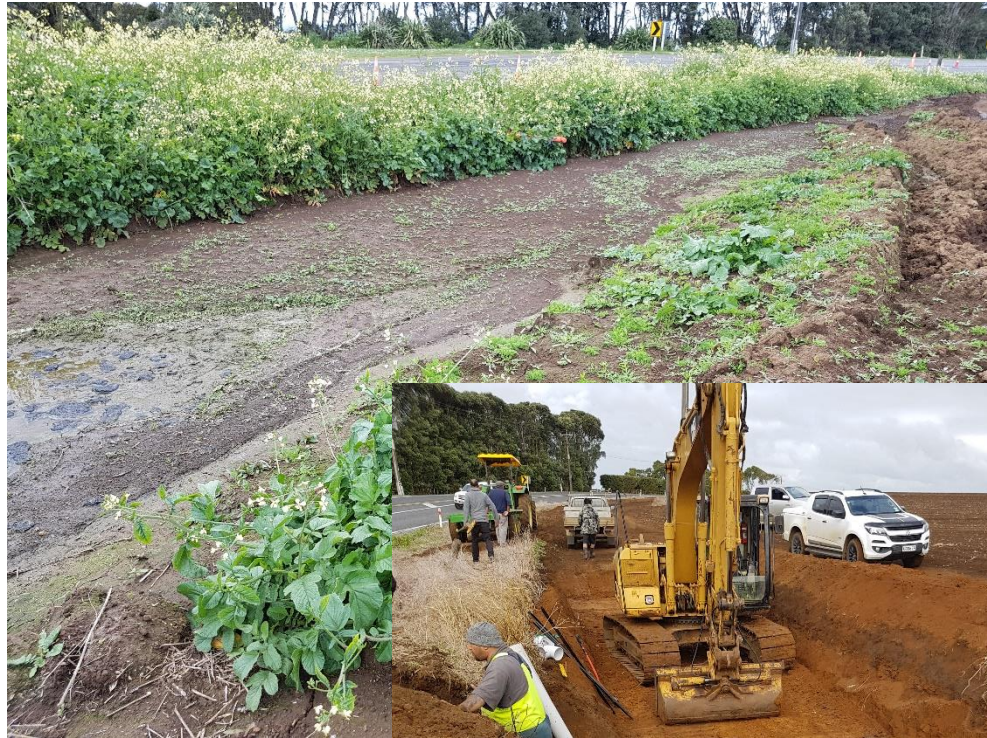
Above – Earth bund trapping bedload sediment (~100m³).

Right – Construction of a 0.5% decanting SRP (~200m³) following the E&S Control Plan.

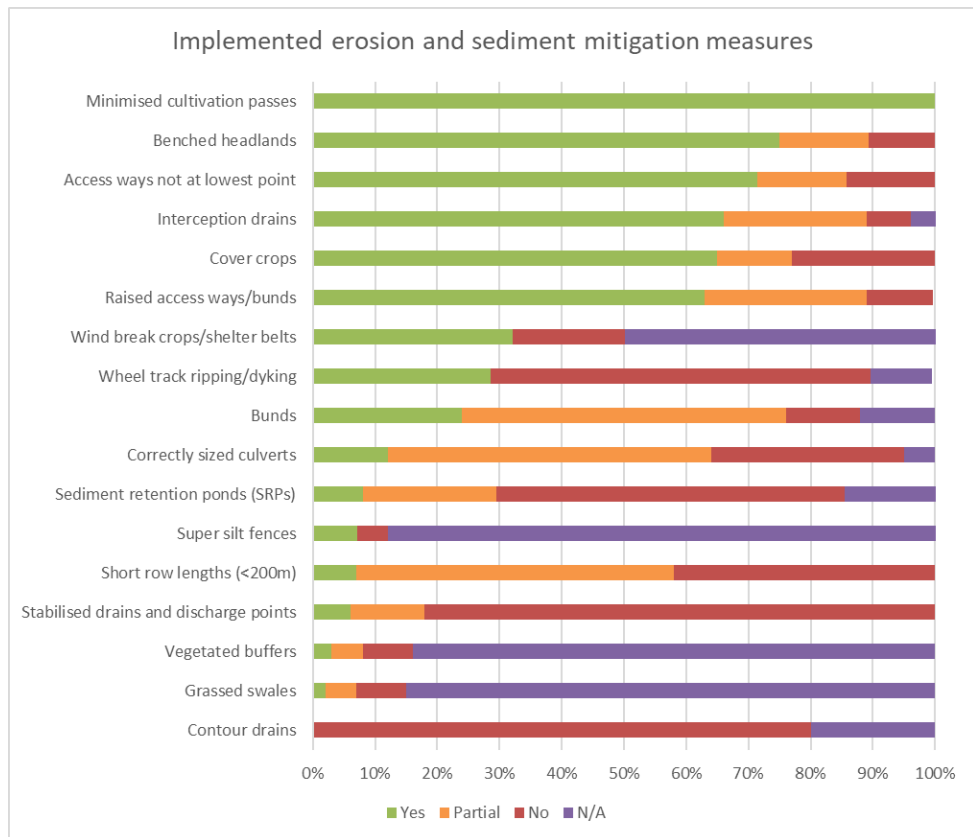
59. Following on from the DMTW project, E&S Control Plans are being prepared and their metrics are being aggregated for individualised benchmarking and industry tracking purposes.
60. In paragraphs 18 and 21 I referred to the success of the wine industry's benchmarking reports that lead to practice base changes. Below is an example of what an individualised erosion and sediment control report for the case study property described above could look like.
61. An example Erosion and Sediment Control Report is attached as Appendix B.
62. At a national or regional level, Good Management Practices collected through the E&S Control Plans could be aggregated and tracked as shown in the example below.

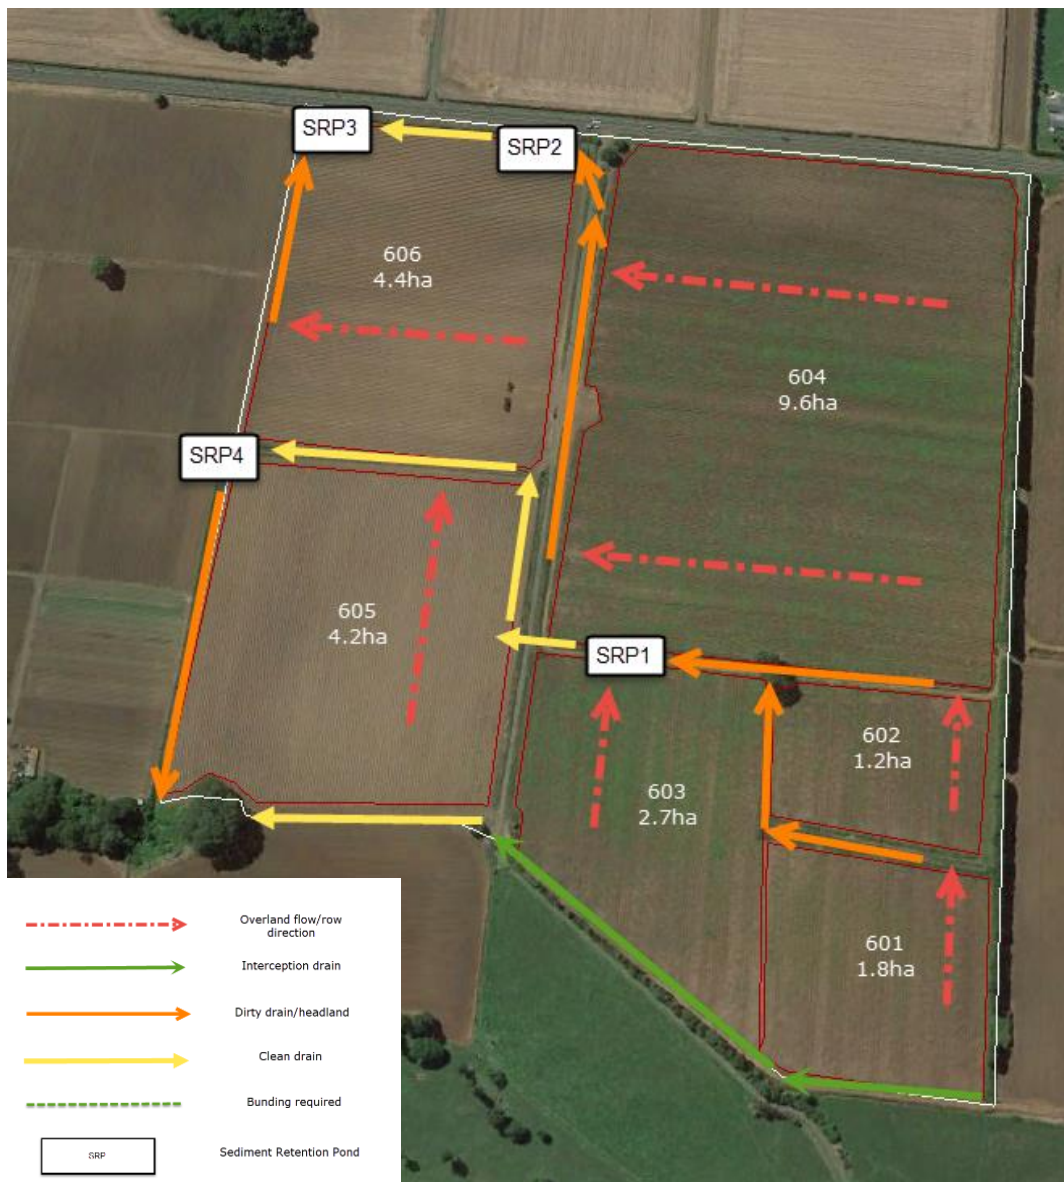
Figure 1. Current paddock map.

The current overland flow direction and area of the paddocks, as well as SRP locations, are shown on the map (Fig.1), with the overland flow directions after action plan mitigation measures shown in Figure 4.

Table 1 describes the current overland flow situation. One of the identified issues is where SRP1 & 2 lead into drains which in turn leads to SRP3. Essentially clean water is discharging into dirty water and needs recleaning. This currently causes SRPs 3 to become overloaded, due to accepting overland flow from a much larger catchment area than they were designed for.

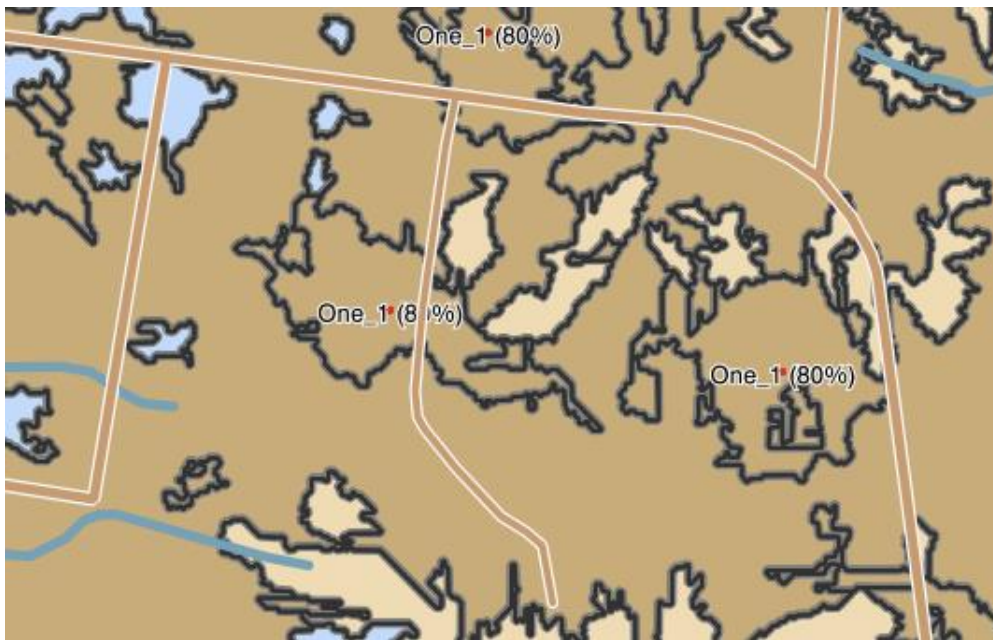
Figure 3. Soil map from S-maps (Landcare Research)

The soil type according to Landcare Research S-map reports is a clay, *Onewherof*, a Typic Oxidic Brown Soil. Physical observation showed the soil to be very light and friable.

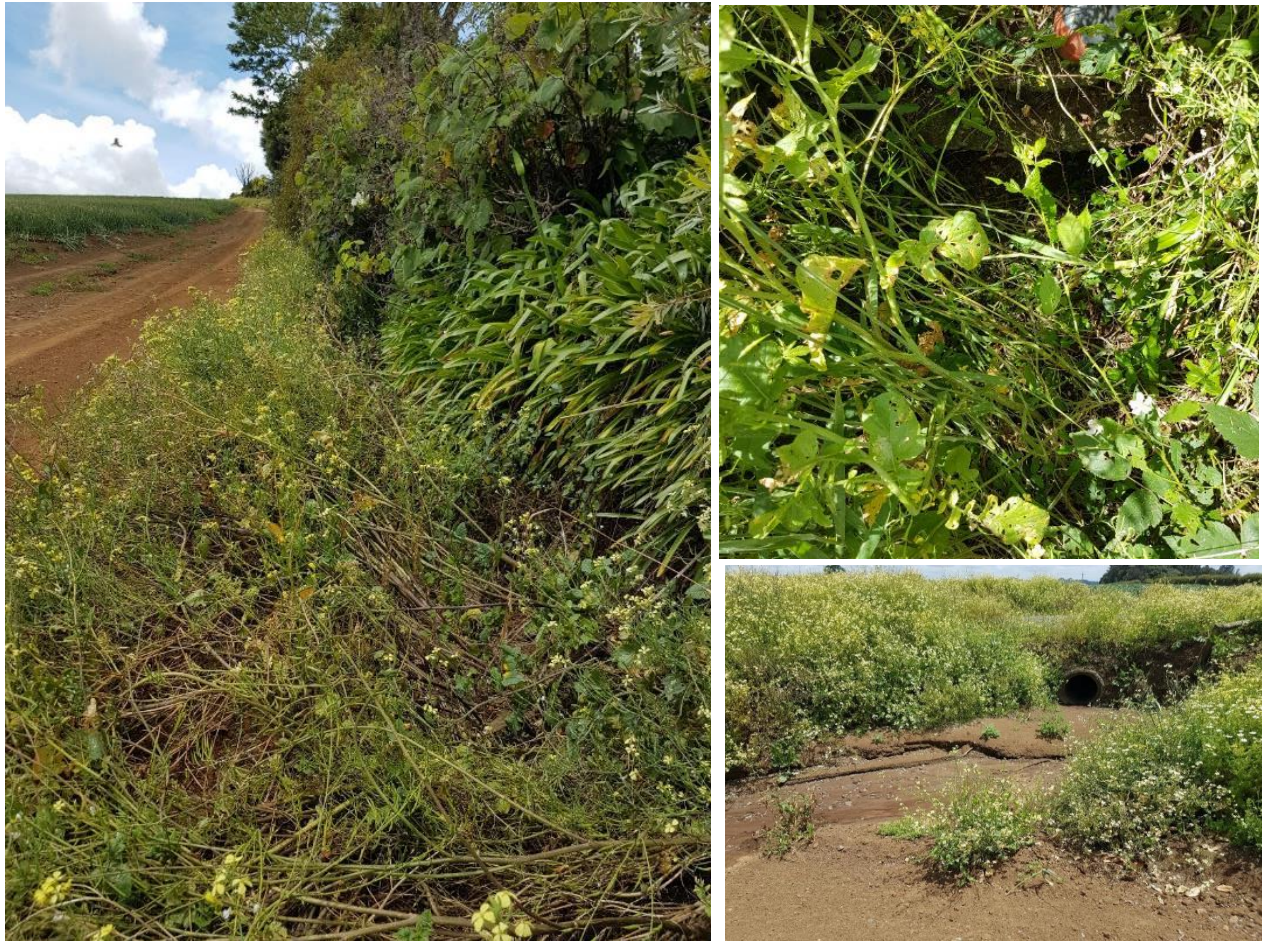
Figure 7. From top left clockwise: i) Overgrown and shallow interception drain along southern boundary. ii) Blocked culvert from southern boundary interception drain. iii) Culvert leading to SRP2.

2. The interception drain along the southern boundary needs re-digging. The culvert it leads to on the south-western edge of paddock 603 also needs digging out.

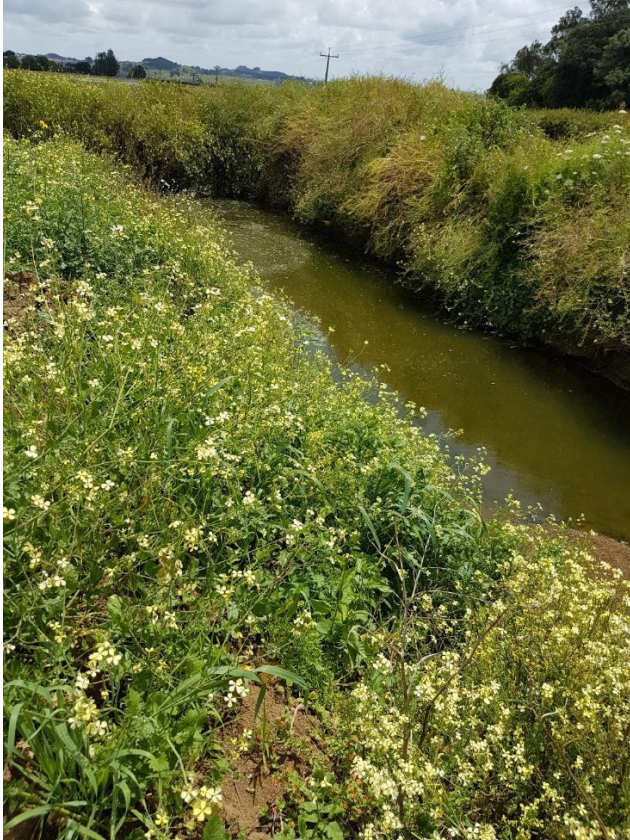
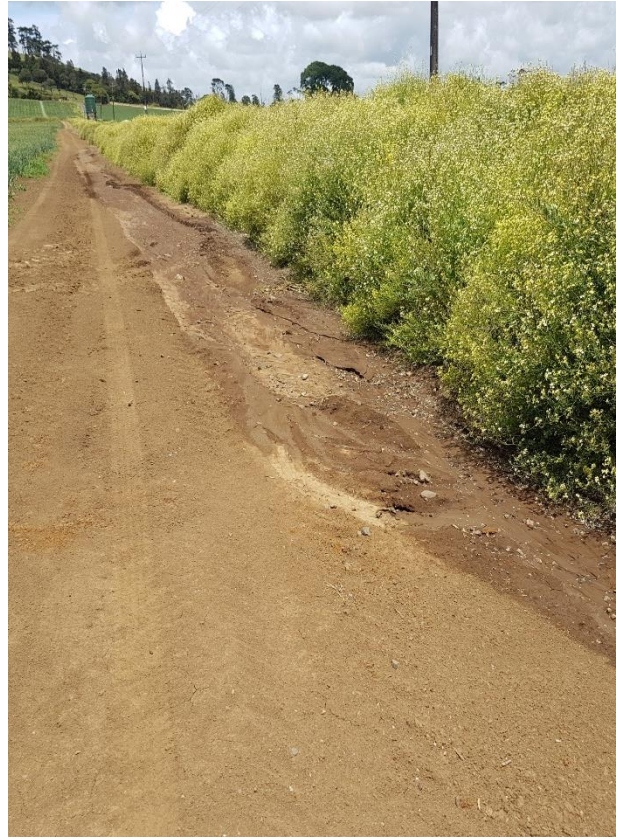
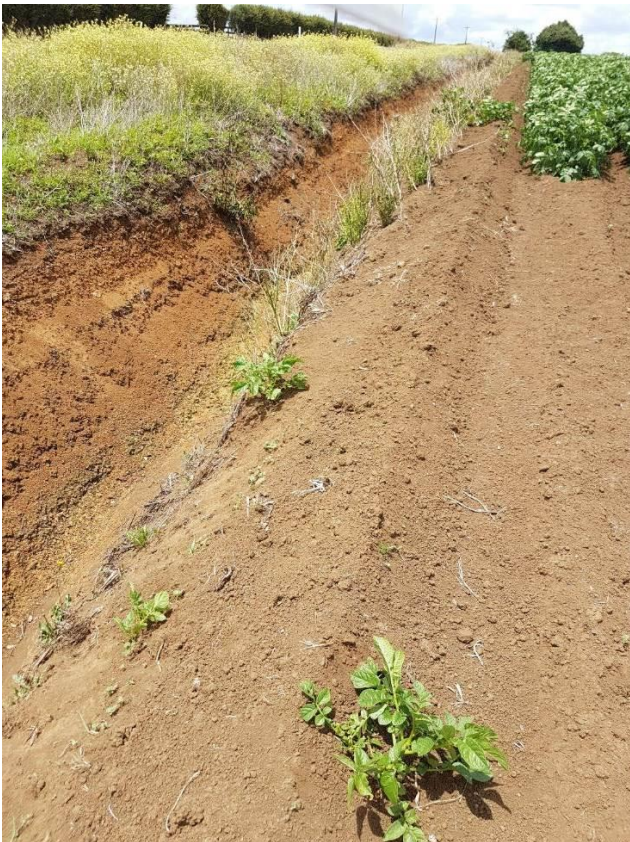
Figure 8. From top left clockwise: i) SRP3. This SRP will need to be separated from the SRP2 outflow drain. ii) Bunding at bottom of headland in paddock 604. iii) An example of cultivation too close to a drain.

10. For future best practice, do not cultivate within 1m of drains.

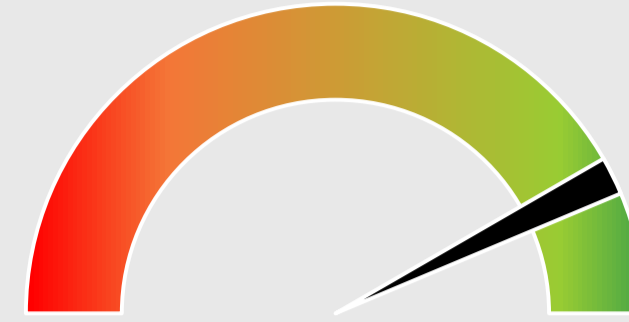
Average whole farm sediment loss with current practice:	7.9	t/ha/yr
Average whole farm sediment loss with enhanced practice:	0.25 or 2.99	t/ha/yr

Good Management Practice achieved
