14 Matahuru catchment

**Farm menus**

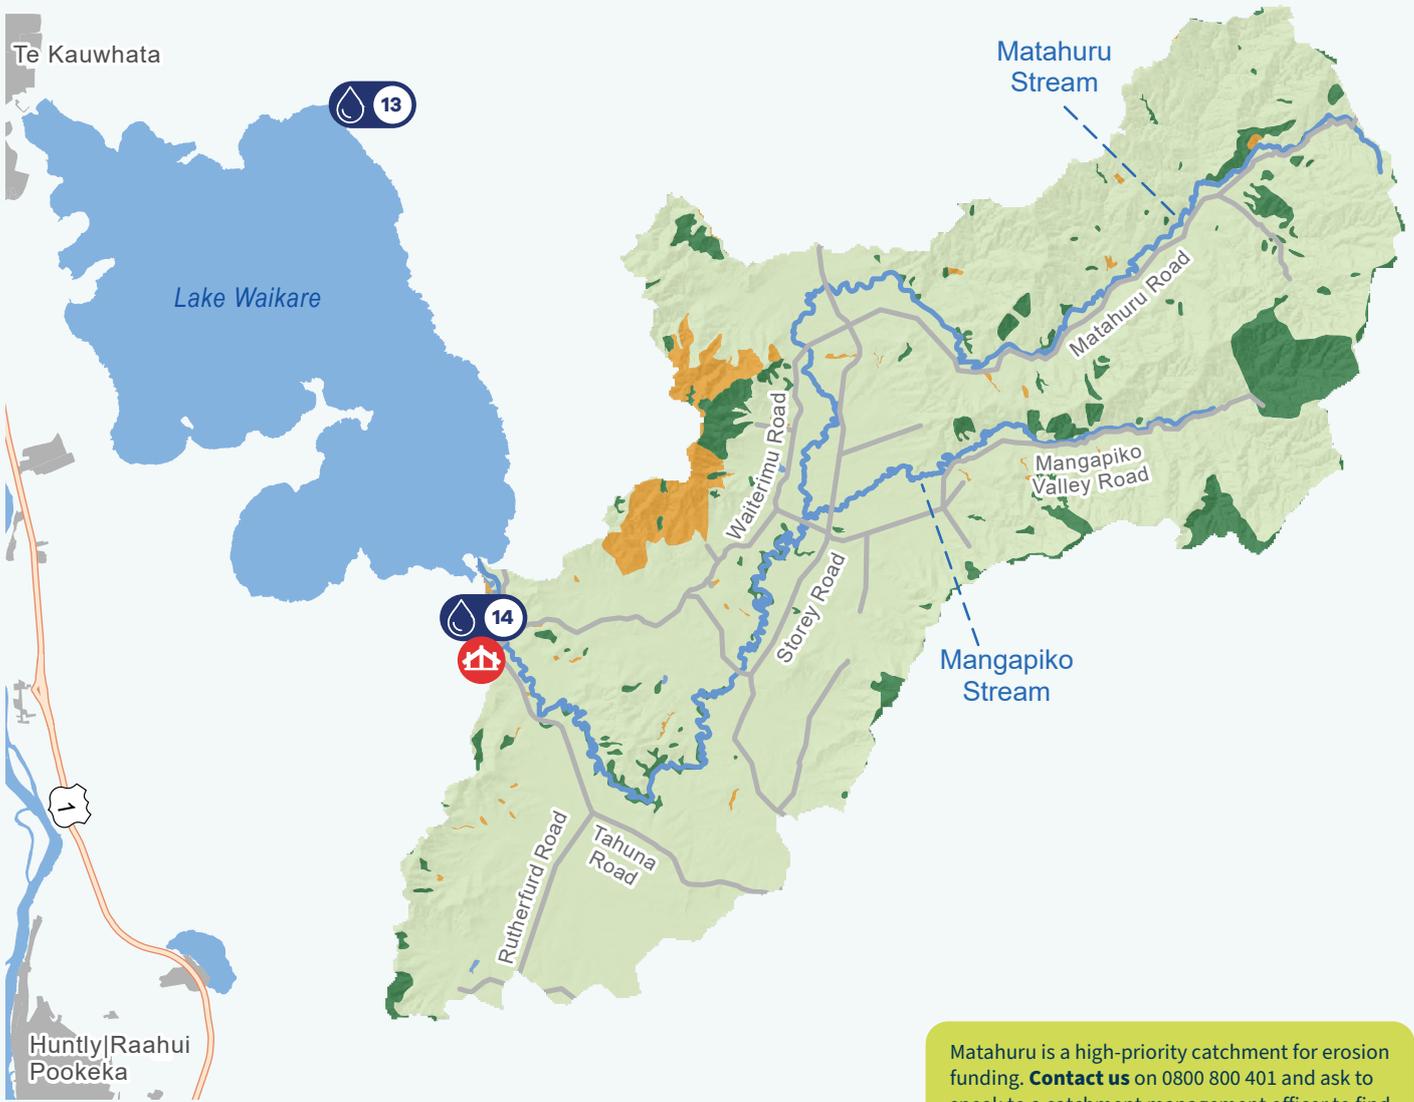
Matahuru Catchment: 10629ha

Catchment features

- Exotic forest (3%)
- Native forest (8%)
- Pasture (89%)

- Waterbodies
- Roads
- Matahuru Papakainga Marae
- Water quality monitoring point

The national land cover database (LCDB, version 6) was used to define land cover in this catchment.

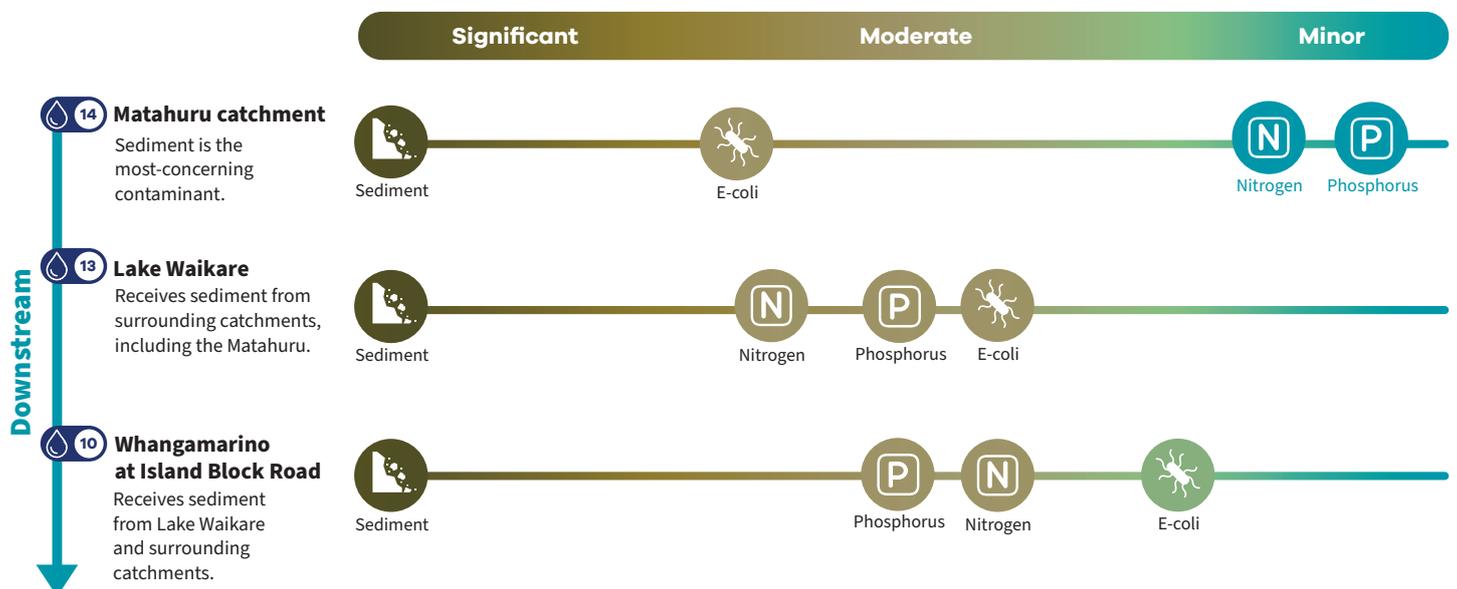
Water quality improvement for the four contaminants

This diagram shows the level of collective effort needed to positively impact water quality specific to the Matahuru catchment and further downstream. Focus on best practices within your farm and catchment, while keeping your neighbours downstream in mind.
