Limitations of guidance and disclosure deterrents for historic sheep dip sites

Limitations of Guidance and Disclosure Deterrents for Historic Sheep Dip Sites

A thesis
submitted in partial fulfilment
of the requirements for the degree
of

Master of Science in Earth Sciences at

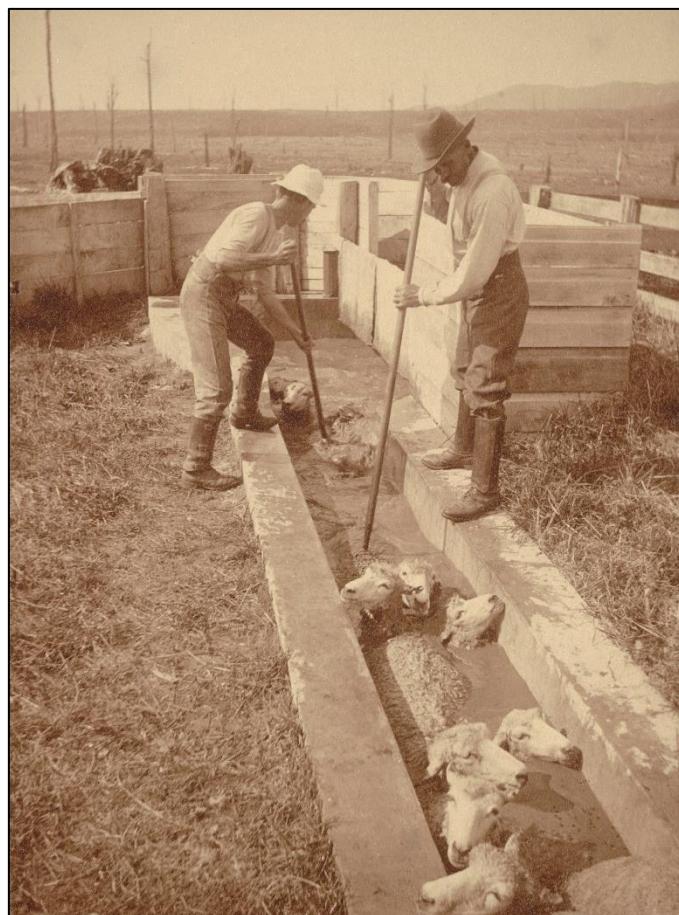
Figure 2.1 Plunge dip in use (Adkin, 1906)

Plunge or swim-through dips were commonly used on farms with large flocks as it was an efficient way of dipping large numbers of sheep (Bigwood et al., 1967). Plunge dips (Figure 2.1 and Figure 2.2) were reasonably expensive to build and maintain due to the need for the sheep to be able to easily enter and safely exit the dip without injury and stopping. Plunge dips also required large quantities of dipping fluid (William Cooper & Nephews, n.d.).

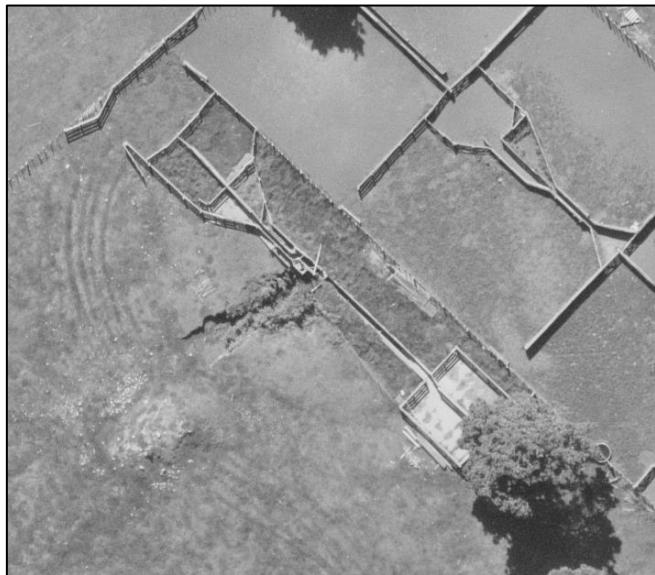
Figure 2.2 **Swim-through dip pictured aerially in 1971 (Local Government Geospatial Alliance, 1971).** Sourced from <http://retrolens.nz> and licensed by LINZ CC-BY 3.0

Despite their expense, plunge dips were commonly used in New Zealand and consisted of concrete channels filled with dip fluid. The sheep were typically funnelled into the channel and pushed to swim the length of the dip while the farmers pushed their heads into the dipping fluid to ensure full saturation (Figure 2.1). Most often, the sheep travelled in the same direction each time given the layout of the yard structures and so would emerge dripping dip solution from the same end each time, resulting in the accumulation of dip solution in the soil.

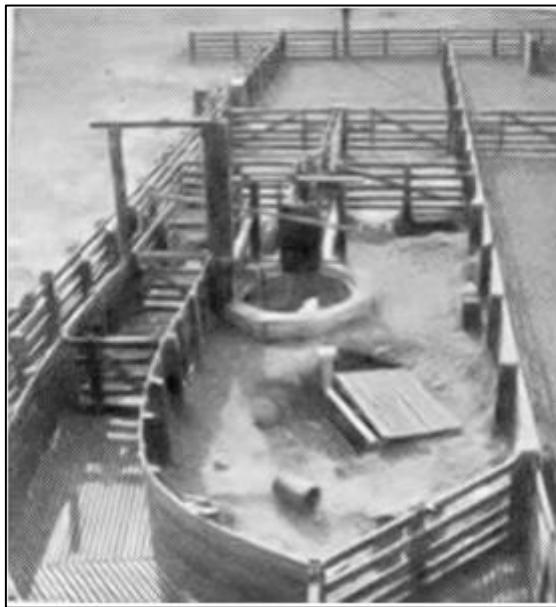
Figure 2.3 Pot dip with sump in foreground (Duncan, 1955)

According to Duncan (1955) pot dips were another common dip type in New Zealand. The pot dip (Figure 2.3) was the more affordable option for those farmers wishing to build a dip on their farm. However, pot dips did not have the same capacity and ease of use for large flocks compared with plunge dips (Duncan, 1955).

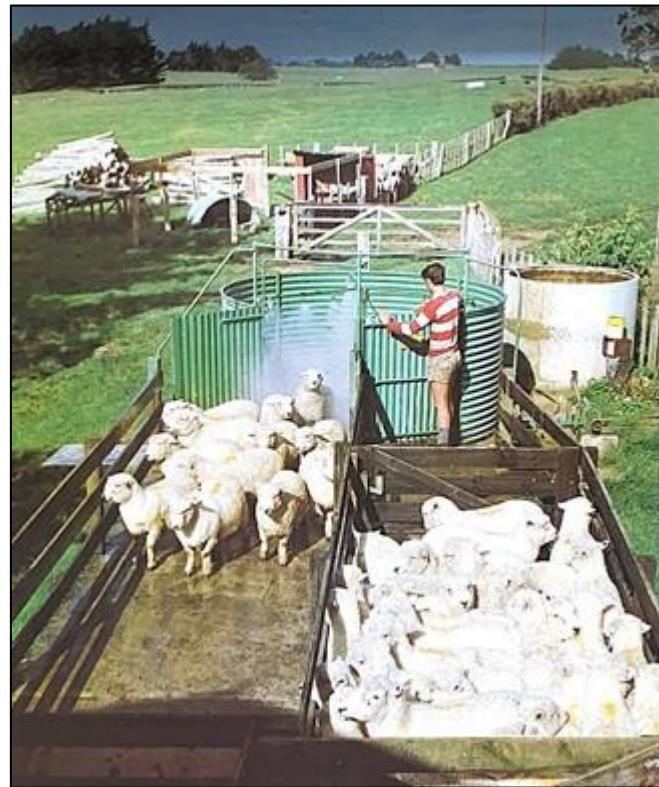
Figure 2.4 Farmer operating spray unit with sheep exiting into drainage pens (Bigwood et al., 1967)

Spray dips (Figure 2.4) were first introduced to New Zealand through their use and testing on the Ruakura Research Station in 1944 (Duncan, 1955). Spray dips were used commonly on farms with relatively small flocks of sheep (Bigwood et al., 1967). The main benefits of spray dips were that less labour was required as the dip could be operated easily by - two to three people and dipping fluid could be recycled through the system, leading to less wastage of product (William Cooper & Nephews, n.d.).

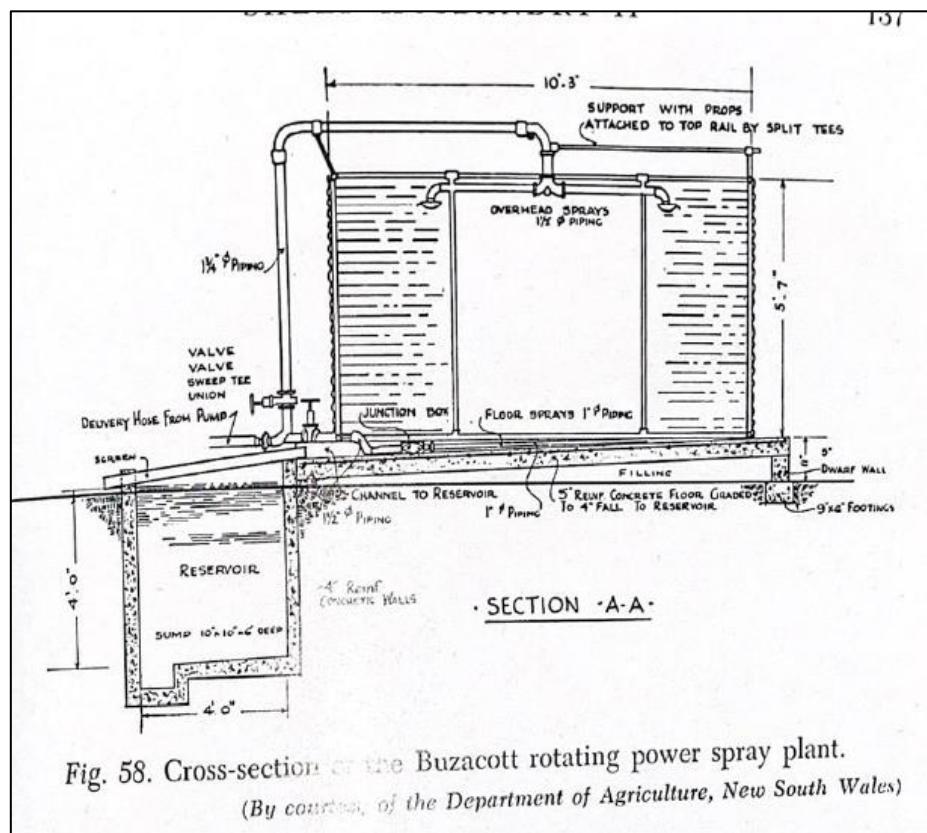
Figure 2.5 Illustration of Buzacott spray unit (Belschner, 1962)

Spray dips (Figure 2.5) were a more modern type of dip which appealed to farmers as no excavation was required and they generally used less dip solution. They were commonly circular or rectangular enclosures of corrugated iron where sheep were herded and sprayed with solution. While mobile structures often left no discernible footprint behind, due to their more recent usage/ younger age, they are the most common dip structure still seen on farms today.

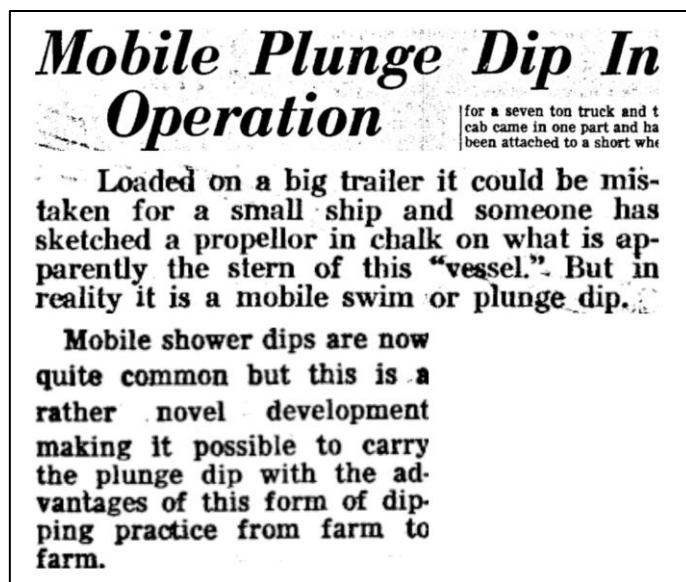
Figure 2.6 Newspaper article covering new mobile plunge dip (Press, 1965)

Mobile dipping units were also used on farms in New Zealand but are difficult to identify due to their transient nature (often shifted around the farm or brought in by a contractor). Both plunge dips and shower units were available in mobile units (Figure 2.6).

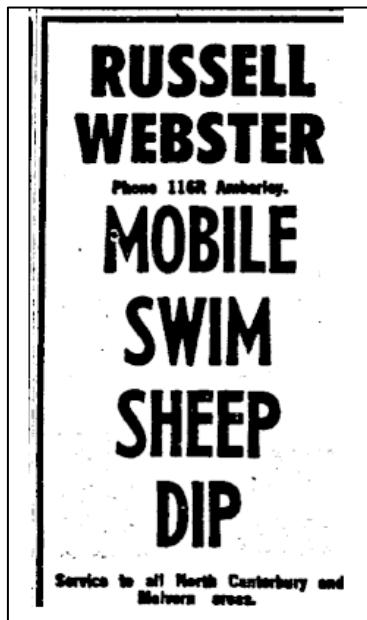
Figure 2.7 Advertisement for a mobile plunge dip in the North Canterbury area (Press, 1969)

It is unclear when mobile dipping units were introduced in New Zealand but are briefly noted in the sheep dip guidelines (Ministry for the Environment, 2006b). Advertisements for mobile dipping units can be found in historic newspapers (Figure 2.7).

- **Timeframe of use of mobile dipping units** – At the time of this research there is currently no readily available guidance on the timeframes of the use of mobile dipping units and it is unclear which chemicals were used. Through historic newspaper advertisements, it is clear that these dips were in use through to the late 1960s (Figure 2.7) indicating the potential presence of arsenic.

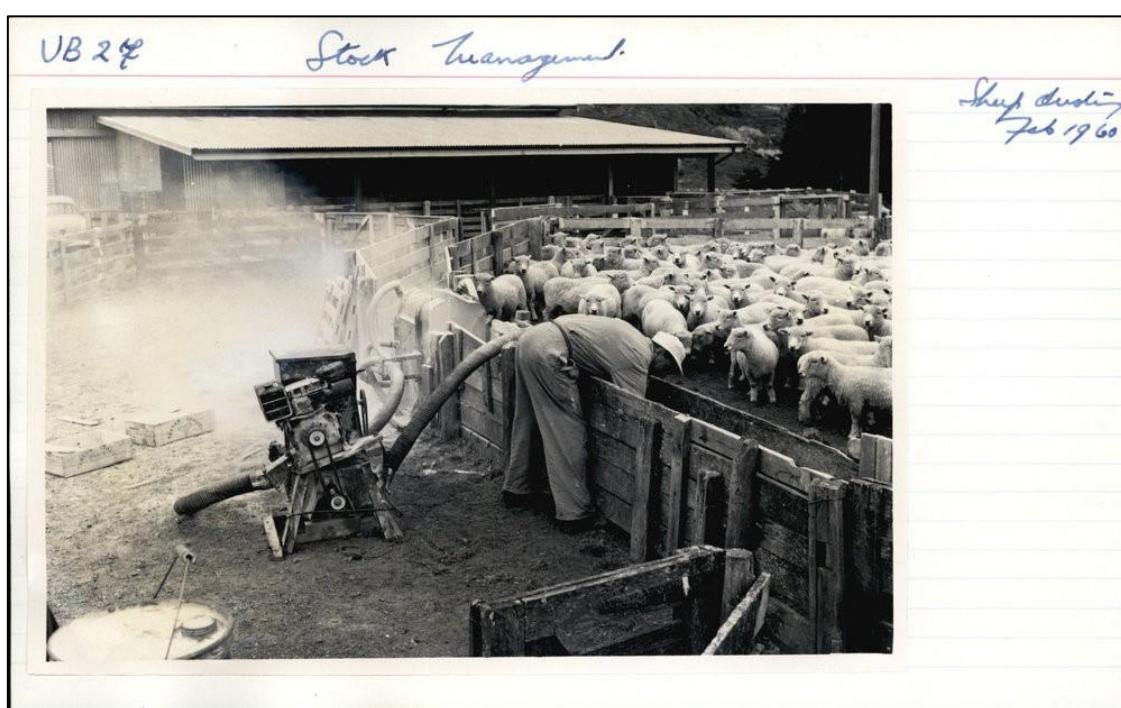
Figure 2.8 Farmer using a dusting machine in the 1960's (Agresearch, 1960). CC-BY 3.0

Dusting machines typically used a mixture of filler agents such as mineral oil or ground marble and OCP powder which was typically dieldrin as it was found to have fewer negative effects on stock than others such as DDT (Thomas, 1958). Research into dusting machines and their effectiveness was first reported in 1945 and it was found that the method was relatively effective when used as per the manufacturer's instructions.

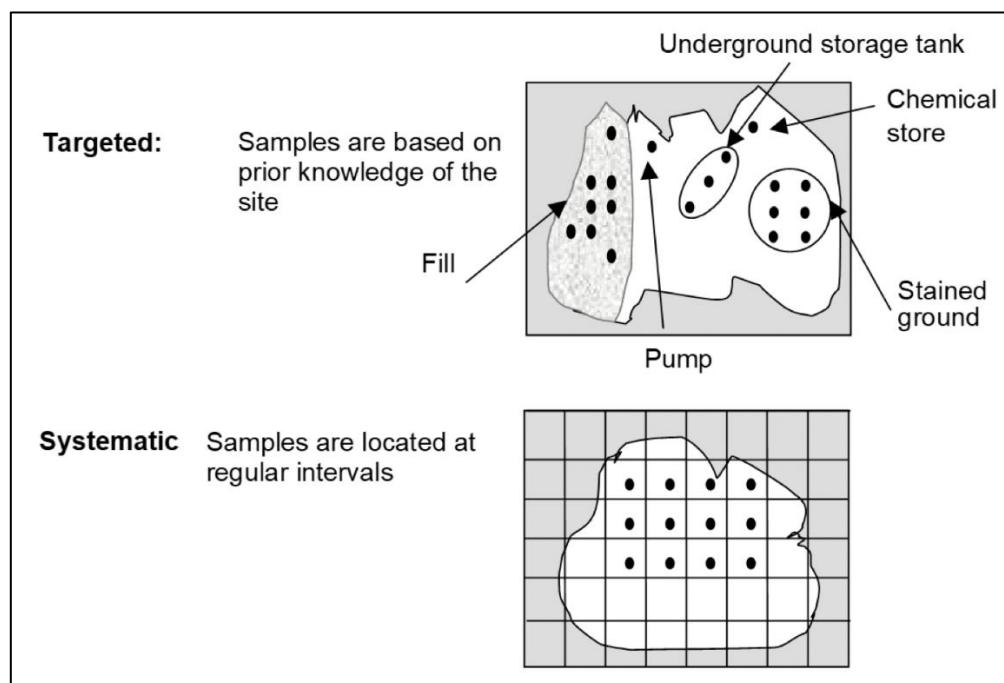
Figure 2.10 Main sampling methodologies as described in MfE CLMG No.5 (Ministry for the Environment, 2021b)

The sheep dip guidelines review multiple sampling methods and approaches including judgmental sampling (selecting specific sampling points based on site knowledge), systemic sampling using sniffer dogs to detect OCP residues and onsite sampling methodologies such as the use of a pXRF (although this technology was relatively new at the time the guidelines were published).

The guidelines consider that systemic sampling (Figure 2.10) is the most effective approach to sheep dip investigation. This sampling approach uses a grid-based sampling pattern and is used to delineate the full extent of potential contamination which reduces the risk of missing hotspots of contaminants. Although this approach was considered to produce the highest quality data, it typically carries a high financial cost and therefore is less feasible for typical contaminated land investigations. This work attempts to investigate whether predictable patterns might enable a less sample intensive, highly targeted alternative.

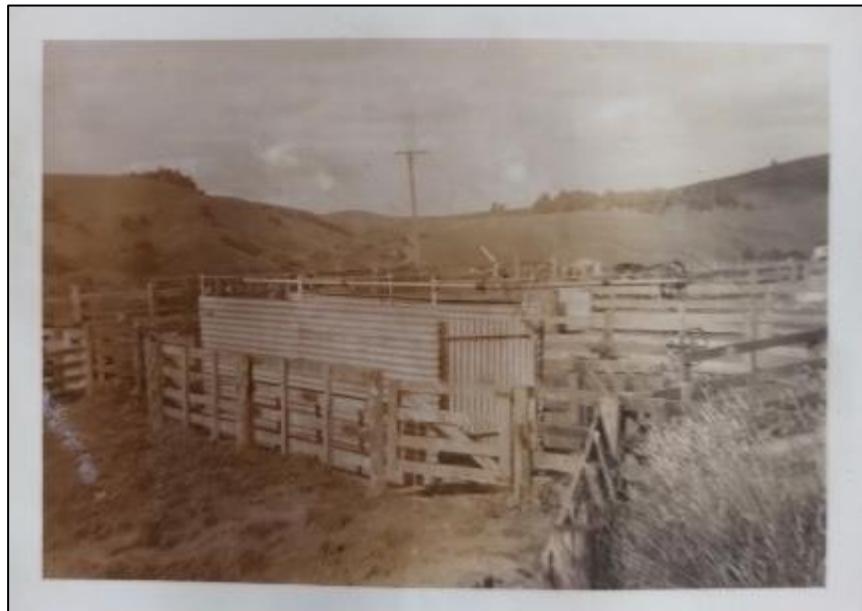
Figure 3.1 Spray shower unit historically located onsite

To ensure the anonymity of the site owner and location of dip, the sheep dip location is herein referred to as 'The Site'. The Site consists of a woolshed and stockyards constructed sometime between 1950 and 1966 (according to available historic aerial imagery). The site owner provided an undated image of the spray shower unit (Figure 3.1).

Based on the shape/design evident in Figure 3.1, the unit was likely a Stewart reciprocating sheep shower (Duncan, 1955). As the shower unit was constructed earlier, sometime between 1950 and 1966, there was a likelihood that both arsenicals and organochlorine pesticides were used in the dipping practices, therefore soils were tested for both heavy metals and organochlorine pesticides.

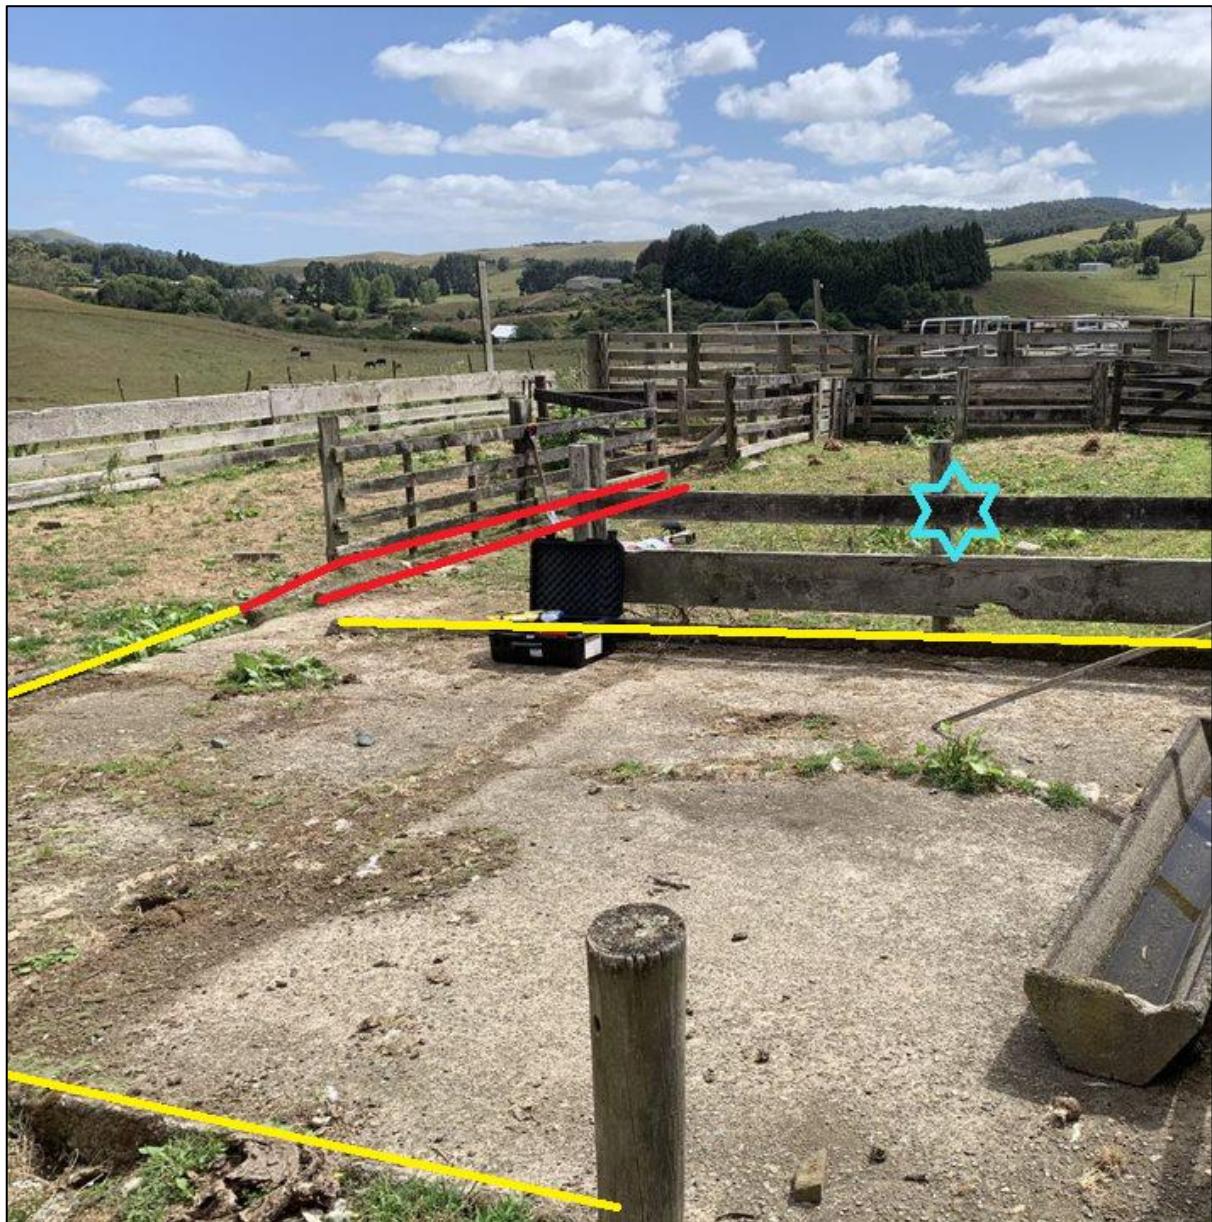
Figure 3.2 Picture across historic sheep unit area from the woolshed. The red outline indicates the historic spray unit location, the yellow outline indicates the drainage pads, and the blue star indicates the location of the spray unit sump as indicated by the site owner.

The site was visited on the 27th of January 2022. The weather conditions at the time of sampling were fine with some clouds. At the time of the visit, the spray unit had been removed (Figure 3.2) but the woolshed and surrounding stockyards were still in place. The site owner noted that the sump was still in-situ, but had been covered by soil in the centre of the pen (Figure 3.2)

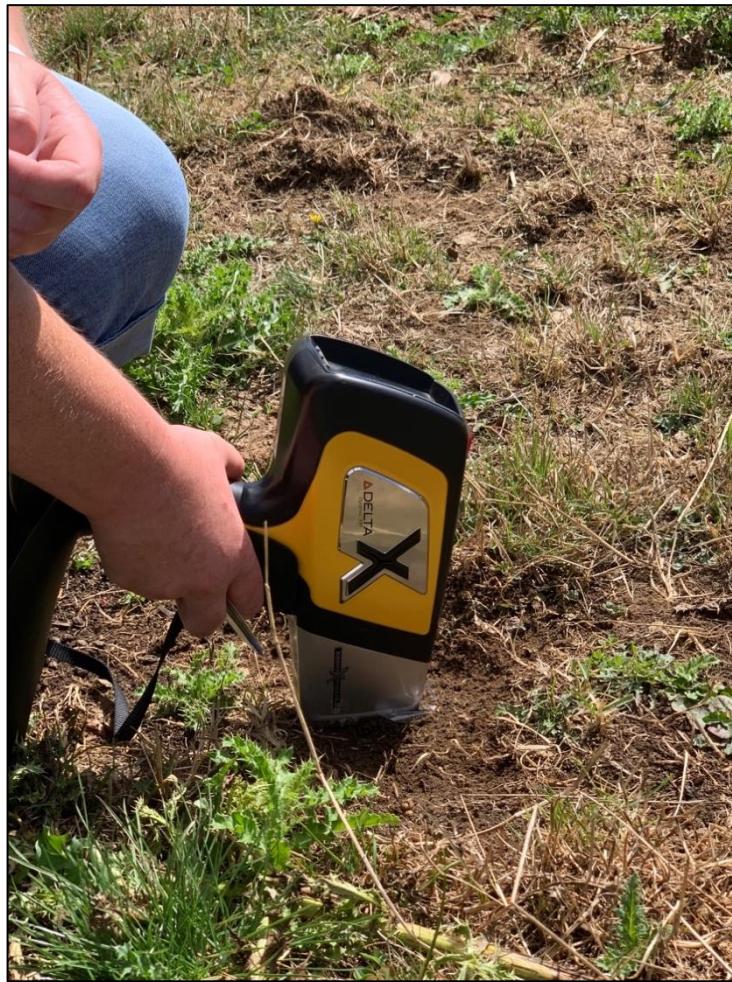
Figure 3.3 Olympus Delta pXRF in use on the site

Site investigation for historic sheep dip contamination was undertaken through a combination of in-situ analysis of heavy metals using a portable X-ray fluorescence analyser, specifically the Olympus Delta pXRF (Figure 3.3) and an analysis of collected soil samples (heavy metals and organochlorine pesticides). Organochlorine pesticide samples were only taken in locations where the highest heavy metal concentrations were found to confirm presence/absence, as it was assumed that if the dip had been used consistently throughout its life, the same area would be affected by both contaminant types.

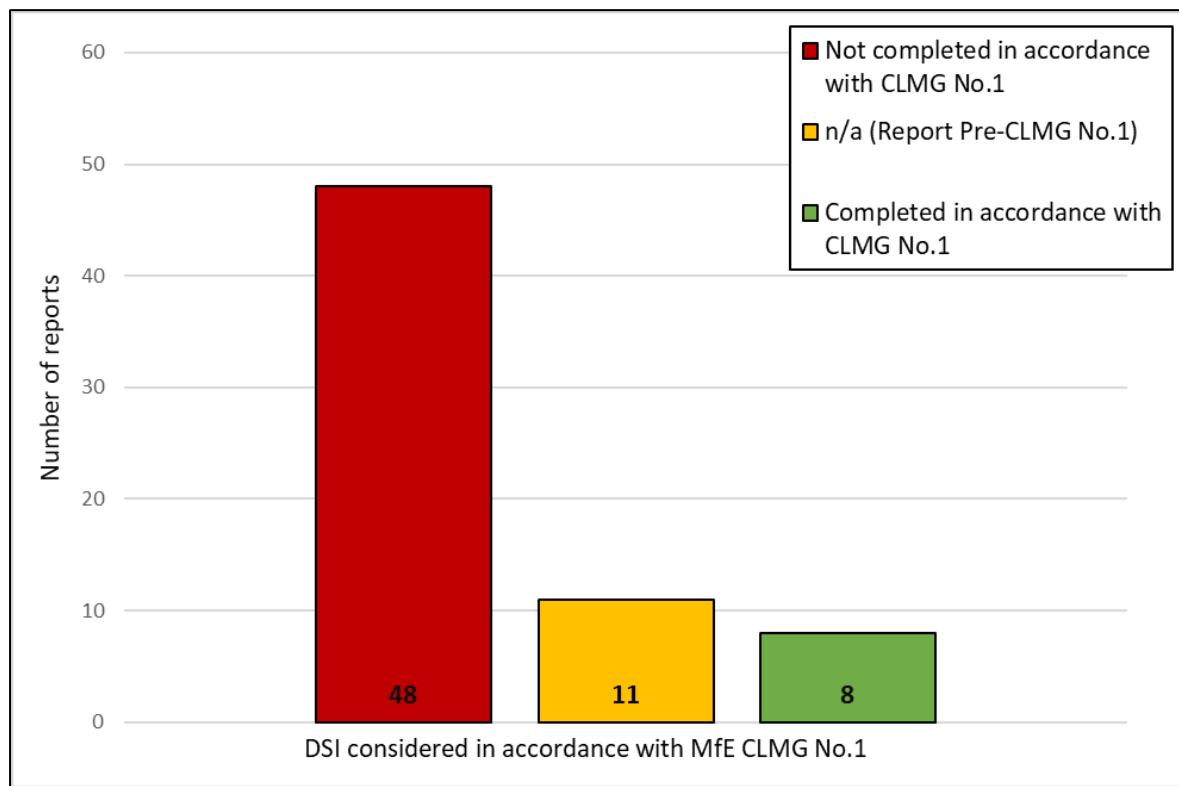
Figure 4.1 Graph showing the number of reports completed in accordance with MfE CLMG No.1

Approximately 48 of the total 67 (72%) DSIs received that were reviewed against MfE CLMG No.1 were found to not be completed in accordance with guidelines (Figure 4.1). The values noted as n/a (Figure 4.1) were taken from investigations that were completed prior to the release of MfE CLMG No.1 and therefore cannot be compared with the guidance. The DSIs that fall into this category account for 16% of reports reviewed. Of the DSIs reviewed, approximately 12% were considered to be completed in accordance with MfE CLMG No.1 (Figure 4.1).

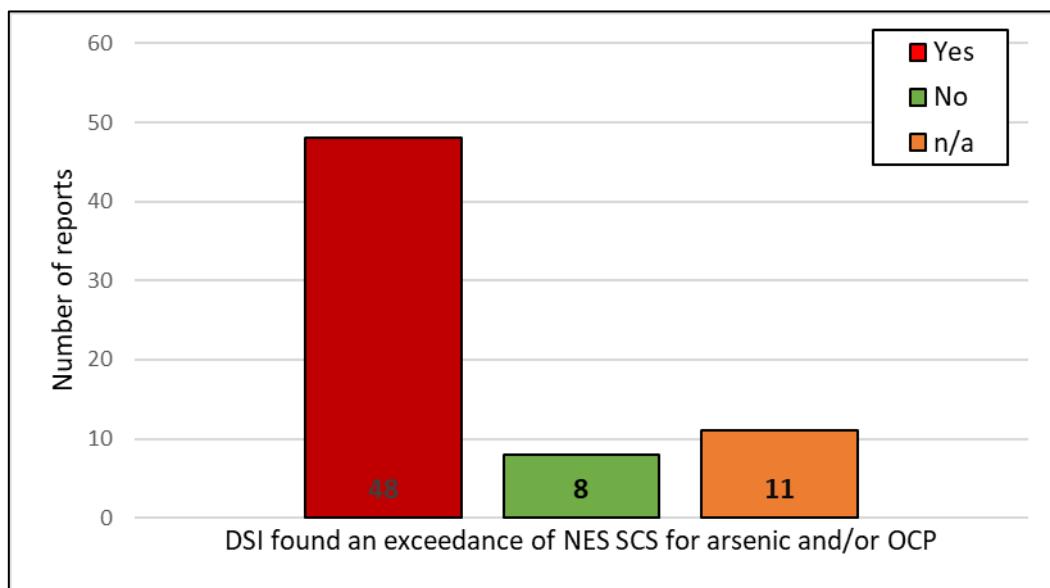
Figure 4.2 Graph showing the number of detailed site investigations which found exceedances of NES SCS for the intended land use

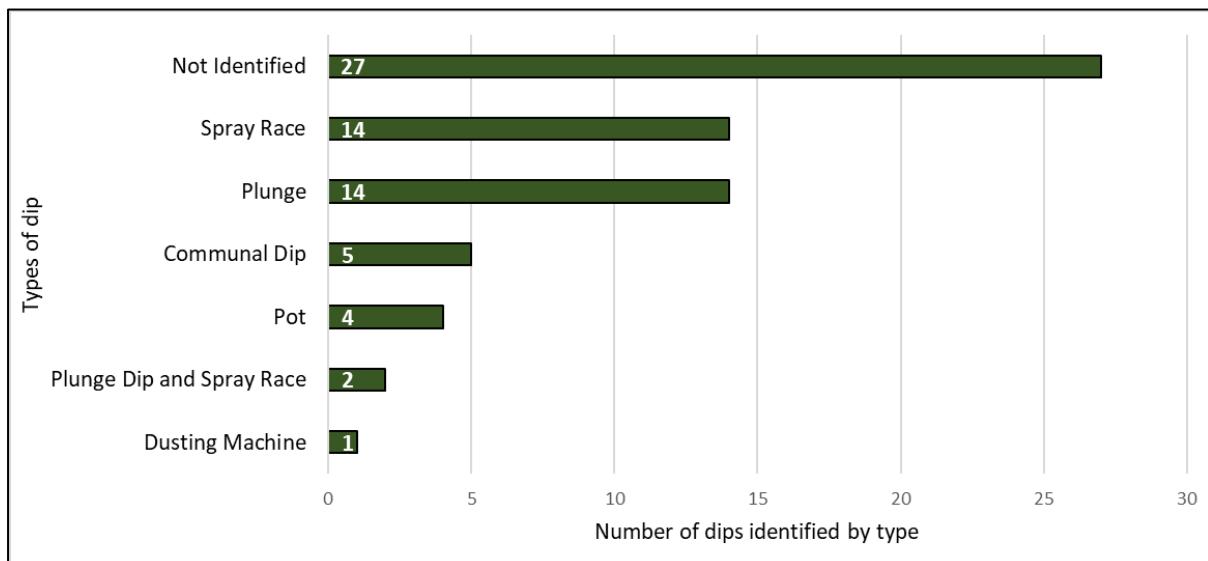
Figure 4.3 Graph showing the number of each dip type identified by DSIs

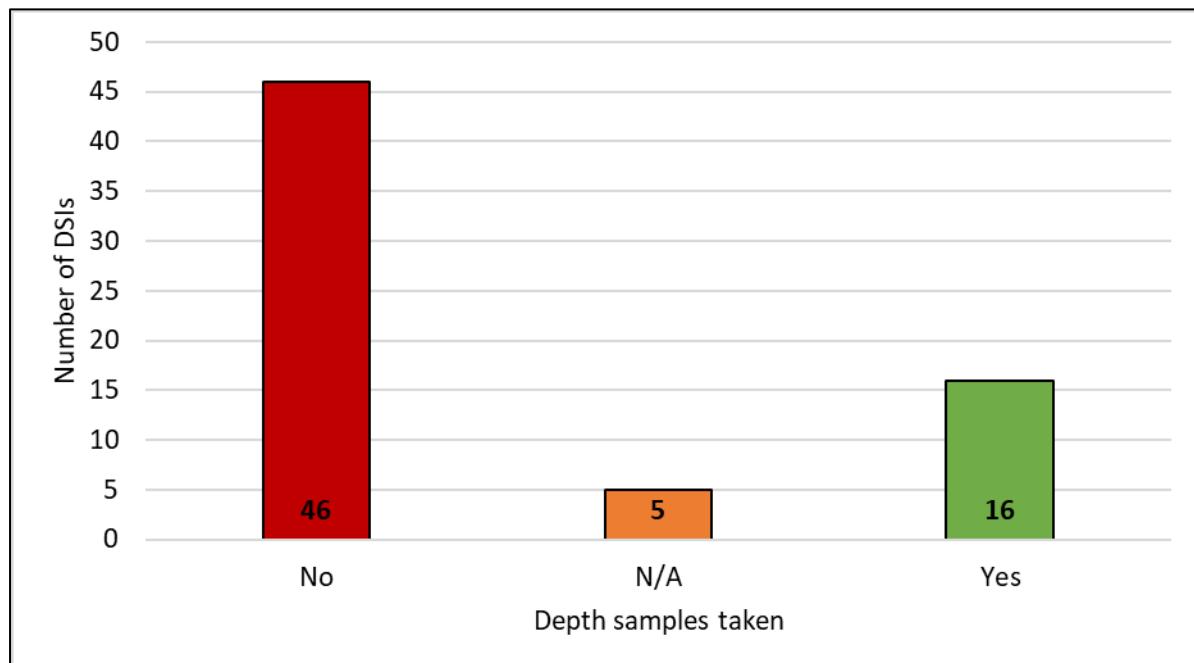
Figure 4.4 Graph showing the number of DSIs that included soil samples at depths greater than 300mm

Out of the 67 DSIs provided, 46 (68.5%) did not provide any depth sampling beyond 300 mm depth (Figure 4.4). Of the remaining DSIs, 16 (24.5%) did provide sampling at depth and the remaining 5 DSIs (7.5%) were completed as either part of interim reporting/revisions to existing reports and it was unclear if depth sampling had been completed (Figure 4.4).

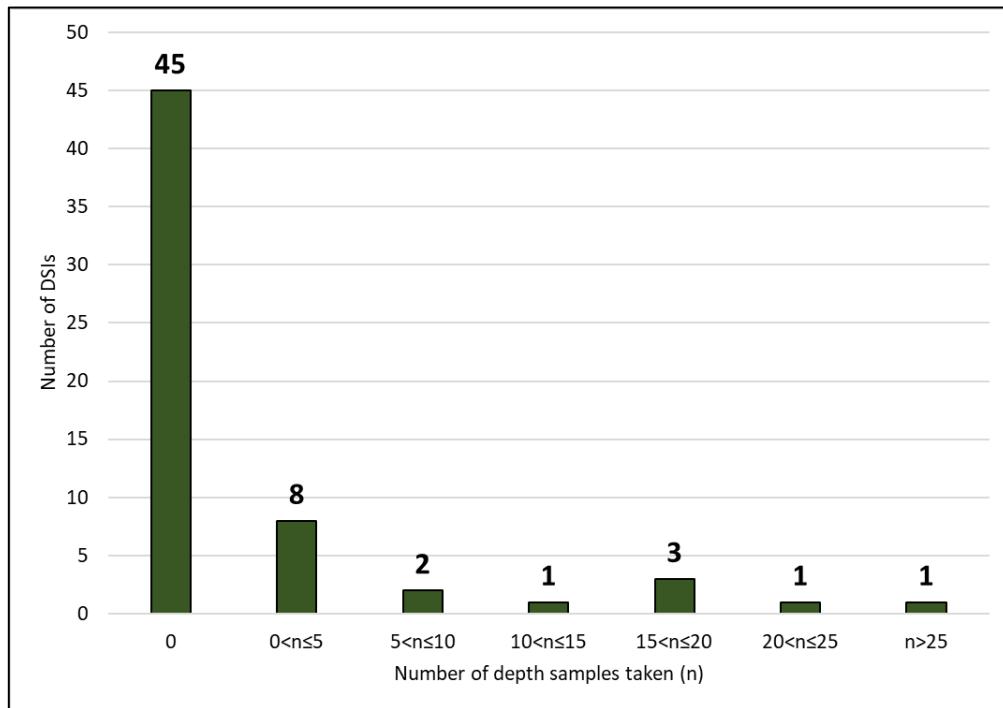
Figure 4.5 Number of depth samples taken by DSIs that analysed depth samples

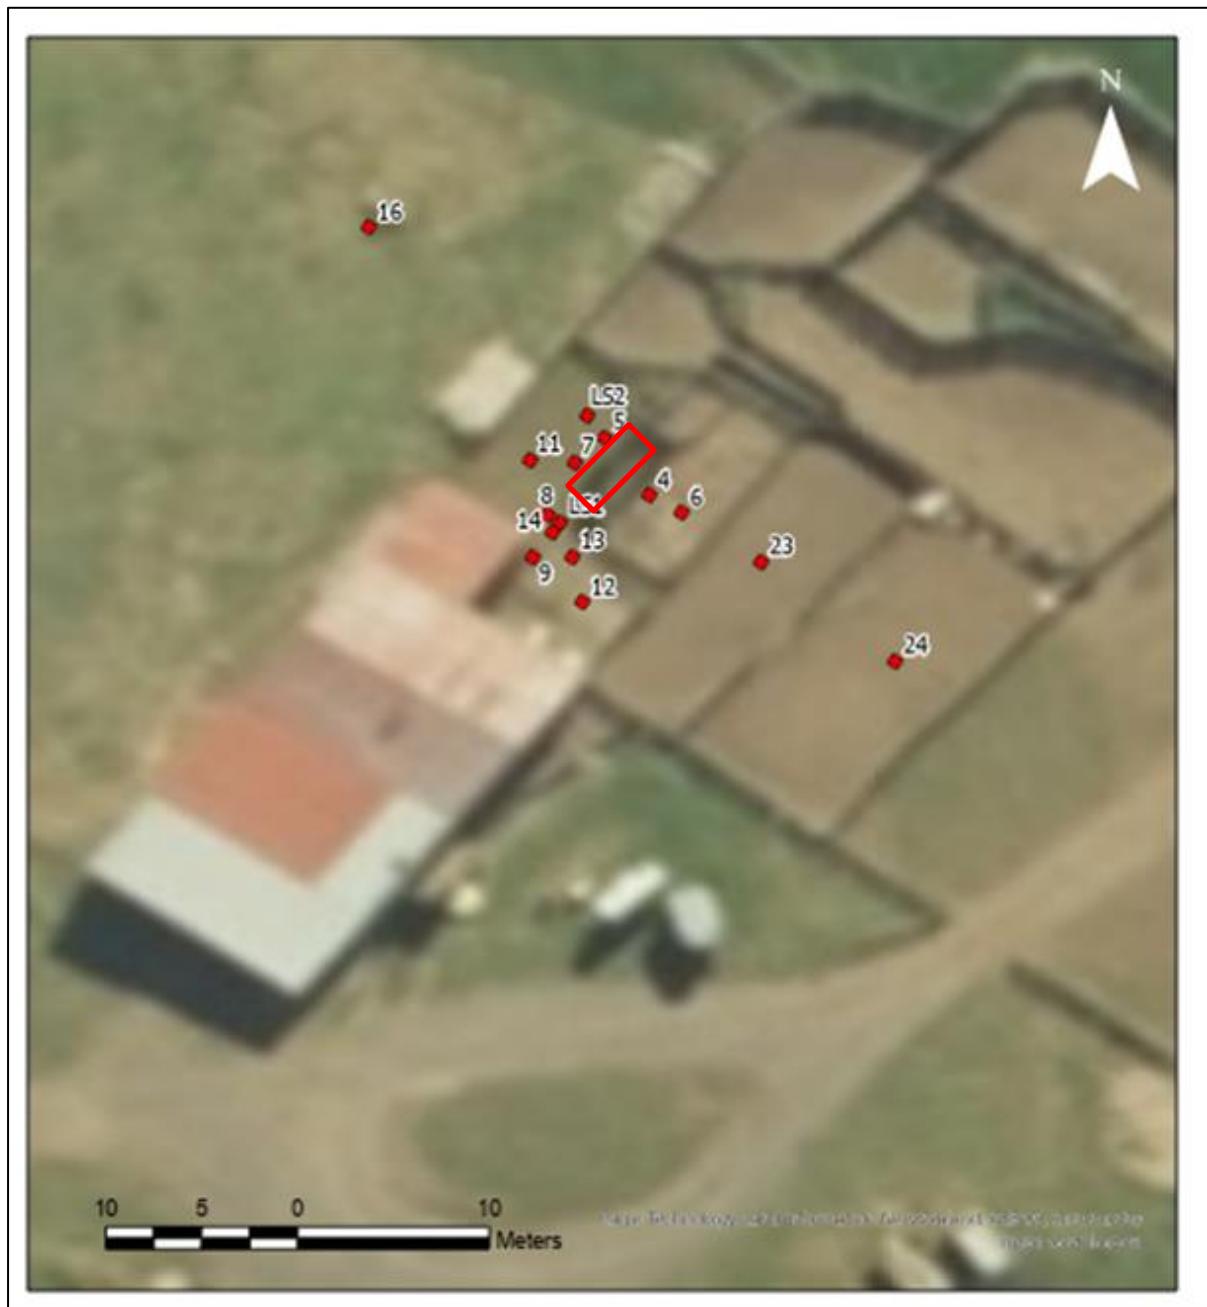
Figure 4.6 Soil sample locations at the site as detailed in Table 4.1, red rectangle indicates the location of the historic spray unit. Sample labelled with LS are samples submitted for lab analysis.

The site (Figure 4.6) consisted of a woolshed, stockyards, and the concrete remnants of the historic spray unit.

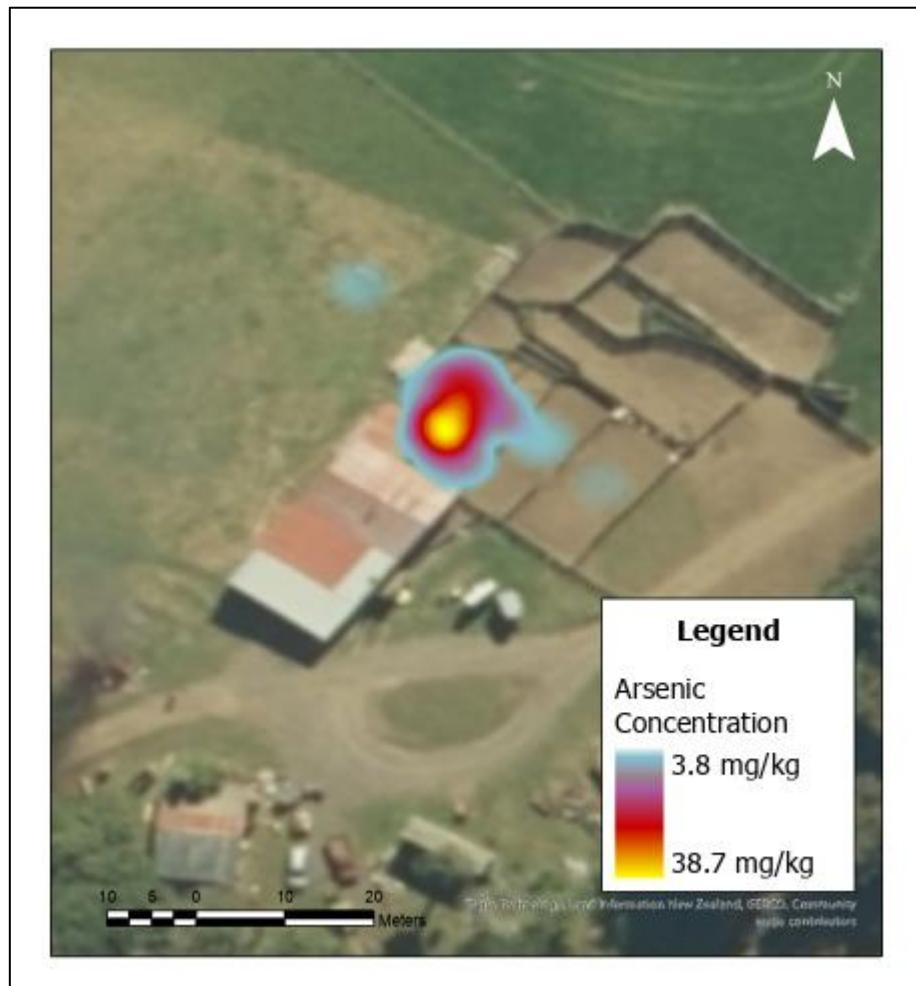
Figure 4.7 Arsenic heat map of sampling area (not including timber fence post sample). Red shading indicates higher levels of arsenic, blue indicates lower levels of arsenic.

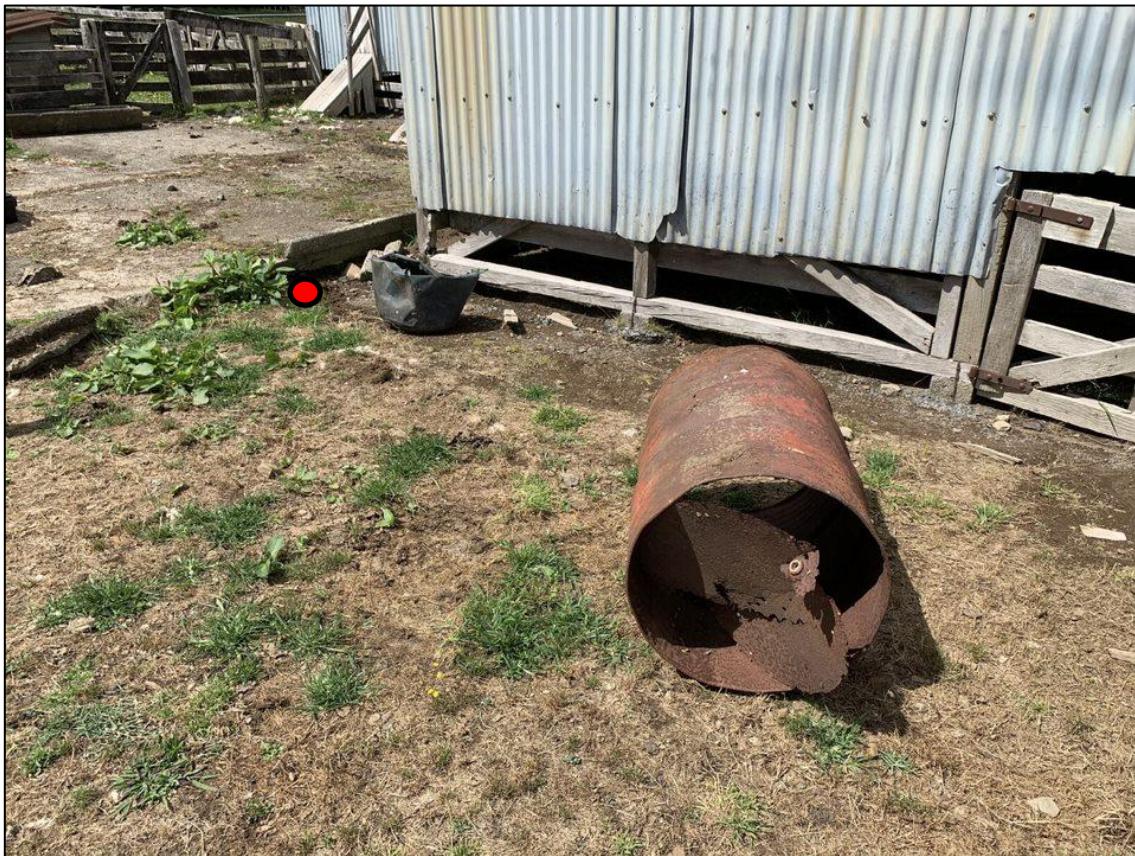
Figure 4.8 Rusted drum and container in the vicinity of sample 9 (indicated by the red point)

Samples 9 and 11 were taken adjacent to the drainage pad of the historic spray unit. Sample 9 was taken on the north-western edge (the assumed direction of drainage) of the drainage pad in the vicinity of a rusted drum and container. It was unclear what the use of the drum and container was as there was no clear labelling, and both were in a deteriorated condition (Figure 4.8), however, arsenic was found in this location in excess of NES SCS for rural residential land use (17 mg/kg). Sample 11 was taken from the edge of the drainage pad, arsenic was found to be elevated above background levels but was found to be below the NES SCS for rural residential land use (17 mg/kg).

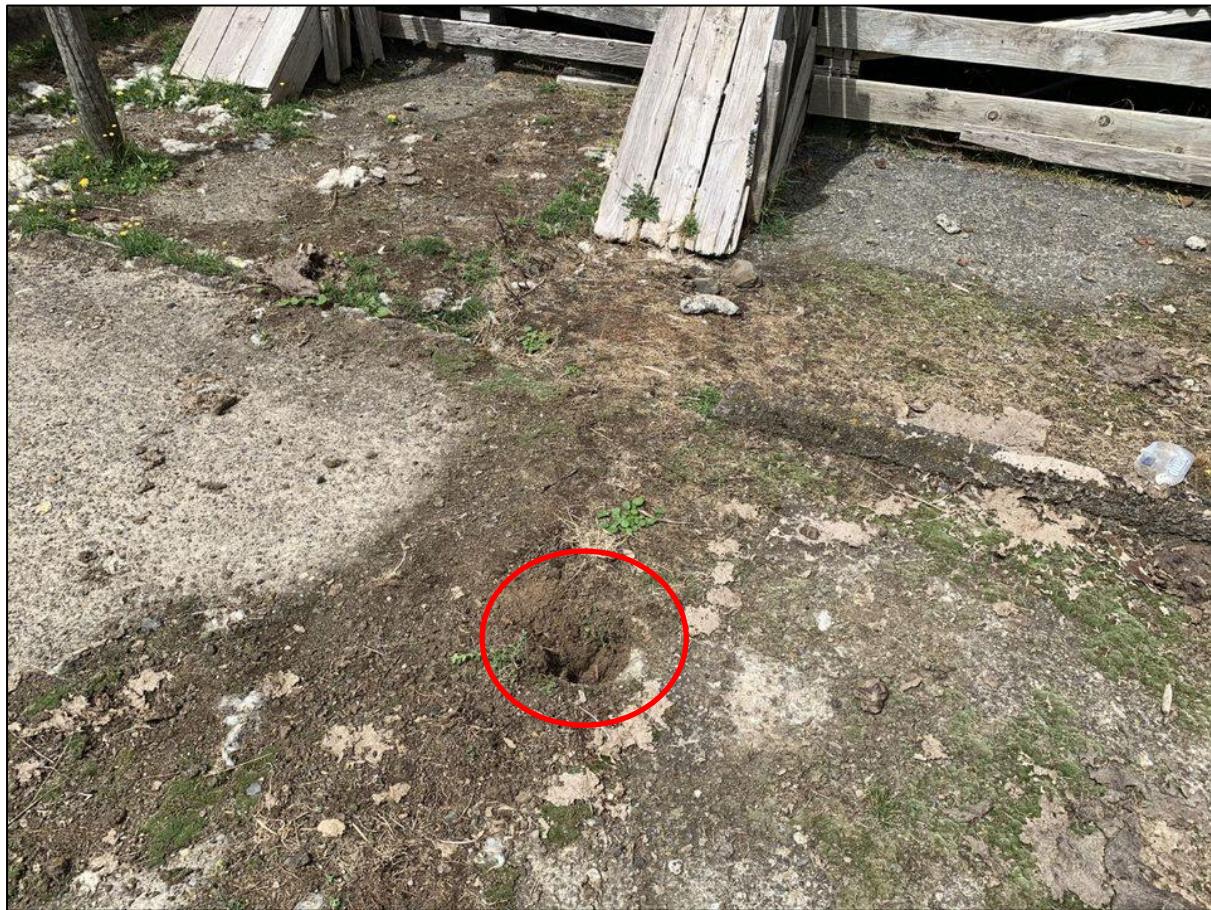
Figure 4.9 Hole in drainage pad where sample 12 was analysed (indicated by red circle)

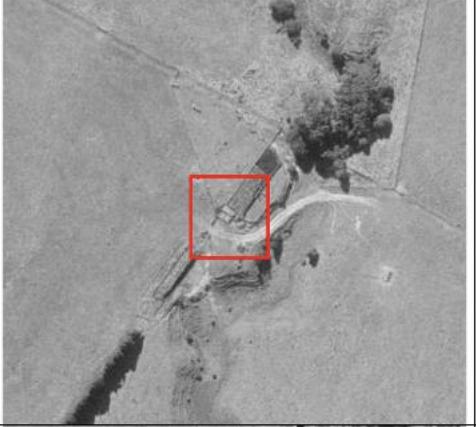
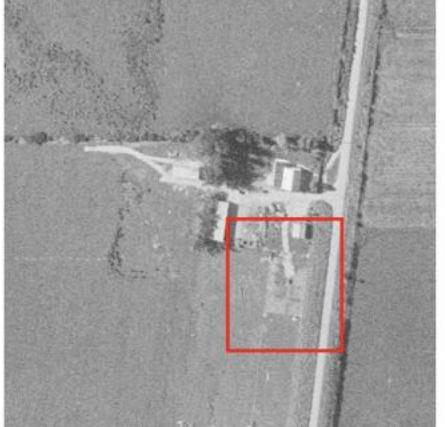
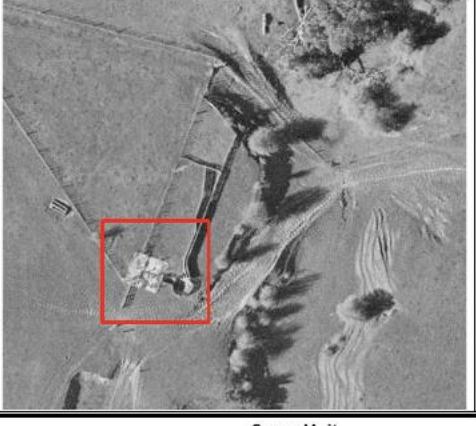
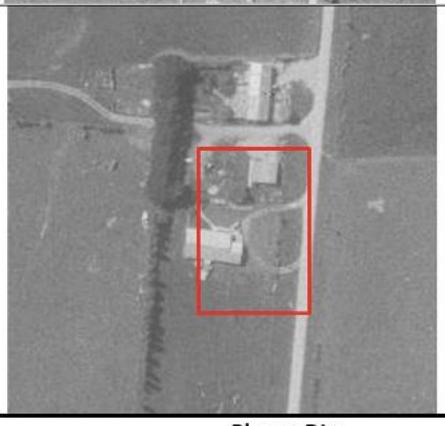
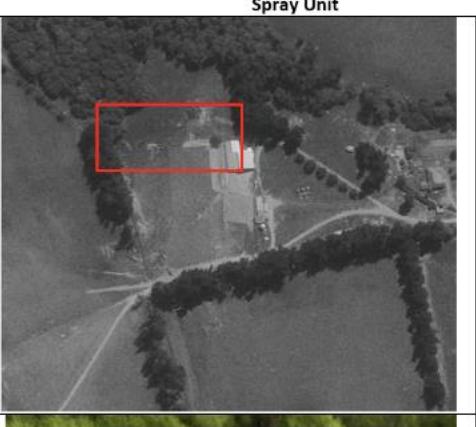
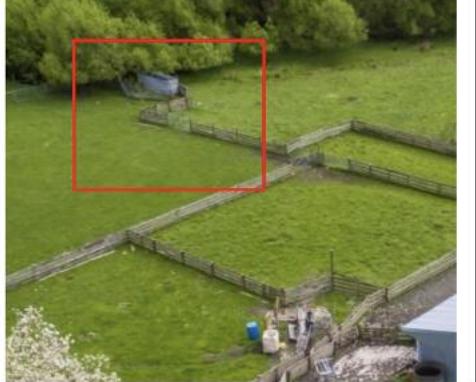
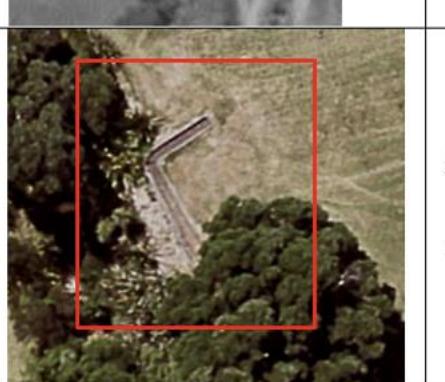
Figure 5.1 Images of known sheep dip locations with features that significantly differ from those indicated as identifying features in the sheep dip guidelines. Sheep dips are identified by the red box. LGGA images are sourced from <http://retrolens.nz> and licensed by LINZ CC-BY 3.0

Currently the sheep dip guidelines only provide limited guidance regarding the identification of historic sheep dip sites from a desktop survey. Desktop surveys often consist of a review of historic aerial imagery for sites, which is where historic HAIL activities are most often identified. Historic aerial imagery is used by local government to add sites to their contaminated land registers and also by practitioners' conducting initial research on a site for investigations. The main indicators of a potential sheep dip noted in the sheep dip guidelines as stockyards, woolsheds, and a water source (Ministry for the Environment, 2006). There, however, appears to be significant variation in the layout of each sheep dip site, with some being visible and easily picked up in aerial imagery to sites that it may not initially be apparent that a sheep dip was once present (Figure 5.1).

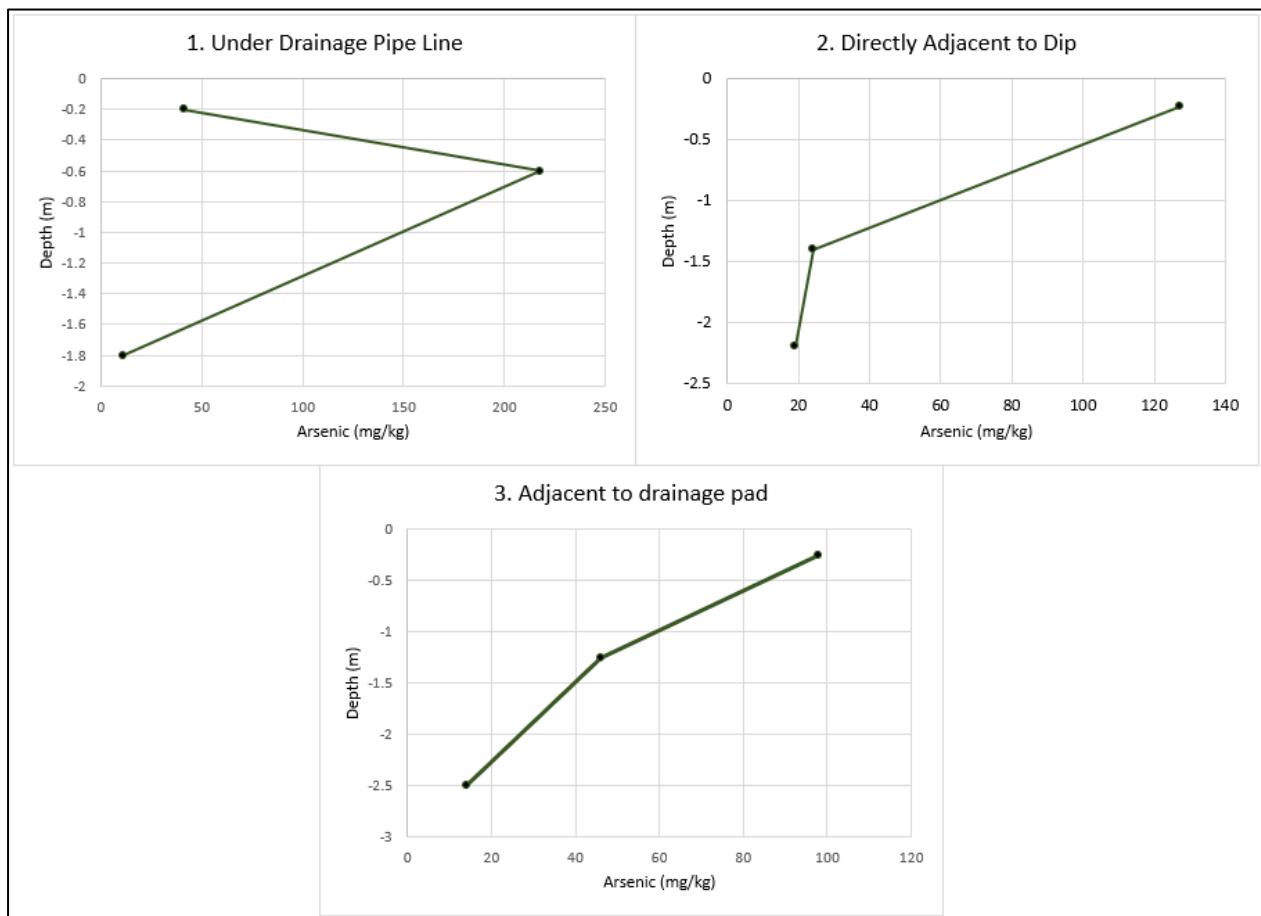
Figure 5.2 Graphs showing the changes in arsenic concentrations (mg/kg) at depth. The three graphs represent three sampling locations from a pot dip DSIs reviewed as part of the methodology.

Due to the lack of an adequate site history in the reviewed DSIs, limited discussion regarding the rationale behind sampling design was provided. As there was often limited knowledge about environmental factors such as soil type, the potential for vertical migration of contaminants was often ignored. At least 69% of DSIs reviewed did not provide any depth sampling or assessment of potential vertical migration of contaminants. Due to the lack of depth sampling, it is considered that the sites investigated were not fully characterised and therefore pose a risk to future remediation, management plans and human health.

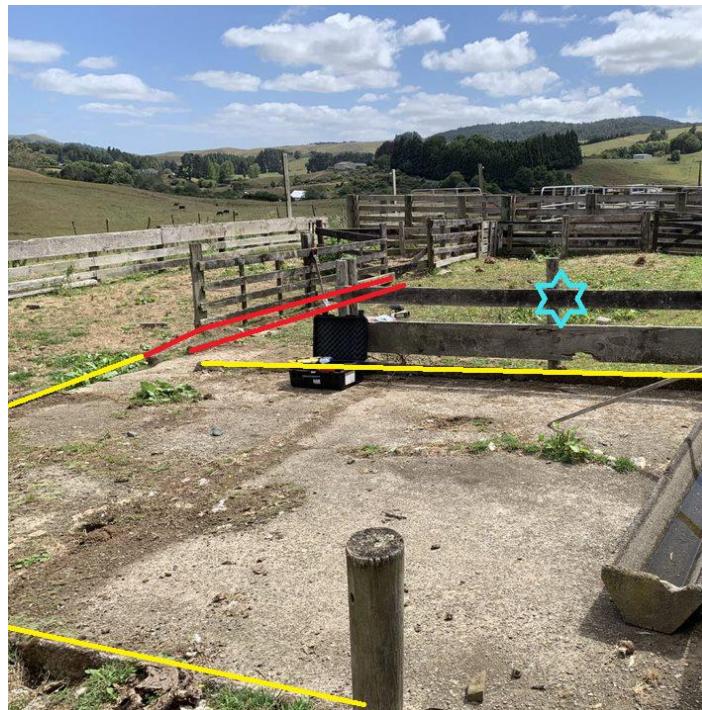
Image 1: Picture of sheep yards showing location of unit, drainage pens and sump

The site was visited on 27th of January 2022 as a spray unit was historically located onsite. The weather conditions at the time of sampling were fine with some clouds. At the time of the visit, the spray unit had been removed, but the woolshed and surrounding stockyards were still in place. The site owner noted that the sump, although not visible, was still in-situ but had been covered by soil in the centre of the middle pen (approximate location is denoted by the blue star below in image 1). The spray unit had been removed, but the concrete base (red area in image 1 below) and drainage pad (yellow area in image 1 below) remained in place.

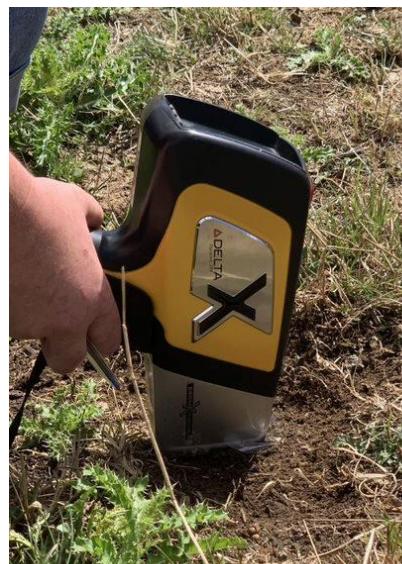
Image 2: pXRF in use onsite

The pXRF was calibrated prior to and during sampling using provided stainless steel calibration plates, soil standard (2711a) and SiO₂ standard. Plants and any large debris were removed from the soil surface, a film was placed on the soil surface to protect the pXRF (as seen in image 2 below) and the sample was analysed. Samples highlighted in the results table below indicate that they have been taken at depth (10-15 cm below ground level). Heavy metals included in the discussion are common contaminants found in areas of sheep dipping, chromium was also included as it may help indicate sources of arsenic (i.e., elevated copper, chromium and arsenic may indicate that the soil has been affected by treated timber).
