Limitations of guidance and disclosure deterrents for historic sheep dip sites

Limitations of Guidance and Disclosure Deterrents for Historic Sheep Dip Sites

A thesis
submitted in partial fulfilment
of the requirements for the degree
of

Master of Science in Earth Sciences at

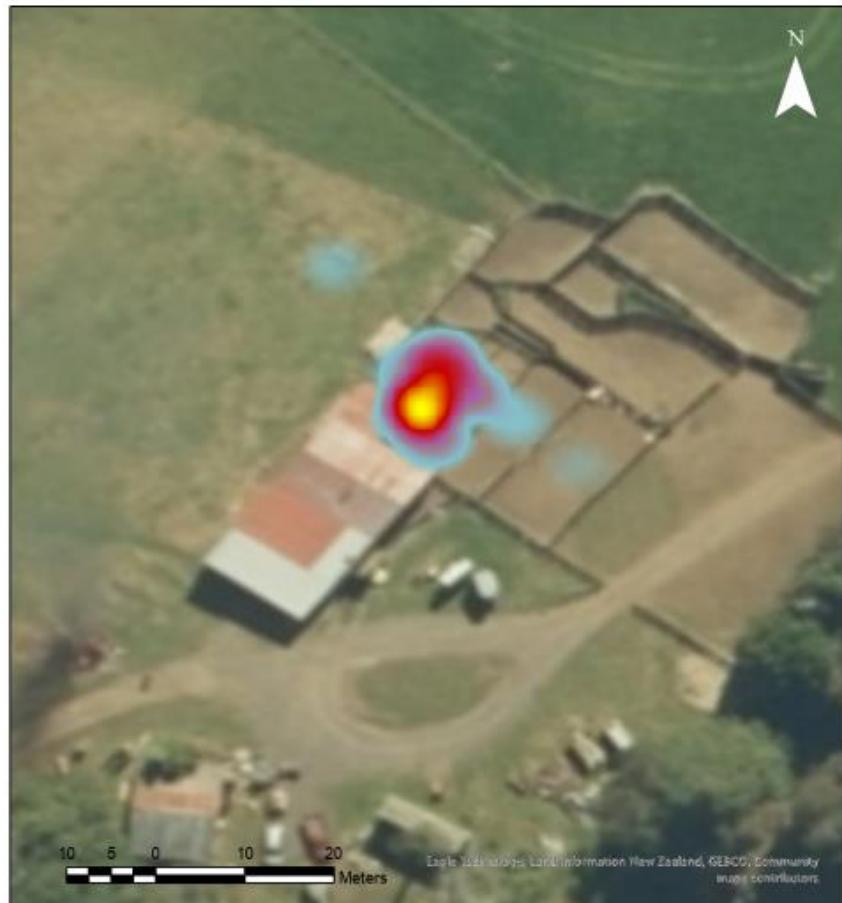
Heatmap of arsenic concentrations in surface samples:

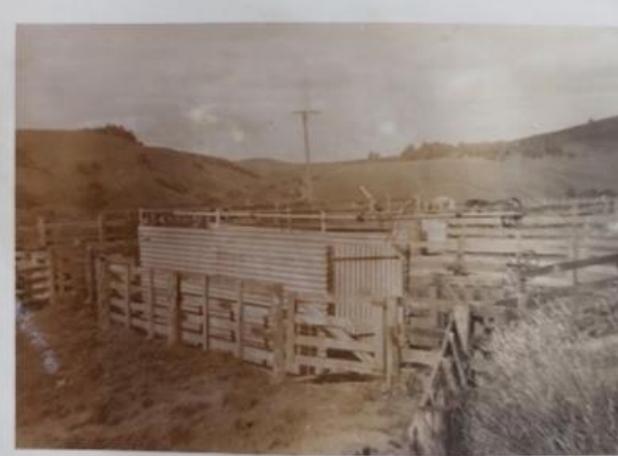
Historic photo provided by site owner showing spray unit (Unknown date)

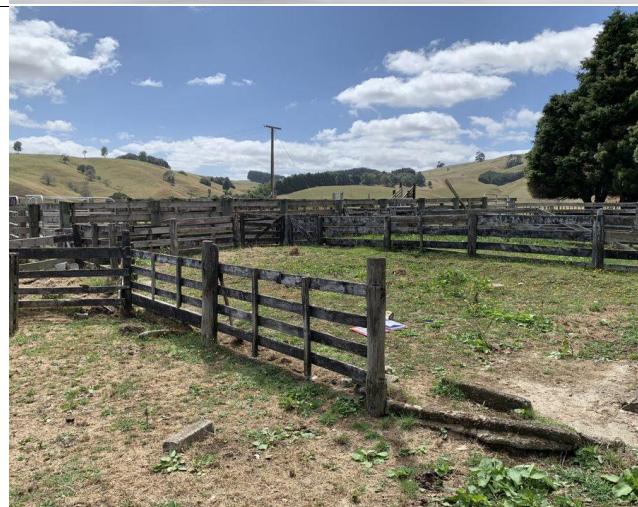
Photo of spray unit area taken at approximately the same place as the historic image

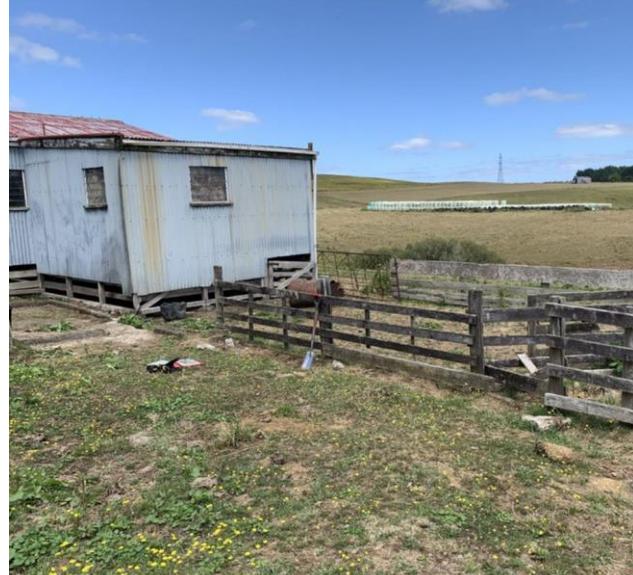
Spray unit area and entrance to concrete drainage pads

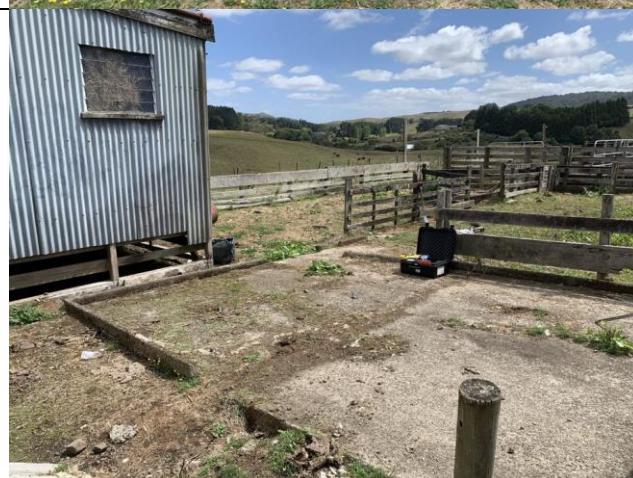
View from woolshed looking across drainage pads towards the spray unit

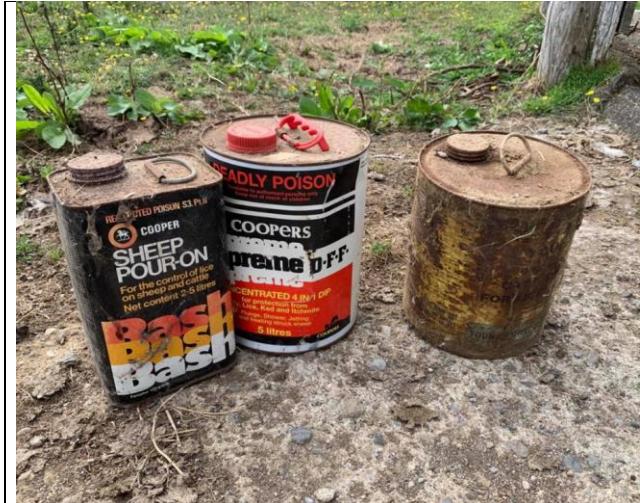
Chemicals stored in HAZCHEM storage onsite that were historically used onsite (from left to right with active ingredient):

- Coopers sheep pour on - Famphur
- Organothiophosphate
- Coopers supreme D.F.F – Diflufenican
- Youngs sheep dip – Carbophenothion
