# Whāingaroa/Raglan catchment management plan: Supporting information

# Whāingaroa/Raglan Catchment Management Plan

Supporting information

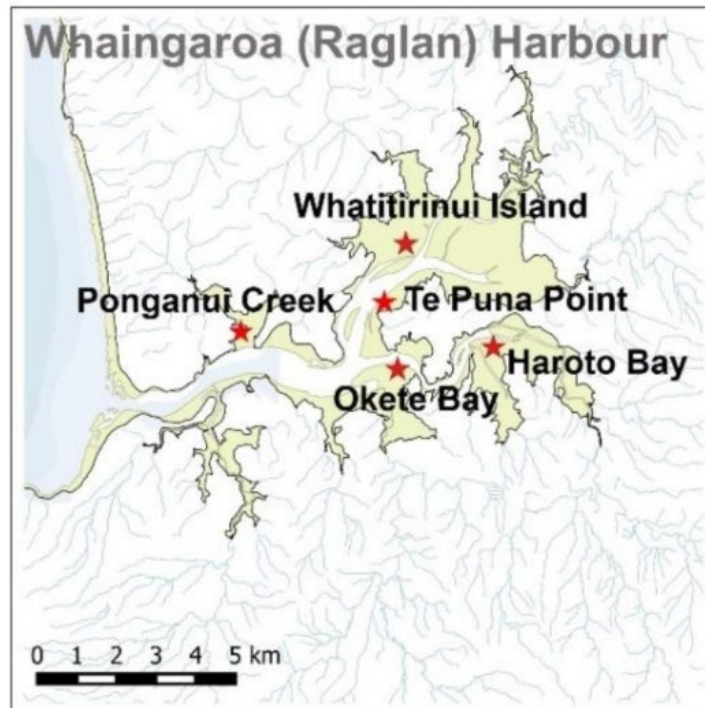
Figure 11. WRC Whāingaroa Harbour State of the Environment (SOE) Regional Estuary Monitoring Programme (REMP) monitoring sites.

To track patterns of contemporary intertidal sedimentation WRC has been monitoring Sediment Accumulation Rates (SAR) in Whāingaroa Harbour since 2003 as part of the State of the Environment (SOE) Regional Estuary Monitoring Programme (REMP). Five sites have been measured in the harbour, Whatitirinui Island, Ponganui Creek, Te Puna Point, Okete Bay, and Haroto Bay (Figure 11). Analysis has found that sedimentation rates are highly variable, with areas of both erosion and accretion ranging between -3.98 (erosion) and 7.04 (accretion) mm/yr in Whāingaroa Harbour. The data collected shows distinct sedimentary environments in each part of the harbour, with stability at the Ponganui plates, erosion at Whatitirinui Island and Te Puna Point in the northern arm, and accretion at Haroto Bay and Okete Bay in the southern arm (Hunt 2019).

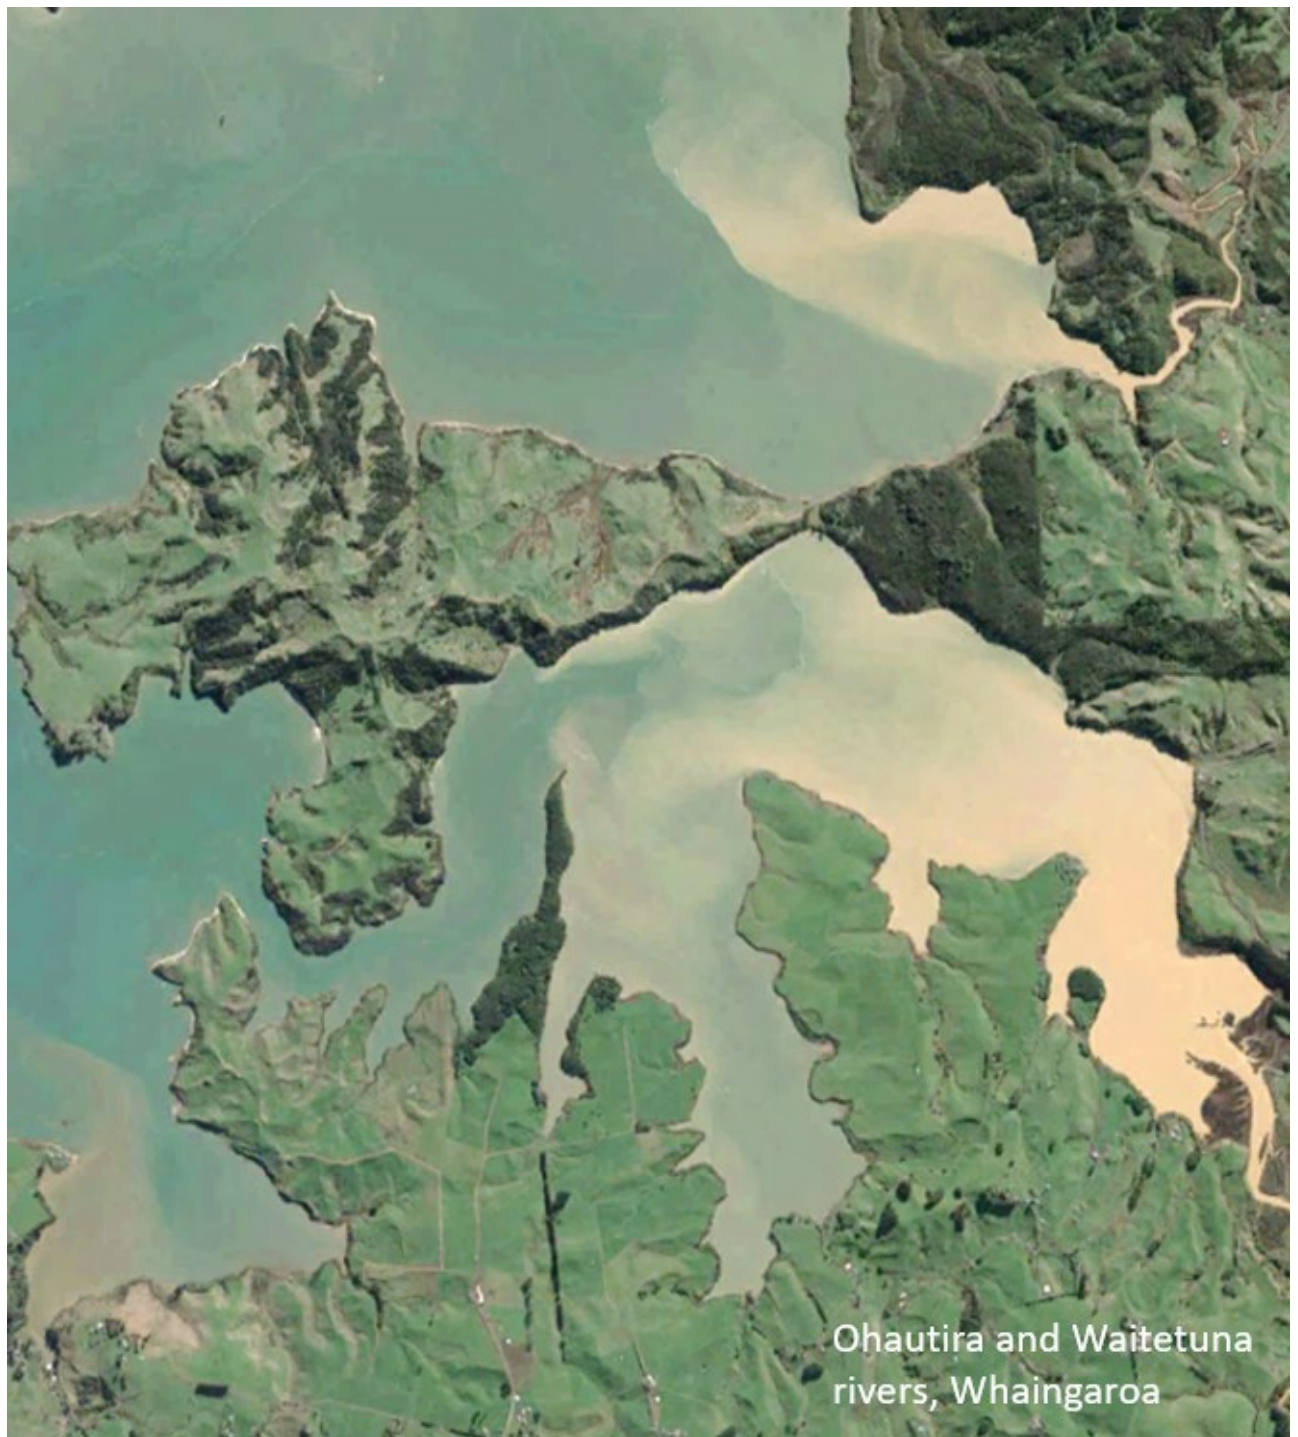
Figure 12. Photograph of sediment plumes from Ohautira (top) and Waitetuna (bottom) rivers. (Source Waikato Regional Council)

The study found major differences in the rates of sedimentation entering the harbour from different sub-catchments. The Waitetuna arm of the harbour (Figure 12) has seen large increases in sedimentation<sup>13</sup> associated with land clearance and most recently, plantation forestry (Swales et al., 2005). By comparison, the Waingaro arm of the harbour has had negligible sediment accumulation in the past 150 years, which is attributed to wave action maintaining sediments in suspension, and to tidal flows of water transporting sediments down-harbour. Sheltered embayments and tidal creeks have experienced continual sedimentation and appear to be the most susceptible to the effects of future changes in the quantity and type of sediment runoff associated with human activities in their land catchments (Swales et al., 2005).

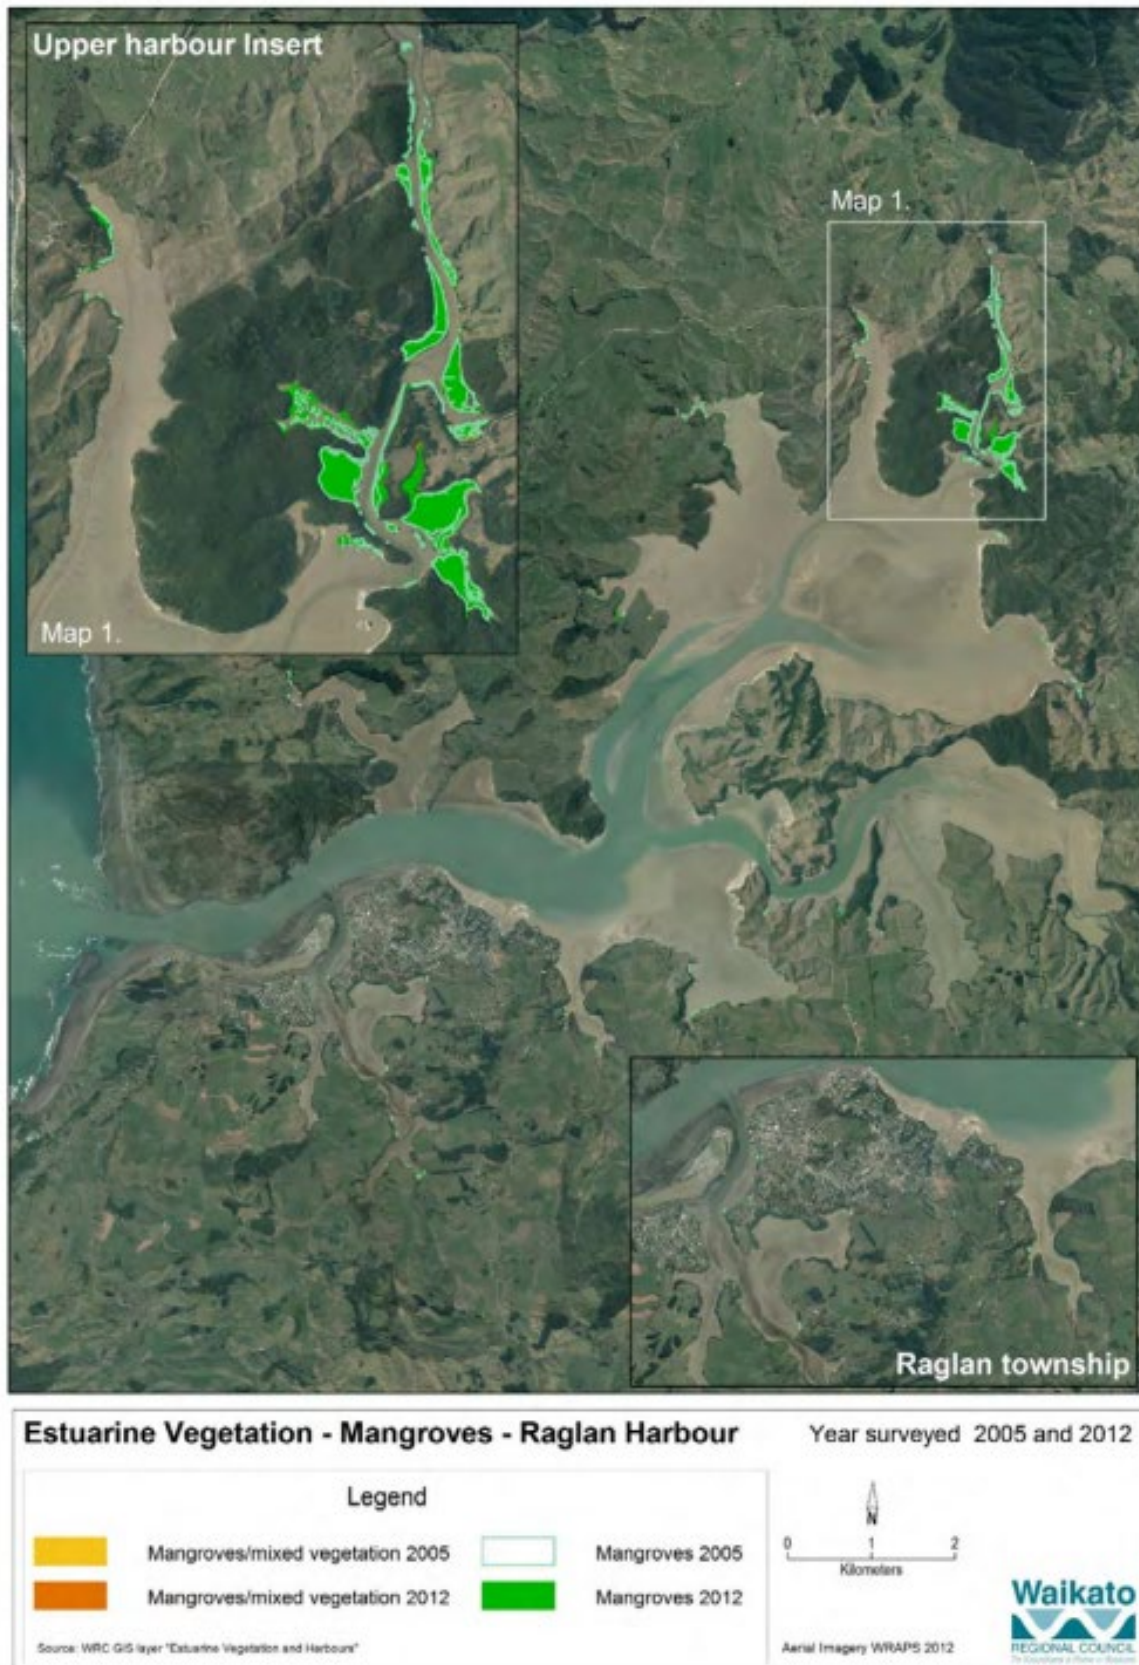
Figure 25. Mangrove distribution in Whāingaroa Harbour. Source: Bouma (2016).

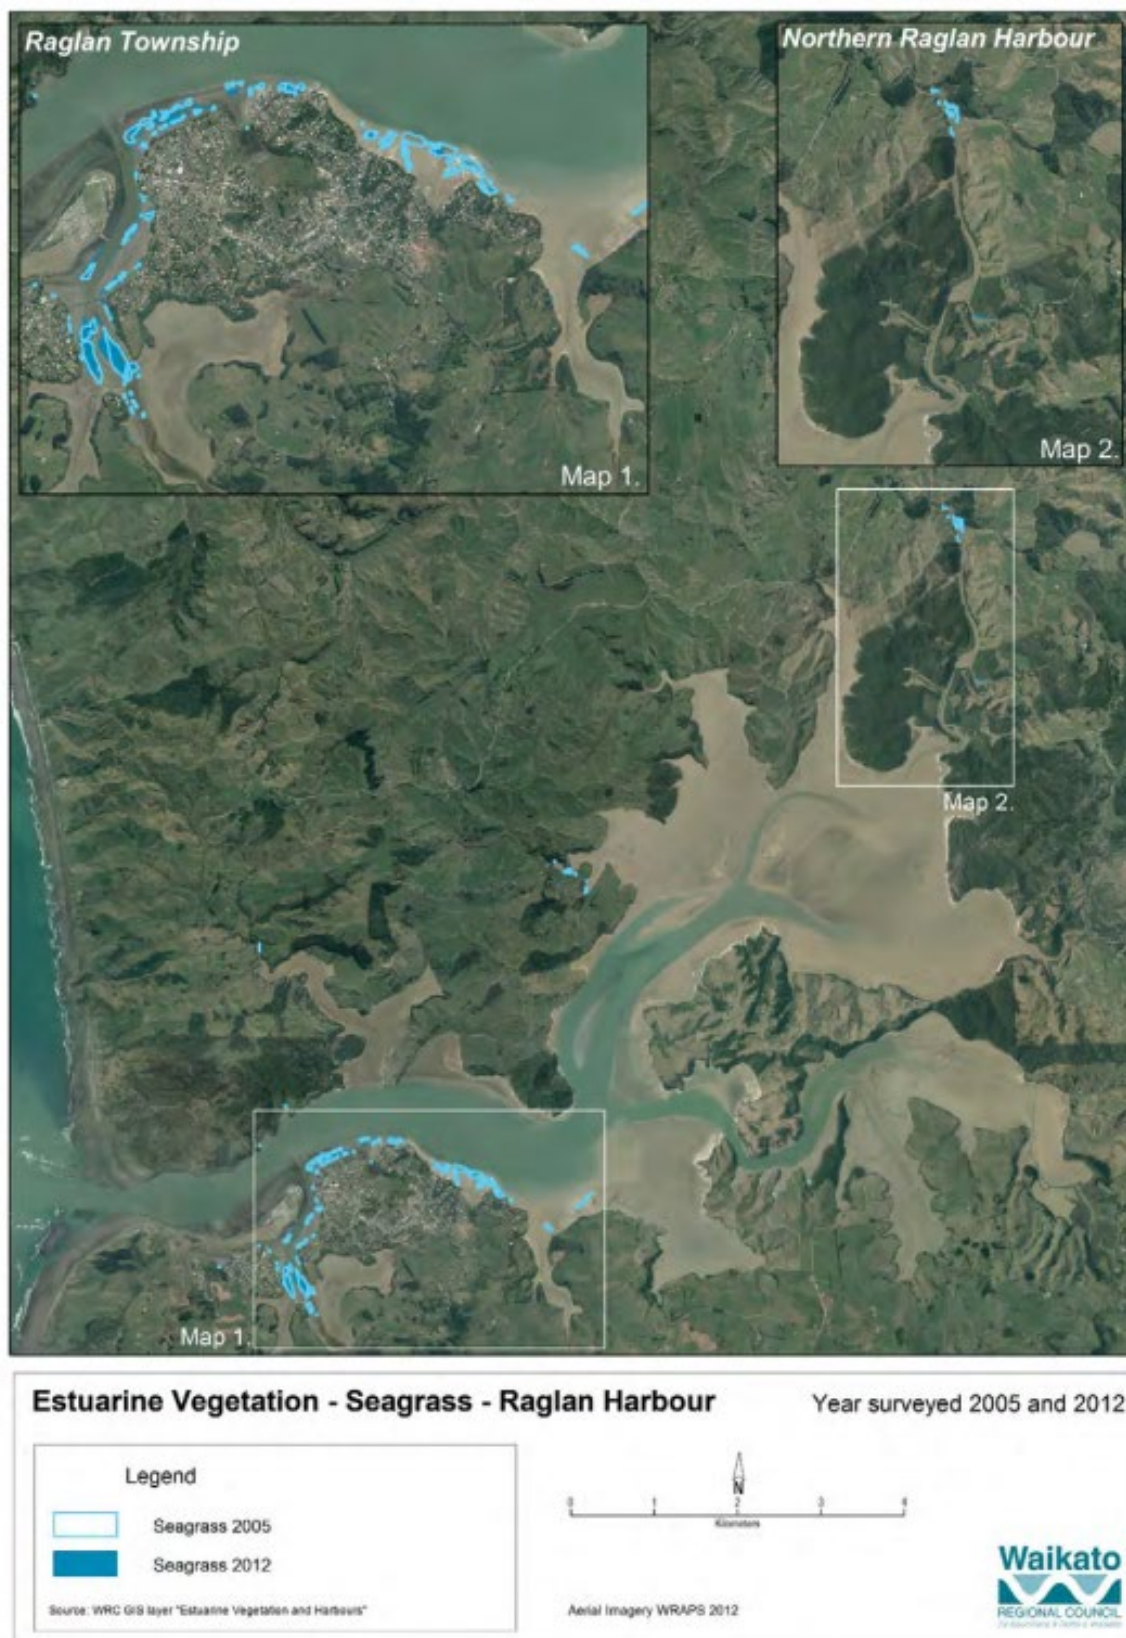
Figure 27. Seagrass distribution in Whāingaroa Harbour. Source: Bouma (2016).

Seagrass has a far more restricted distribution in Whāingaroa harbour (compared with Aotea and Kawhia harbours). Graeme (2012) reports that seagrass beds are a major feature along the town foreshore up past Lorenzen Bay and past the one lane bridge up into the Opotoru River arm. They are also a feature up the freshwater landing side arm of the Waingaro River.

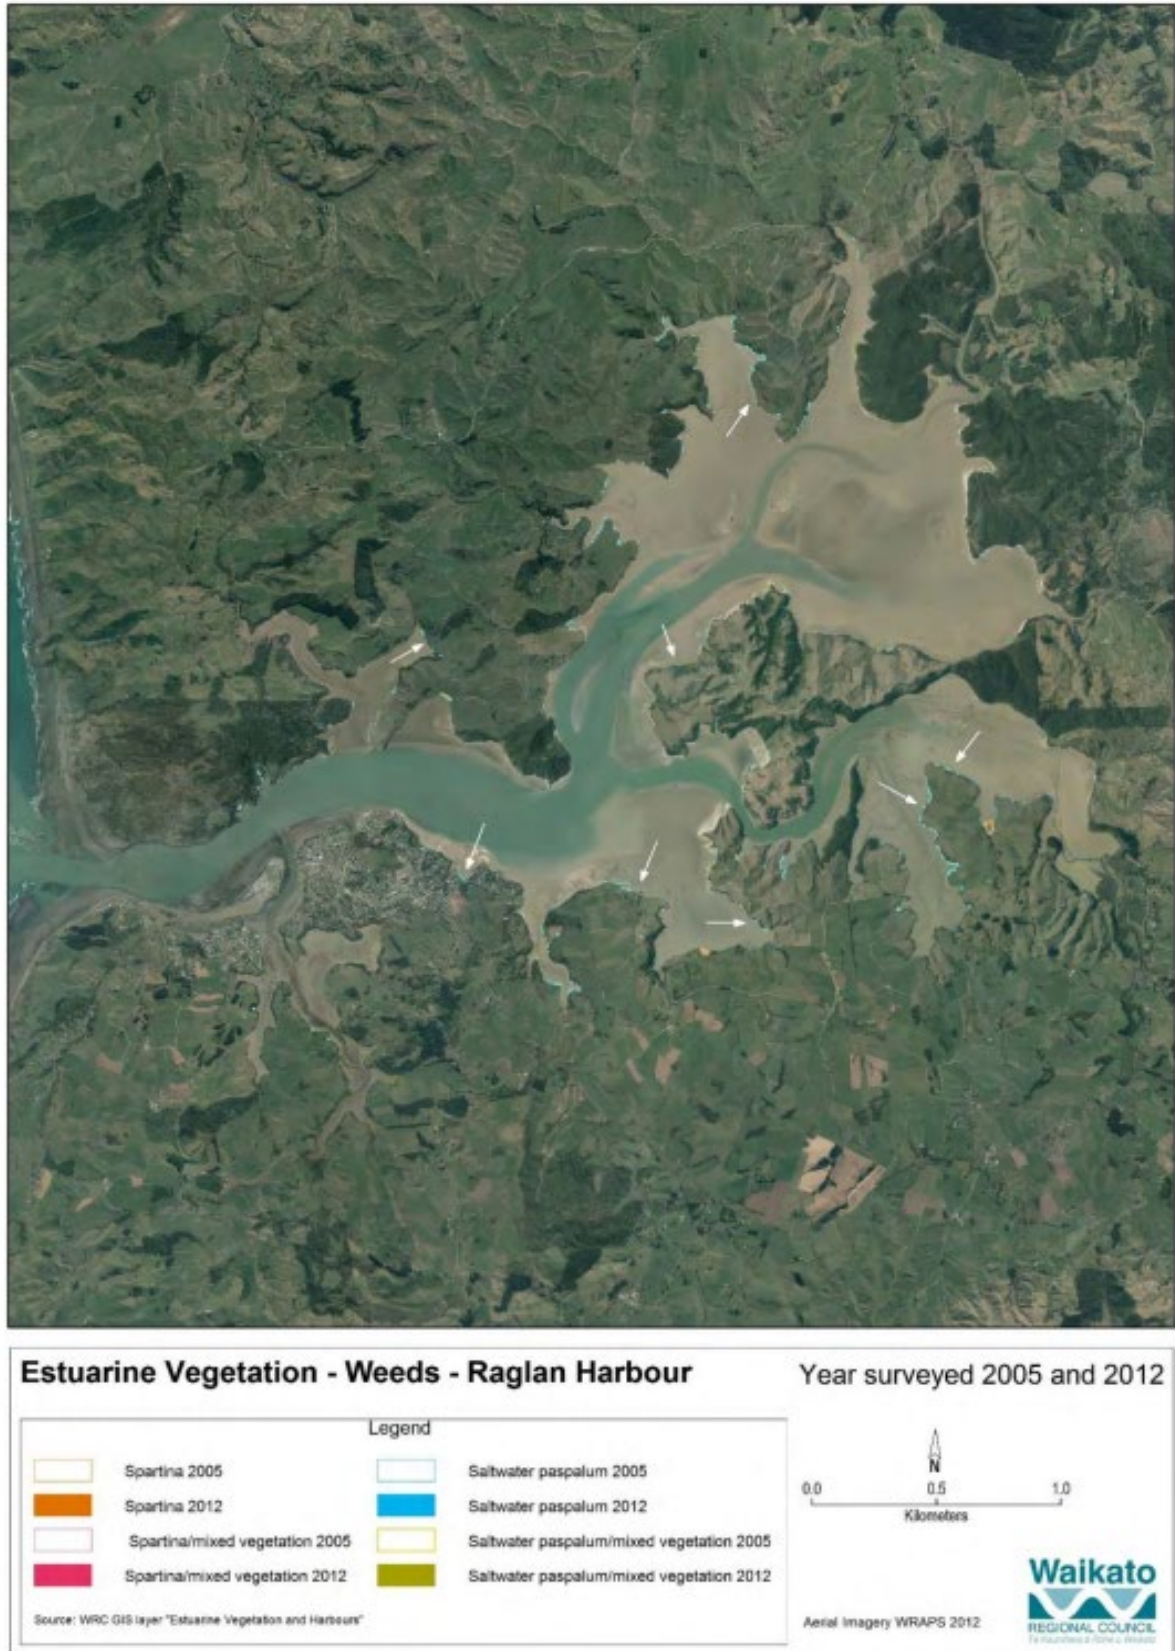
Figure 28. Spartina and saltwater paspalum distribution in Whāingaroa Harbour 2015. Source: Bouma (2016).

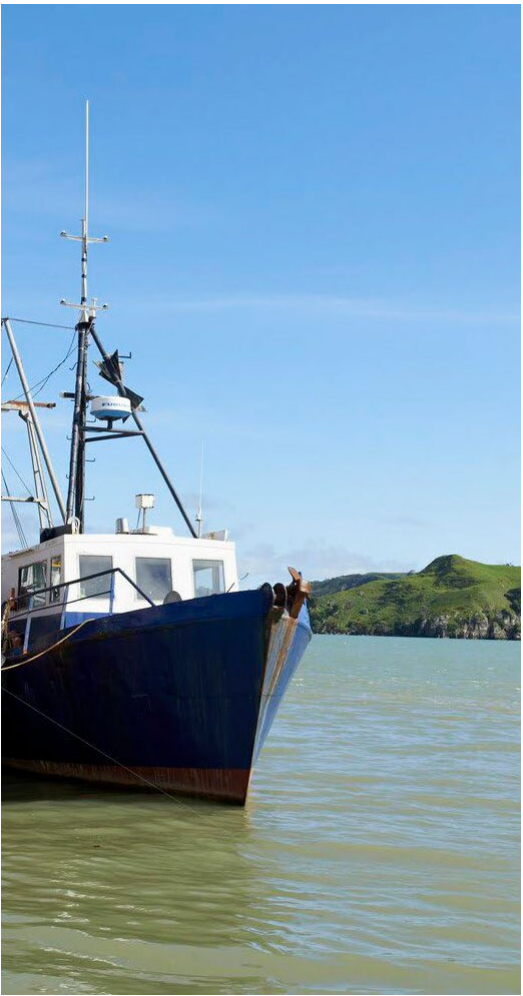
## Estuarine sedimentation

Sedimentation rates at four sites in the harbour are within acceptable guidelines. Rates at Haroto Bay are slightly elevated (1.4mm yr<sup>-1</sup> above sedimentation guidelines).

## Estuarine sedimentation

Sedimentation is the deposition of sands and muds that can smother estuarine plants and animals, causing the estuary to become less suitable for organisms. We have been measuring sedimentation in Whāingaroa since 2003 at five sites around the harbour. The depth of sediment is measured repeatedly with the rate of sedimentation calculated from the changes over time. These results are then compared to ANZECC guidelines to assess the likelihood of negative effects.
