River Styles Assessment of the Hamilton Gullies

RIVER STYLES ASSESSMENT OF THE HAMILTON GULLIES

WAIKATO REGIONAL COUNCIL, WAIKATO NZ

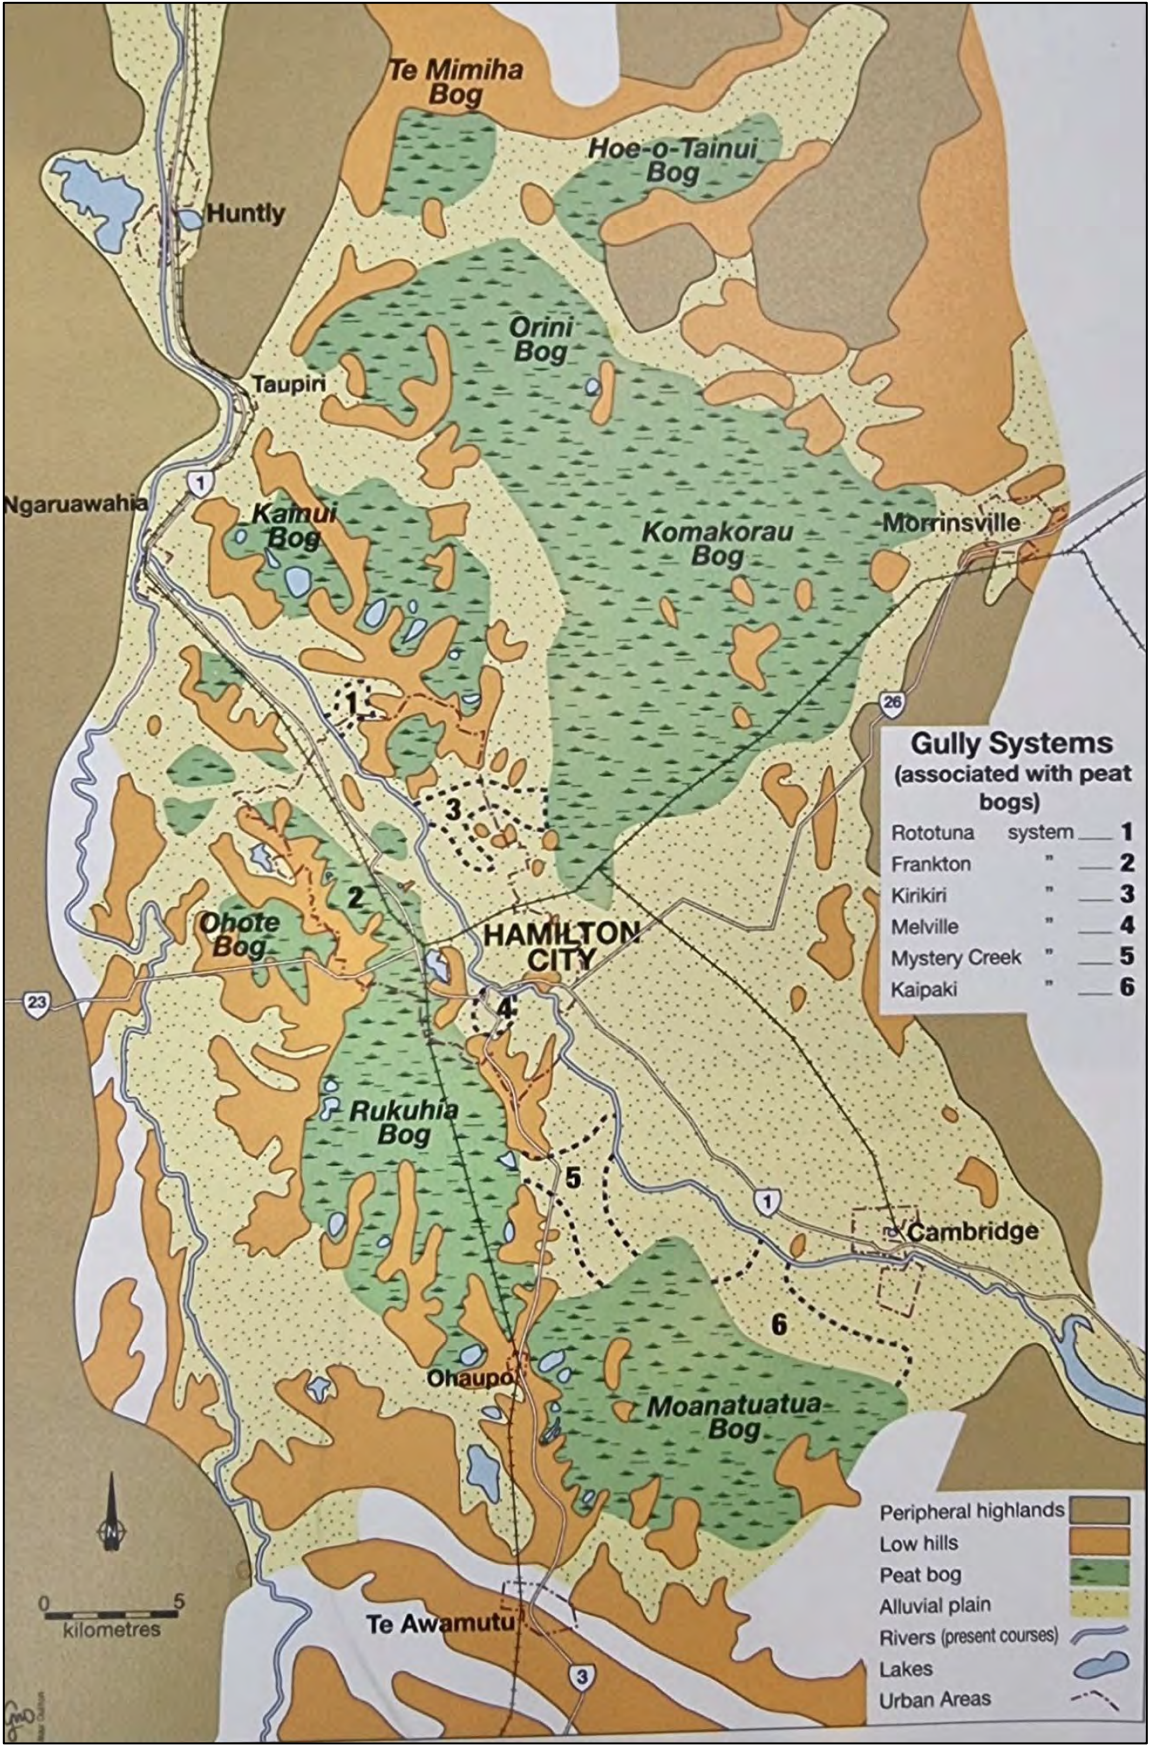
Figure 2-4 Principle areas of peat in the Hamilton Basin (Figure by McCraw, 2011).

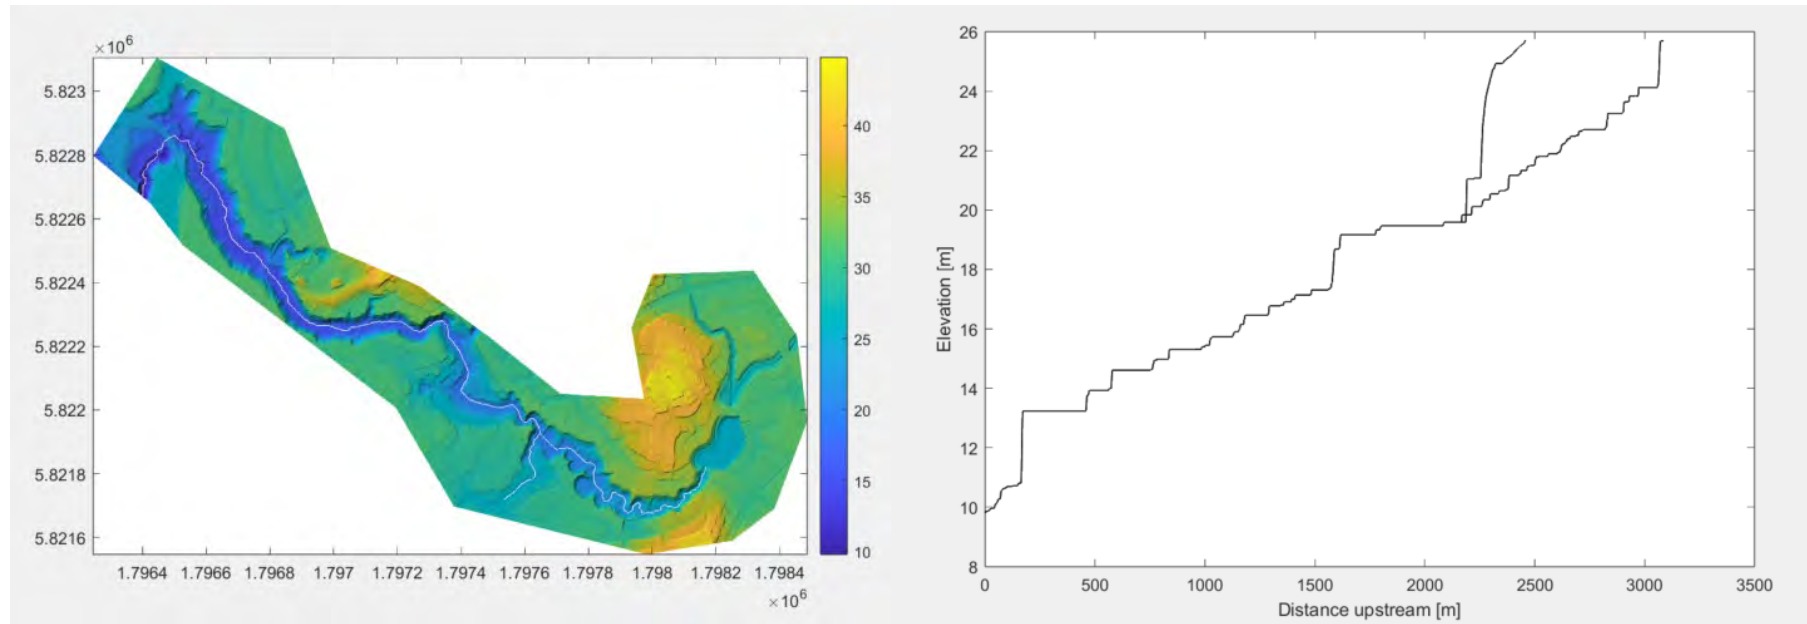
Figure 4-2 Te Awa O Katapaki gully catchment topography and long profiles.

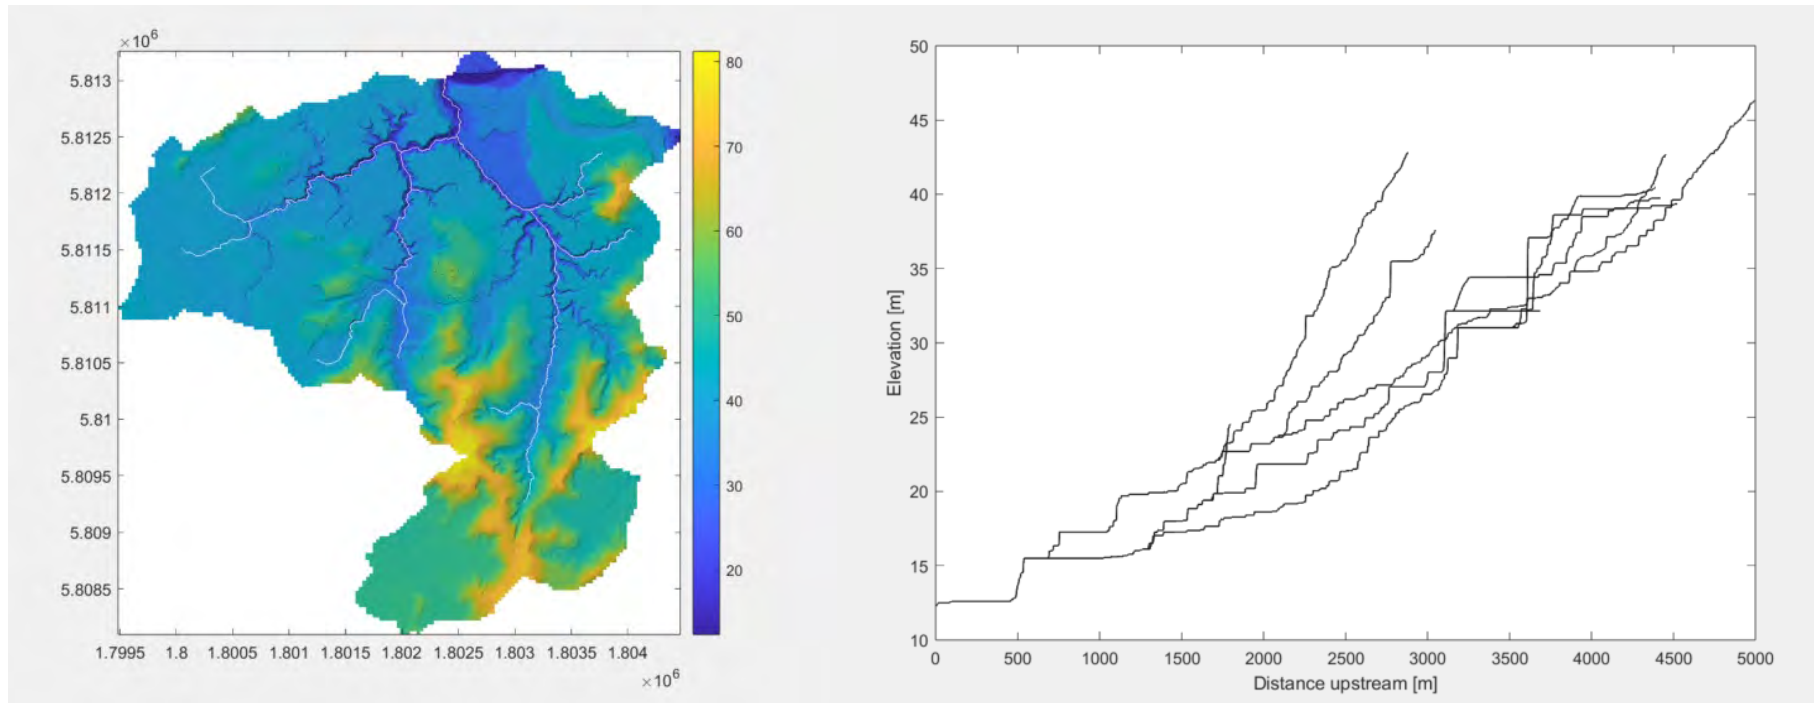
Figure 4-17 Mangakotukutuku gully catchment topography and long profiles.

Downstream variation of 12 different River Style types across 20 reaches found in the catchment is shown in Figure 4-16, with the longitudinal profiles shown in Figure 4-17A summary of attributes of these River Styles (degree of confinement, margin type and bed material type) is displayed in Figure 4-18, Figure 4-19 and Figure 4-20. This catchment is mainly dominated by confined, terrace margin controlled urban gullies, some of which have undergone restoration.

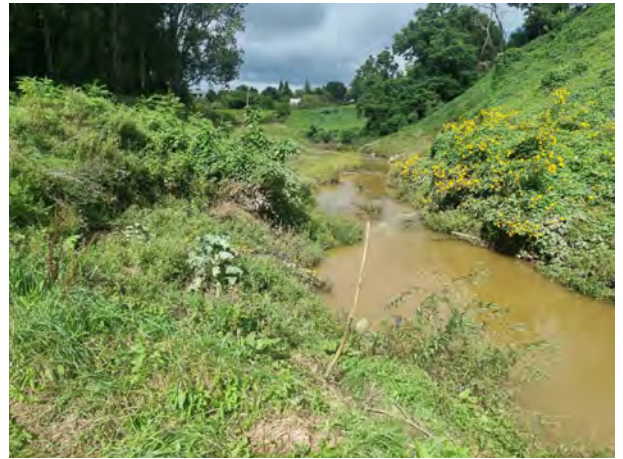
Reach 3B. Degraded reach confined by terrace margin controls- C_TrMC_Gully_Gbed

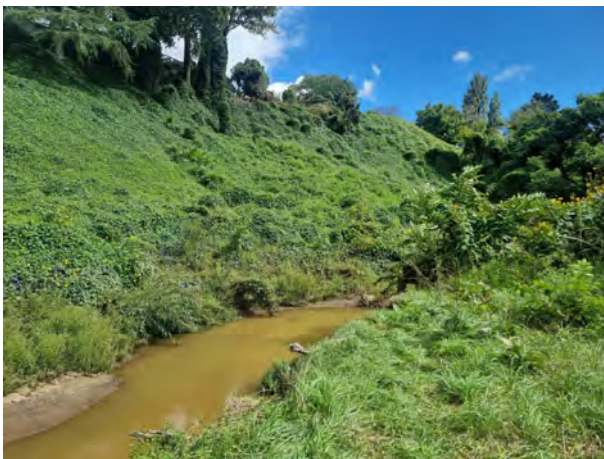
Reach 3B. Terrace surface dominated by weeds. Some sediment accumulation occurring in the form of lateral and point bars. Some LWD present - C_TrMC_Gully_Gbed

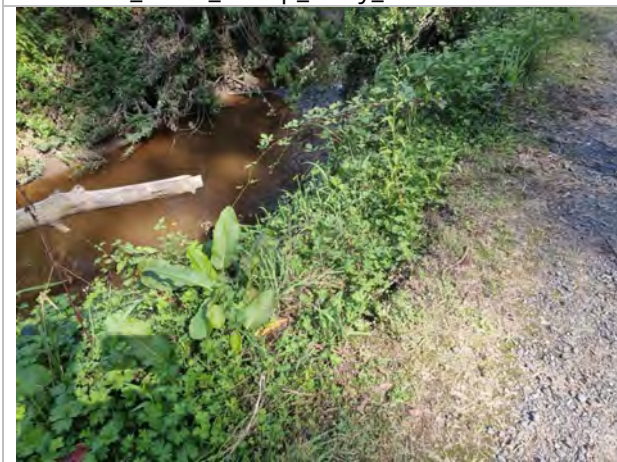
Reach 20B. Tension crack showing evidence of incision and widening. LWD observed in channel - C_TrMC_OccFp_Gully_Fbed

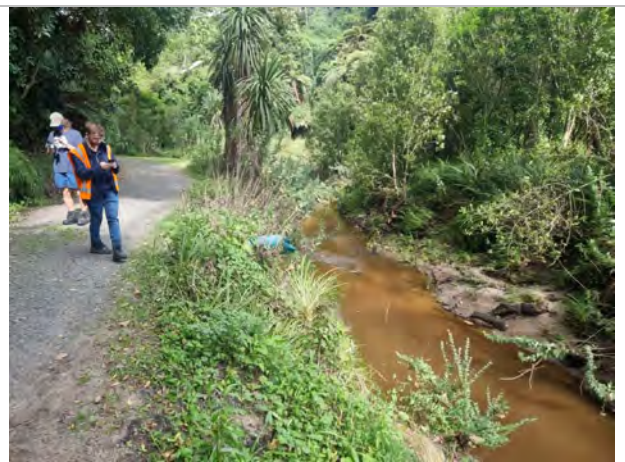
Reach 20B. Inset floodplain pockets. Sediment accumulation on inside bend forming bar. - C_TrMC_OccFp_Gully_Fbed

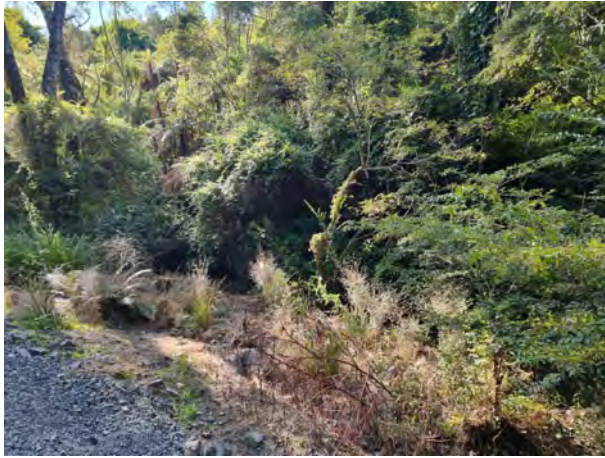
| <p>Reach 1. Incised channel in poor condition - C_TrMc_Gully_Gbed</p> | <p>Reach 1. Actively incising slot channel - C_TrMC_Gully_Gbed</p> |

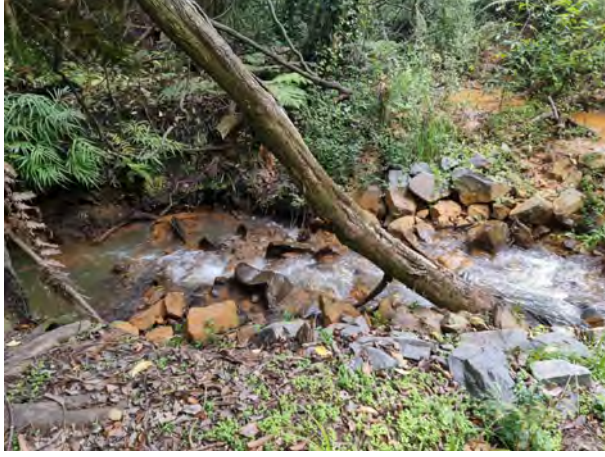
| <p>Reach 1. Grade control structure controlling bed level - C_TrMC_Gully_Gbed</p> | <p>Reach 1. Terrace confinement - C_TrMC_Gully_Gbed</p> |
