Tauranga Taupo River Flood Protection Scheme

Annual Works Programme 2025/2026

WRC Resource Consents 125772 and 125773

Updated 29/8/2025

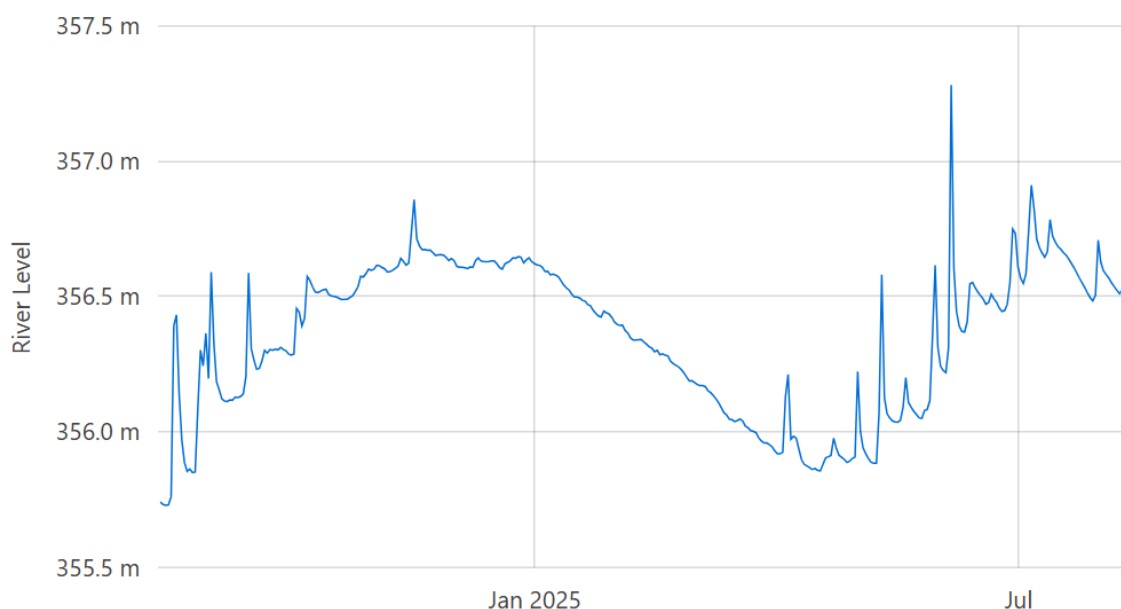
Figure 2: Tauranga-Taupo River - SH1 Br - River level¹
[Environmental maps and data | Waikato Regional Council](#)

River levels recorded at the SH1 bridge over the past 12 months show several moderate storm events and a significant flood overnight 4-5 June 2025. The June event did not result in overly high rainfall measurements at the Kiko Road rain gauge, however this did result in the highest recorded river level at the Te Kono monitoring site upstream, of the scheme, however levels observed at the bridge were less than those observed in previous years.

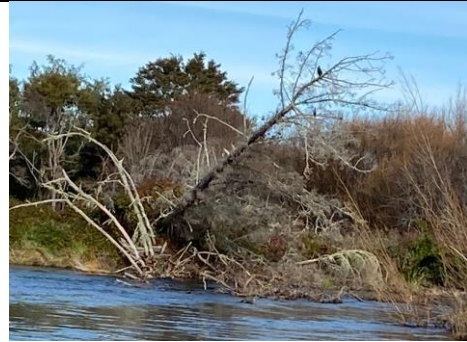
Photo 4:

There are a number of sites upstream of the SH1 Bridge where woody debris were deposited by high flows over the past 24 months and several zones cleared in recent flooding. Much of this debris is native vegetation, kanuka or similar and is not anticipated to cause any issues as woody debris in the river is part of the natural process and can provide important habitat for fish and other instream ecology. Furthermore, some of this material is protecting areas of bank from erosion. Trees that overturned and lodged within the channel at high erosion locations were extracted in the 2024/2025 year. We will continue to monitor the situation and consideration is being given to the removal of material that is deemed to be at high risk of causing erosion.

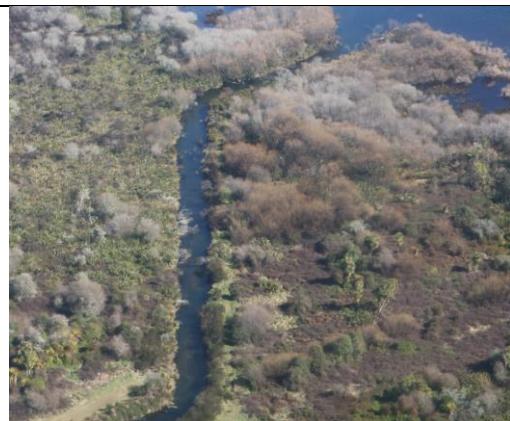
Photo 6 (22/08/2025)

Dead willows continue to break down within the channel. These do not appear to be obstructing flow and will be monitored periodically.

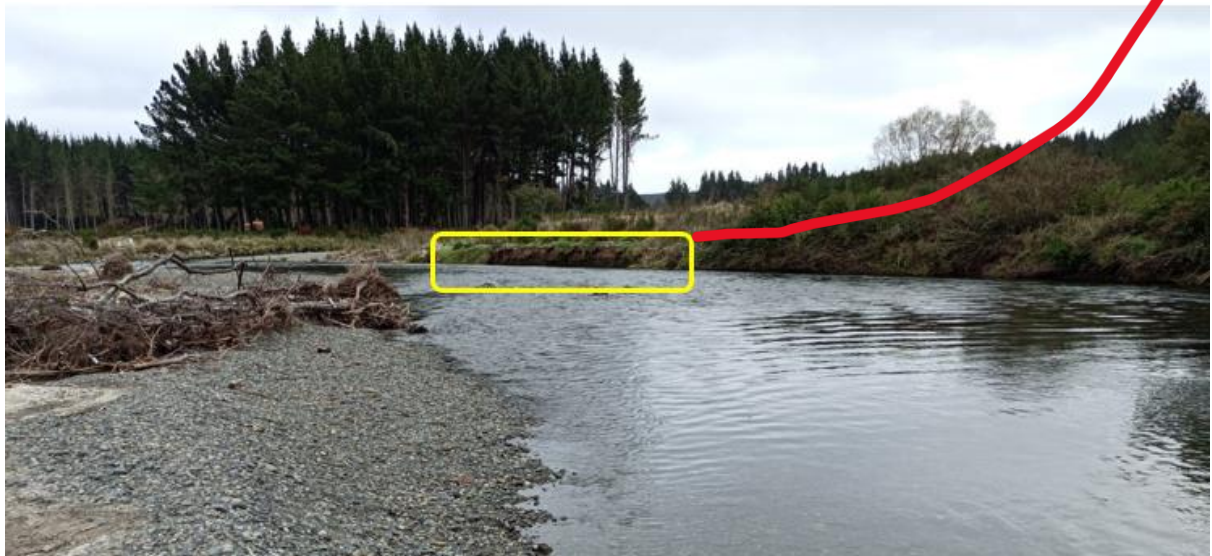
Photo No.8.

Just upstream of the spillway area (known as Maniapoto's Bend), bank erosion has been observed on the right side of the river, this will continue to be monitored to ensure that flow is not permitted to bypass the spillway structure.

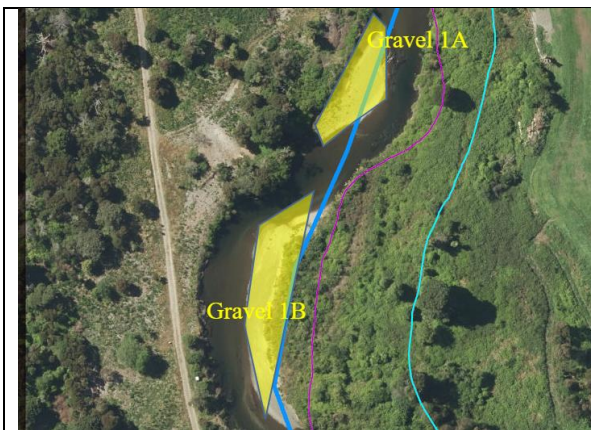
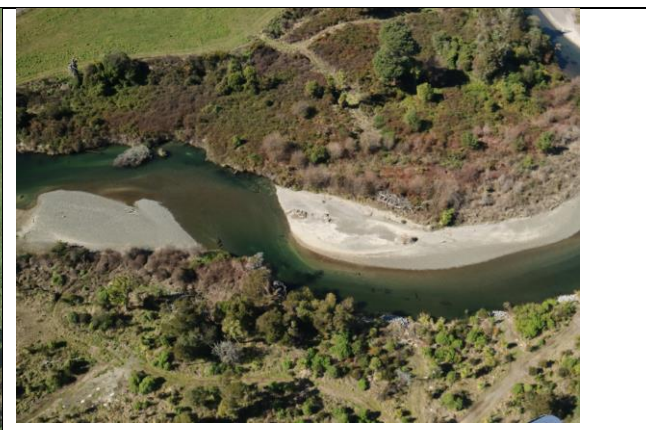
<p>Site 1A and 1B</p>	<p>Site 1 lies upstream of the end of the eastern stopbank. (which follows the western side of Hingapo Road). Around the outside of the bend, the bank is protected with rock armour. Accumulations of gravel are directing the channel toward the upstream end of this rock. Gravel extraction can reduce the impact on the left bank in this area.</p>

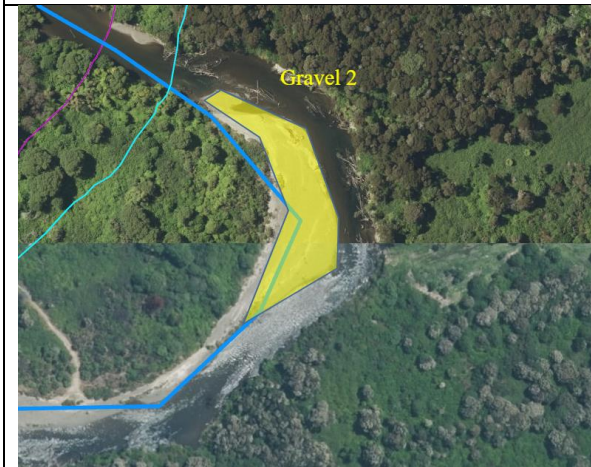
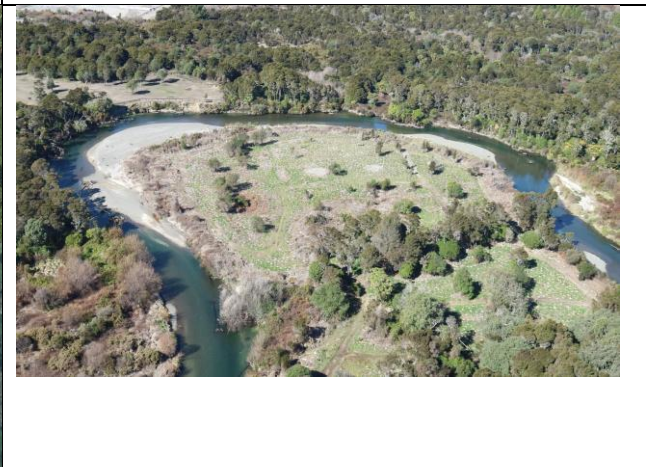
<p>Site 2: (adjacent to the lodge under development off Hingapo Rd)</p>	<p>Significant gravel accumulation on the left bank is applying pressure to the outside bend. Vegetation lodged in the channel currently offers some protection to the right bank, removal of some gravel will reduce the risk of rapid erosion in the event that these logs/trunks become dislodged.</p>

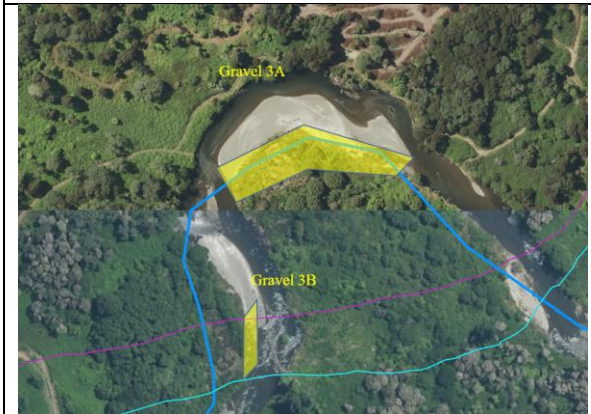
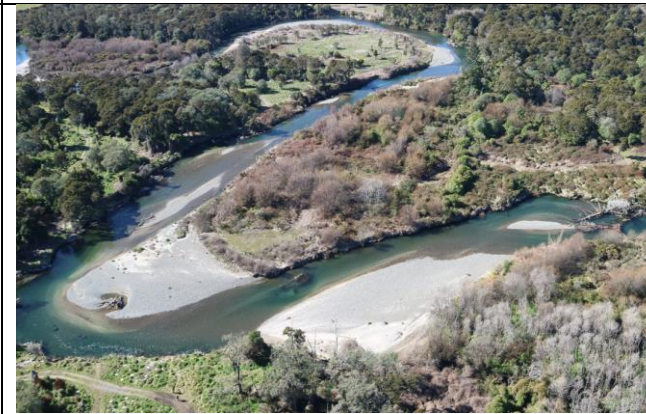
<p>Site 3: The uppermost bend where rock</p>	<p>Rapid erosion over the past 5 years has resulted in</p>

groynes have been installed in recent years.

an extremely acute channel alignment. Groynes have reduced migration of the left bank but the tight bend, and material deposited downstream leads to an elevated water surface, spilling onto the floodplain frequently, and causing further erosion when draining back into the channel. We plan to open a channel further right, around where the main channel was located in the late 90s/early 2000s. This will be undertaken by excavating to approximately low flow water level, and allowing flood waters to re-form the bed. The current alignment will likely remain wet for some time with pools that may gradually fill during subsequent flooding events.

Site 3b, we will likely need to remove a falling pine, and significant accumulated debris from this location upstream of the bend. While machinery is on site, we would look to open the channel up further left to aid transition into the proposed new "3a" channel.

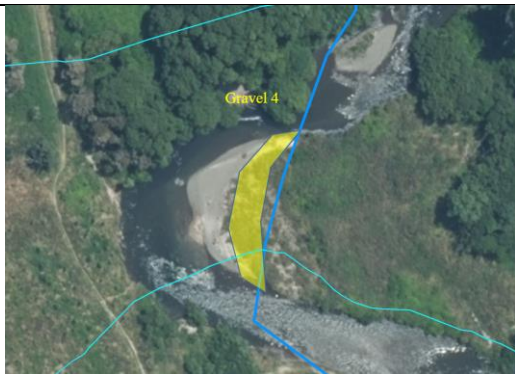
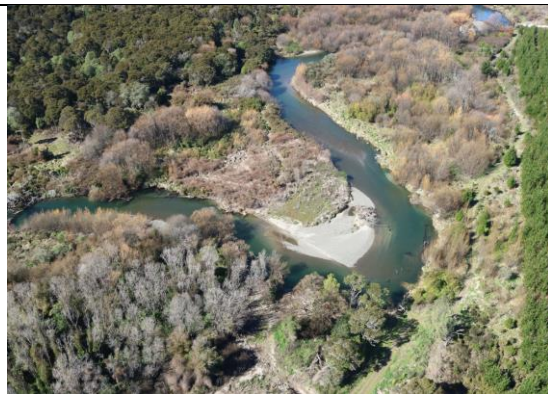
Site 4. Corner at the top of the "DOC reserve" where the anglers access meets the awa.

Similar to site 3, a very sharp bend has formed, Mature willows have been holding this corner in place for some years, however two of these were lost in the last year. A similar solution is proposed by forming a new channel closer to that present in the late 90s/early 2000s.

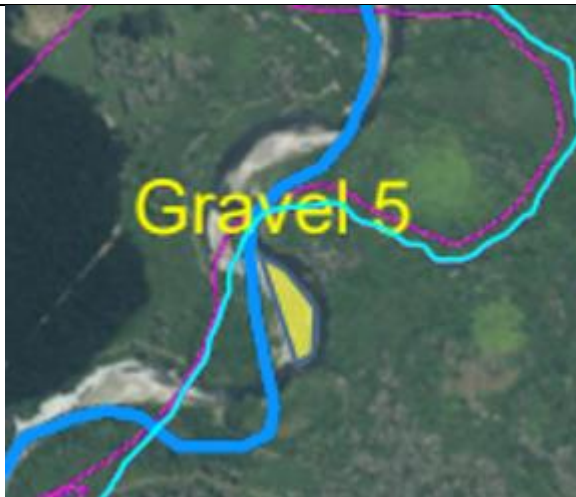
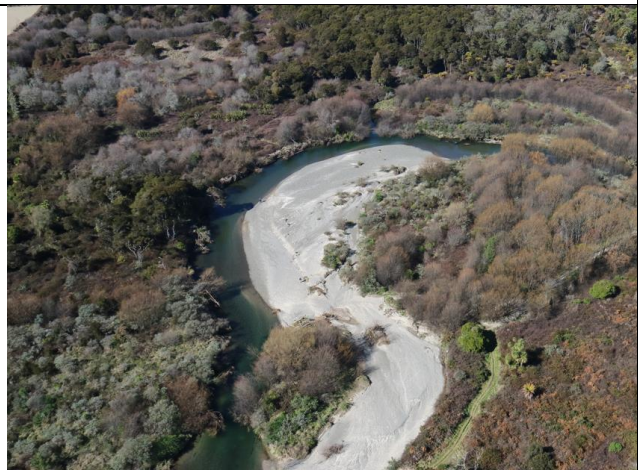
Site 5

This location on the left bank has seen significant

<p>accumulation of material over the last several years and threatens to extend erosion within the right bank. Access may be limiting and work may not be achievable this year.</p>

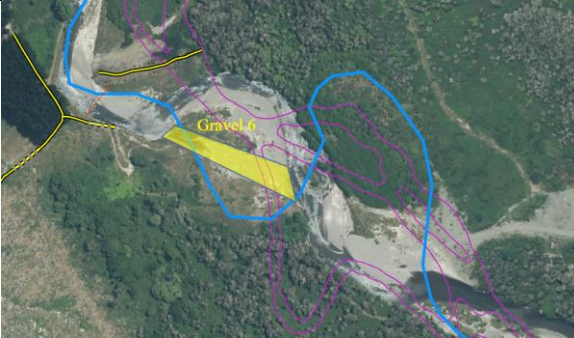
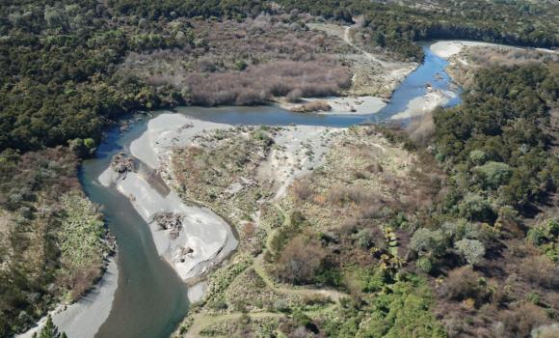
<p>Site 6</p>	<p>This location lies immediately upstream of Maniapotos bend, the spillway and Kiko swale, leading to Kiko farm. Extraction from this area is important to provide a flood channel with a relatively straight alignment, minimising impact on the right bank upstream, (where breakout could bypass the overflow to Kiko swale,) and left bank where excessive erosion could lead to complete diversion of the main channel down Kiko swale. Furthermore this location is ideal to remove material from the channel before it has the opportunity to obstruct the channel downstream.</p>
