# Estuarine Vegetation Survey : Otama Estuary

Prepared by:  
Meg Graeme, Natural Solutions

For:  
Environment Waikato  
PO Box 4010  
HAMILTON EAST

## **Estuarine Vegetation Survey – Otama Estuary, June 2010**

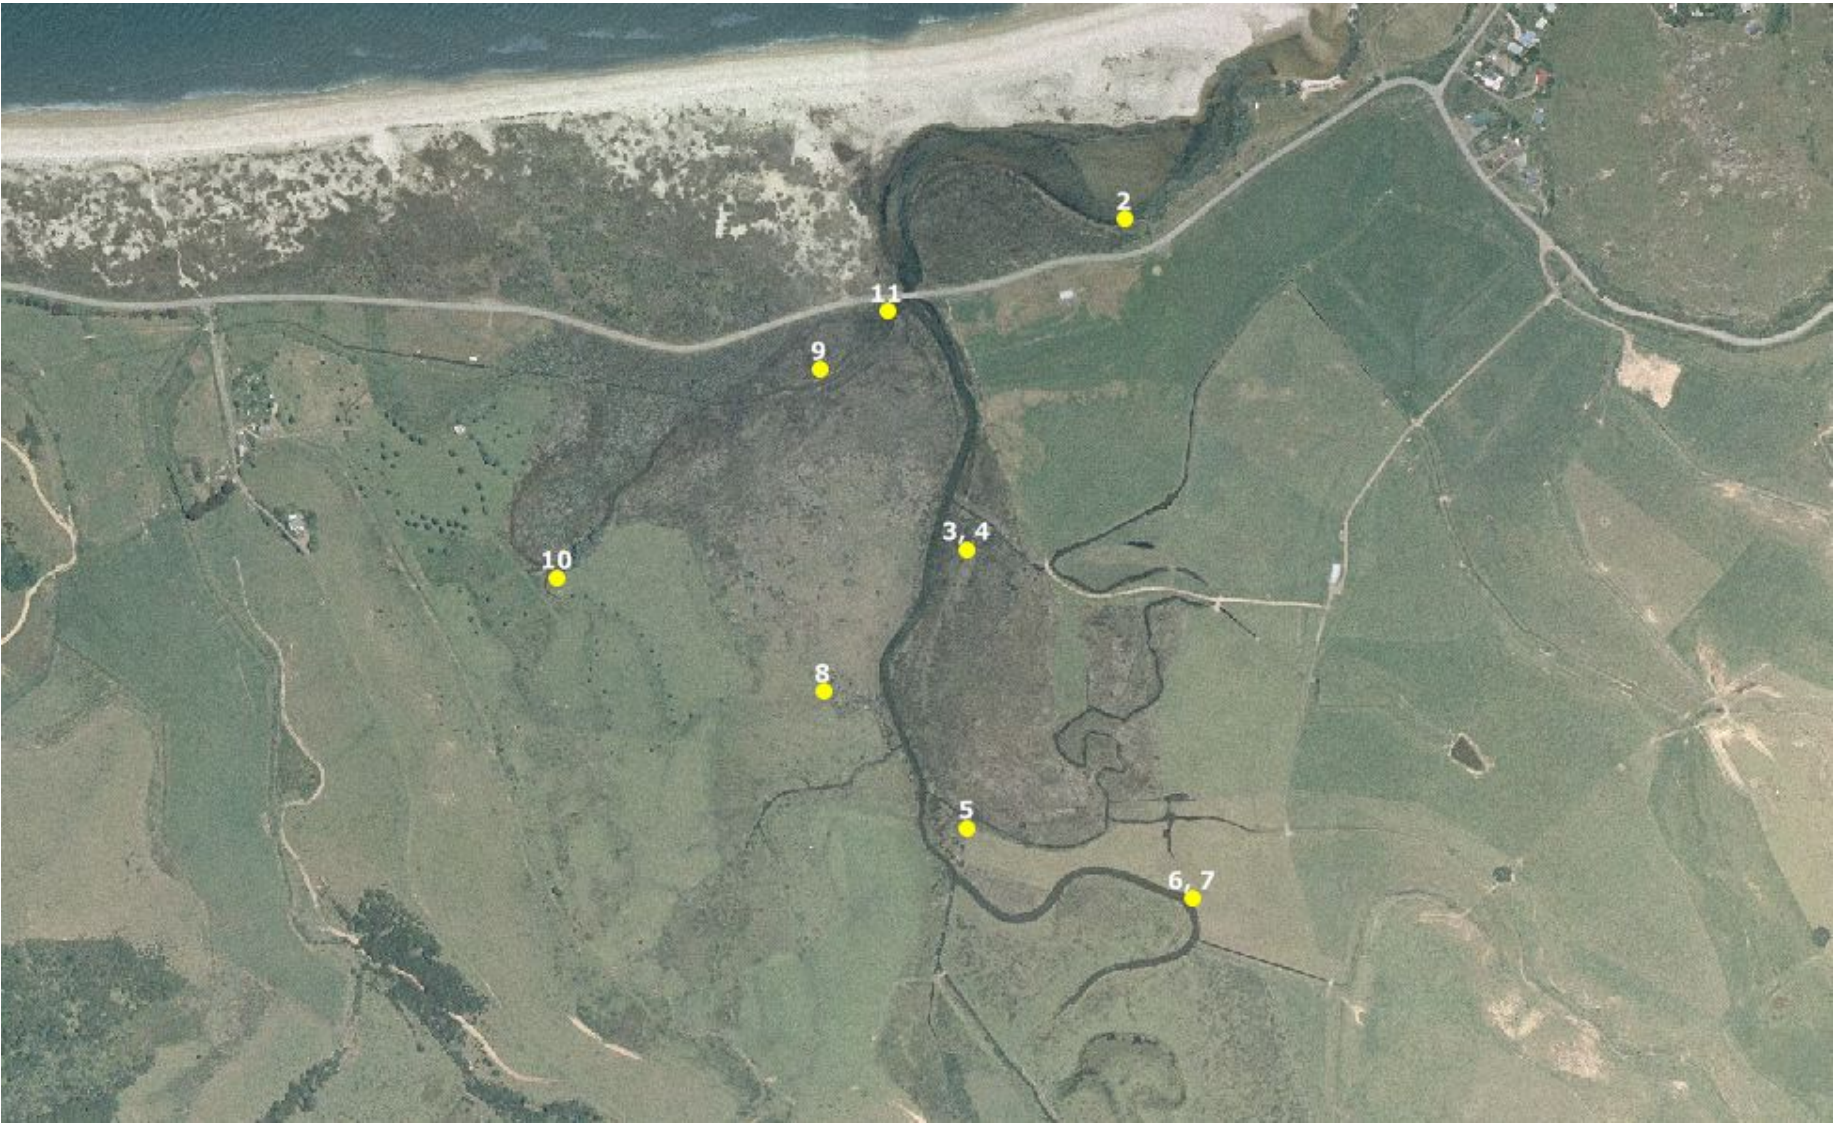
Figure 1: Otama wetland site localities mentioned in this report. The numbers refer to the location of the following figures.

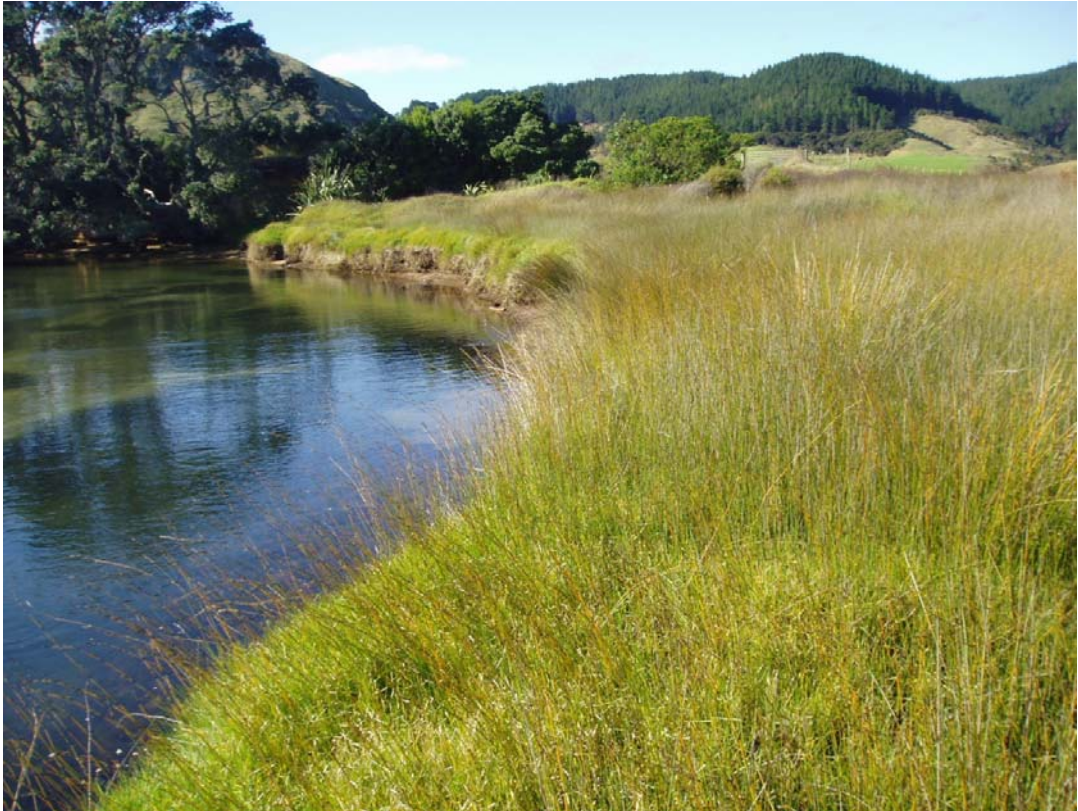
Figure 2: This view looking downstream towards the beginning of the pohutukawa-lined cliff shows saltwater paspalum intermingled with oioi and saltmarsh ribbonwood (closest to pohutukawa). Seagrass beds can be seen within the stream channel.

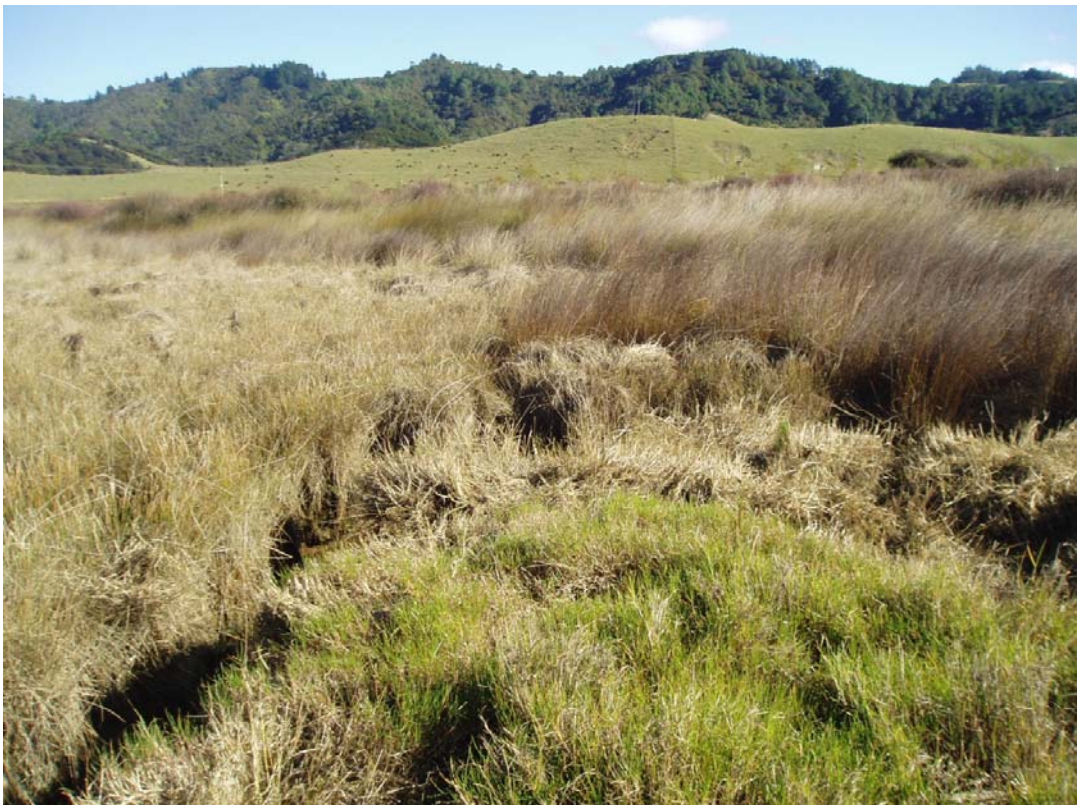
Figure 3: Here the sea rush has a 'cropped' look presumably due to the effect of flooding in this area. Also note the dead (brown) band of oioi fringing the higher healthier green oioi behind. Saltwater paspalum dominates the foreground.

'Cropped' areas of sea rush were noted often associated with dead patches of saltwater paspalum and fringes of dead oioi. This presumably is a result of prolonged flooding over the summer months when the stream mouth blocked up. A 'high tide' line is visible on much of the oioi indicating that water levels had been much higher than at the time of the survey.

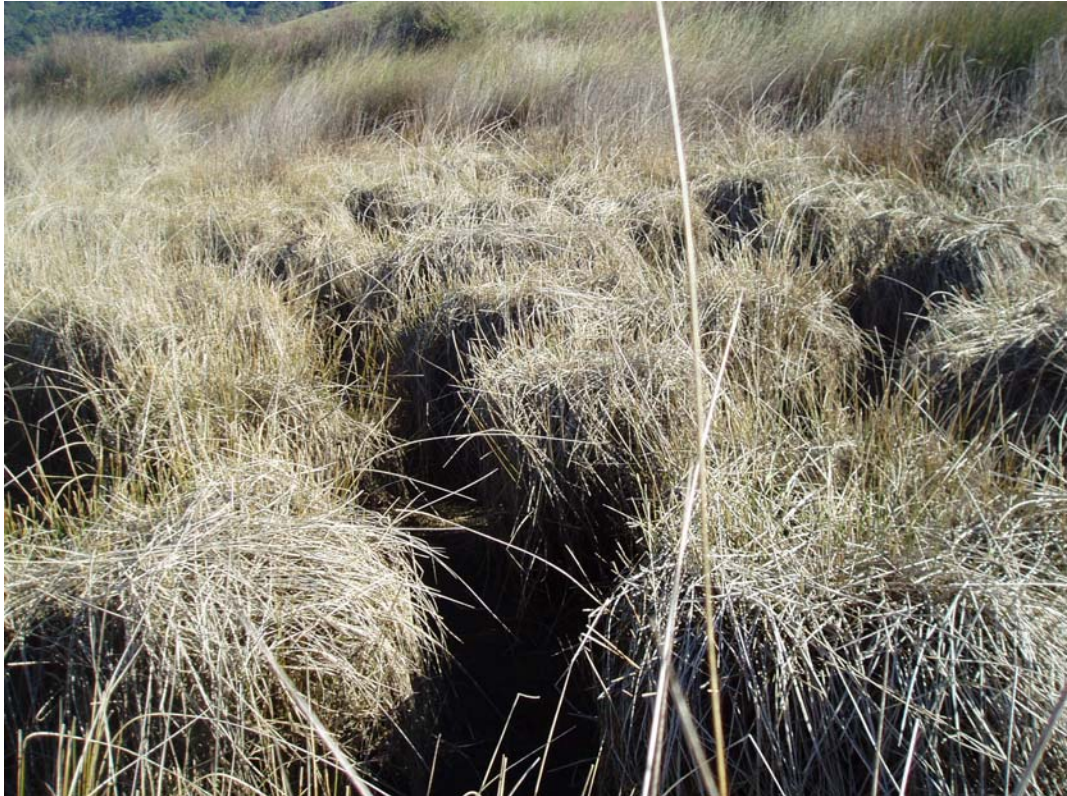
Figure 4: 'Cropped' pedestals of sea rush left behind after flooding.

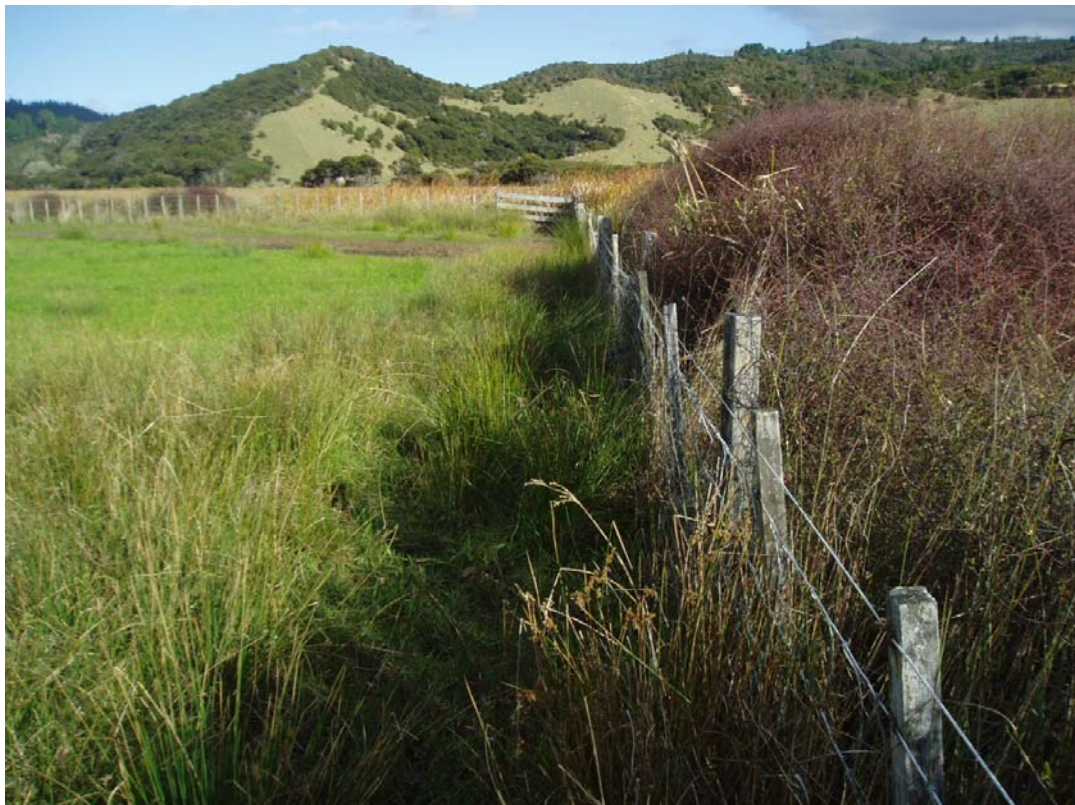
Upstream of the **upper eastern tributary**, saltmarsh ribbonwood intermingles with raupo, giant umbrella sedge and saltwater paspalum where fenced from stock (Figure 5). The stream then forks with the natural stream channel to the east and a drainage channel to the west. Stock have access to both sides of the natural stream channel resulting in pugged and grazed mixed rush (predominately freshwater) and pasture community. Of note was the dense beds of native musk along the natural stream banks (Figure 6 and Figure 7). The upstream extent of estuarine vegetation was indicated by a

Figure 5: An abrupt boundary to saltmarsh ribbonwood. Raupo and saltwater paspalum are in the background.

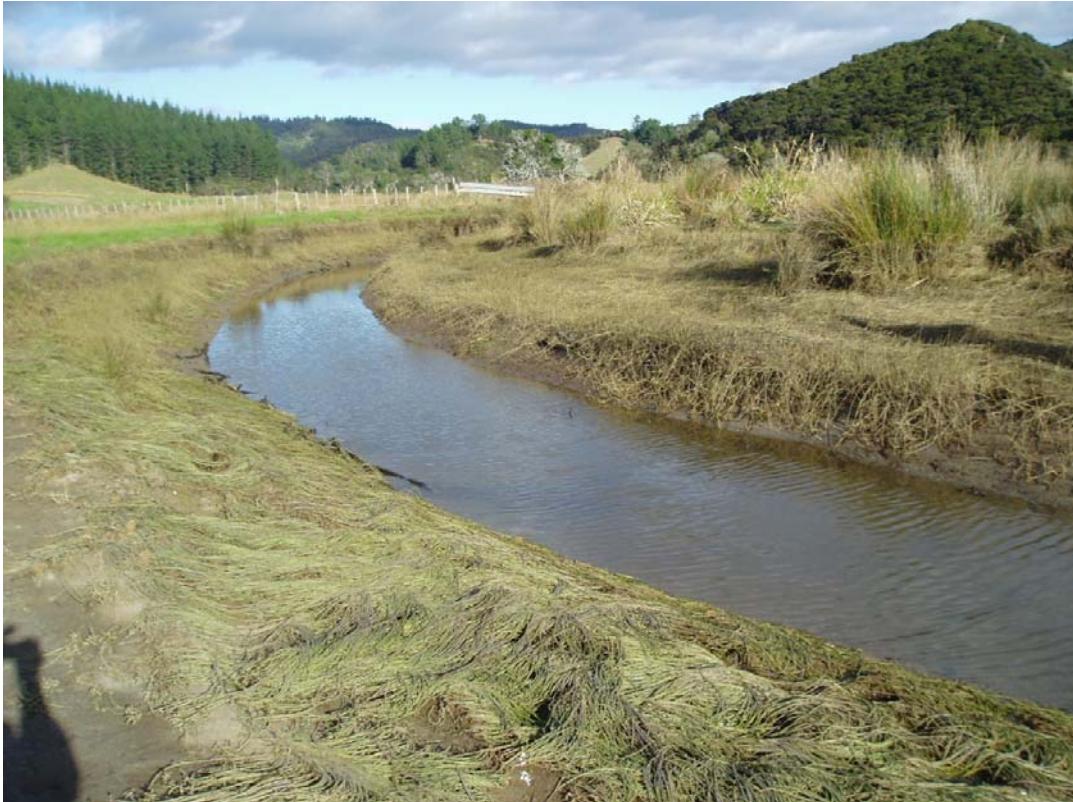
Figure 6: The grazed stream bank here has native musk (*Mimulus repens*) on the TRB (foreground) and mixed native musk and saltwater paspalum on the TRB further upstream. Saltwater paspalum dominates the TLB.

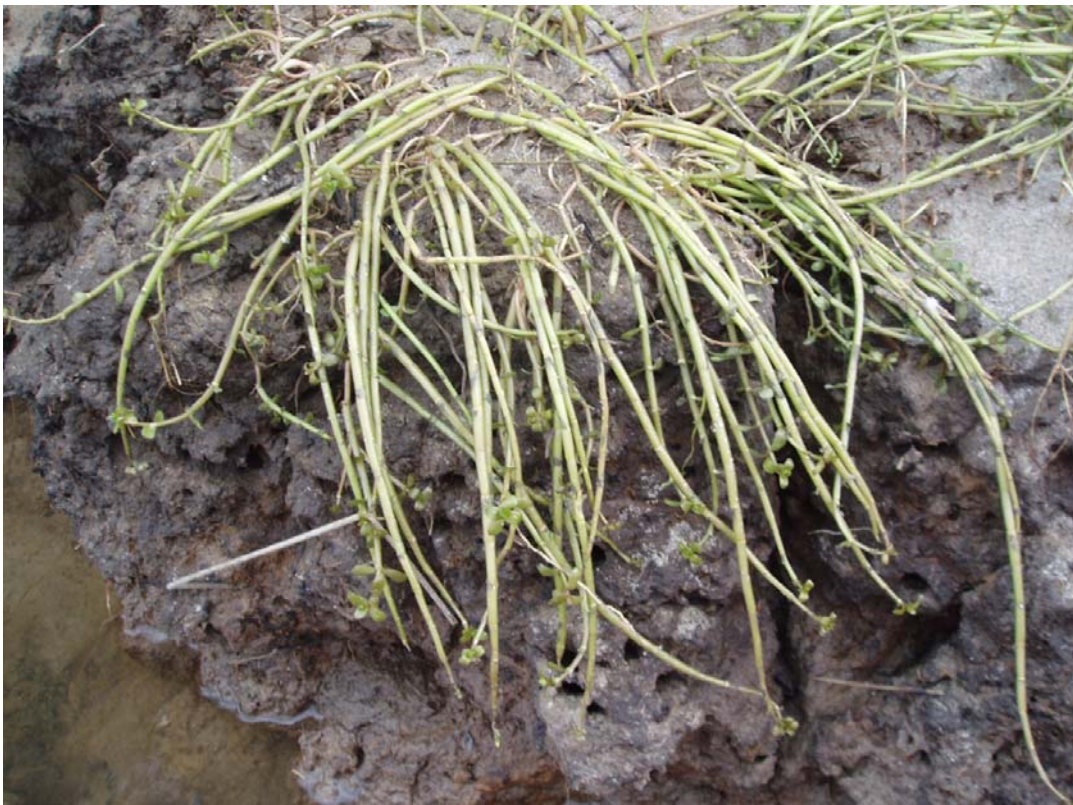
Figure 7: *Mimulus repens* found along the stream banks. Note the elongated form and sparse leaves – presumably a result of the summer water ponding and the recent flood.

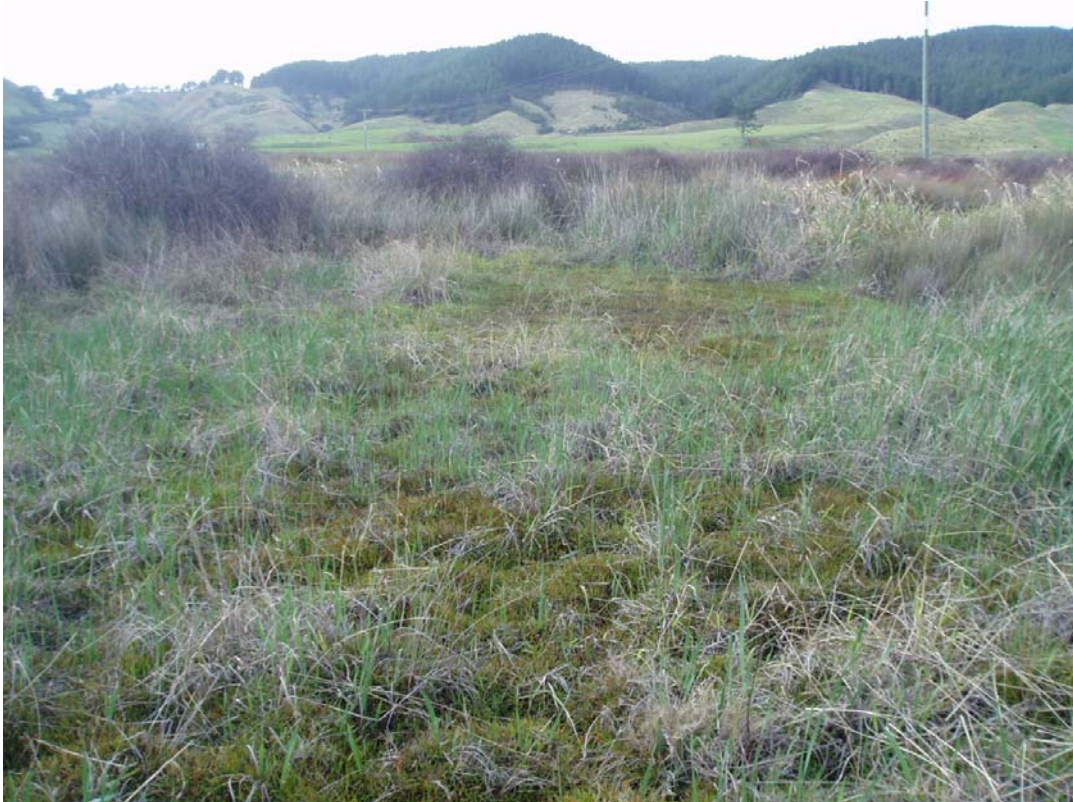
Figure 8: A patch of remuremu and montbretia, with saltmarsh ribbonwood seaward and giant umbrella sedge landward.

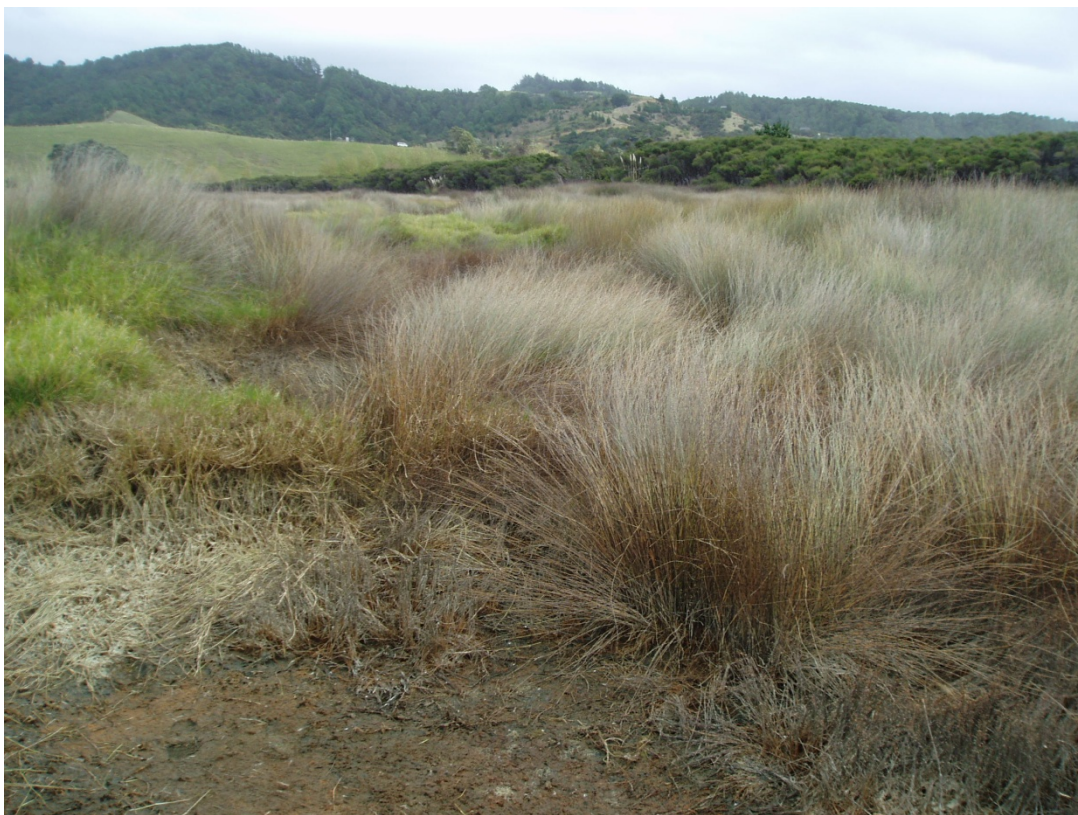
Figure 9: The saltwater paspalum, sea primrose and oioi in the foreground has been affected by ponding water. The healthy saltwater paspalum lines the bank of the western tributary (slightly elevated).

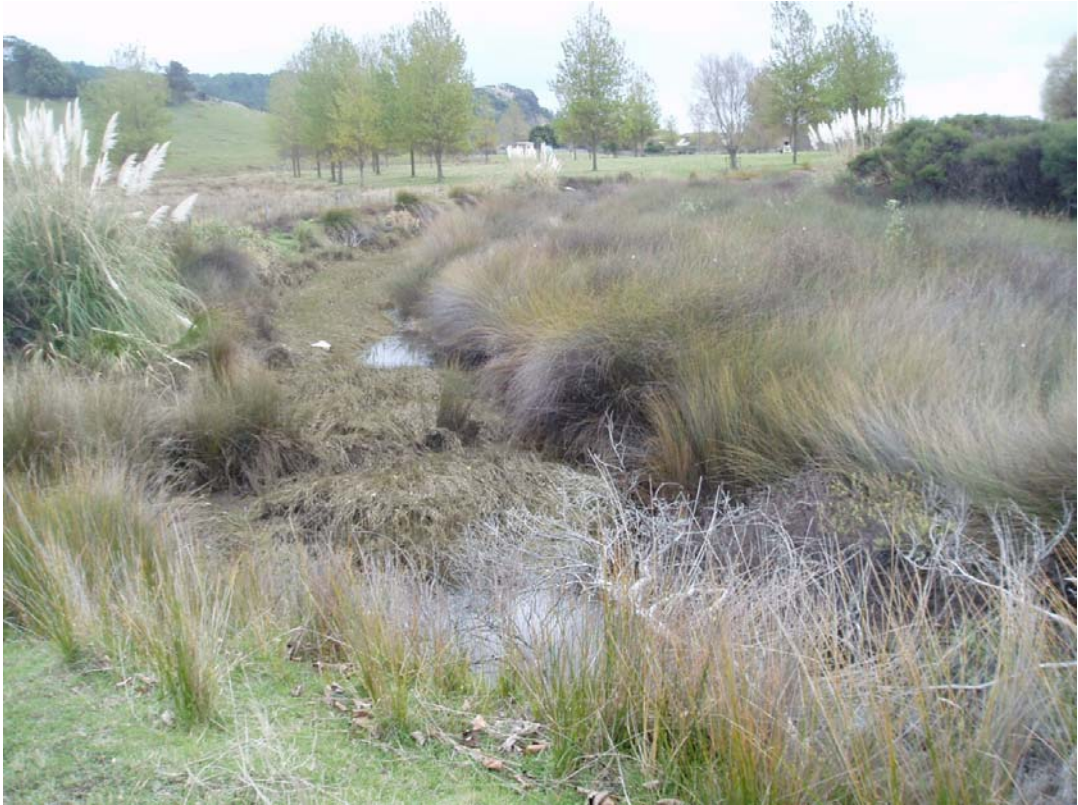
Figure 10: *Mimulus repens* is being overwhelmed by saltwater paspalum in the creek bed here. The oioi and ribbonwood blend into a manuka/Baumea wetland on the TLB (right). Stock have access to the TRB in the foreground.

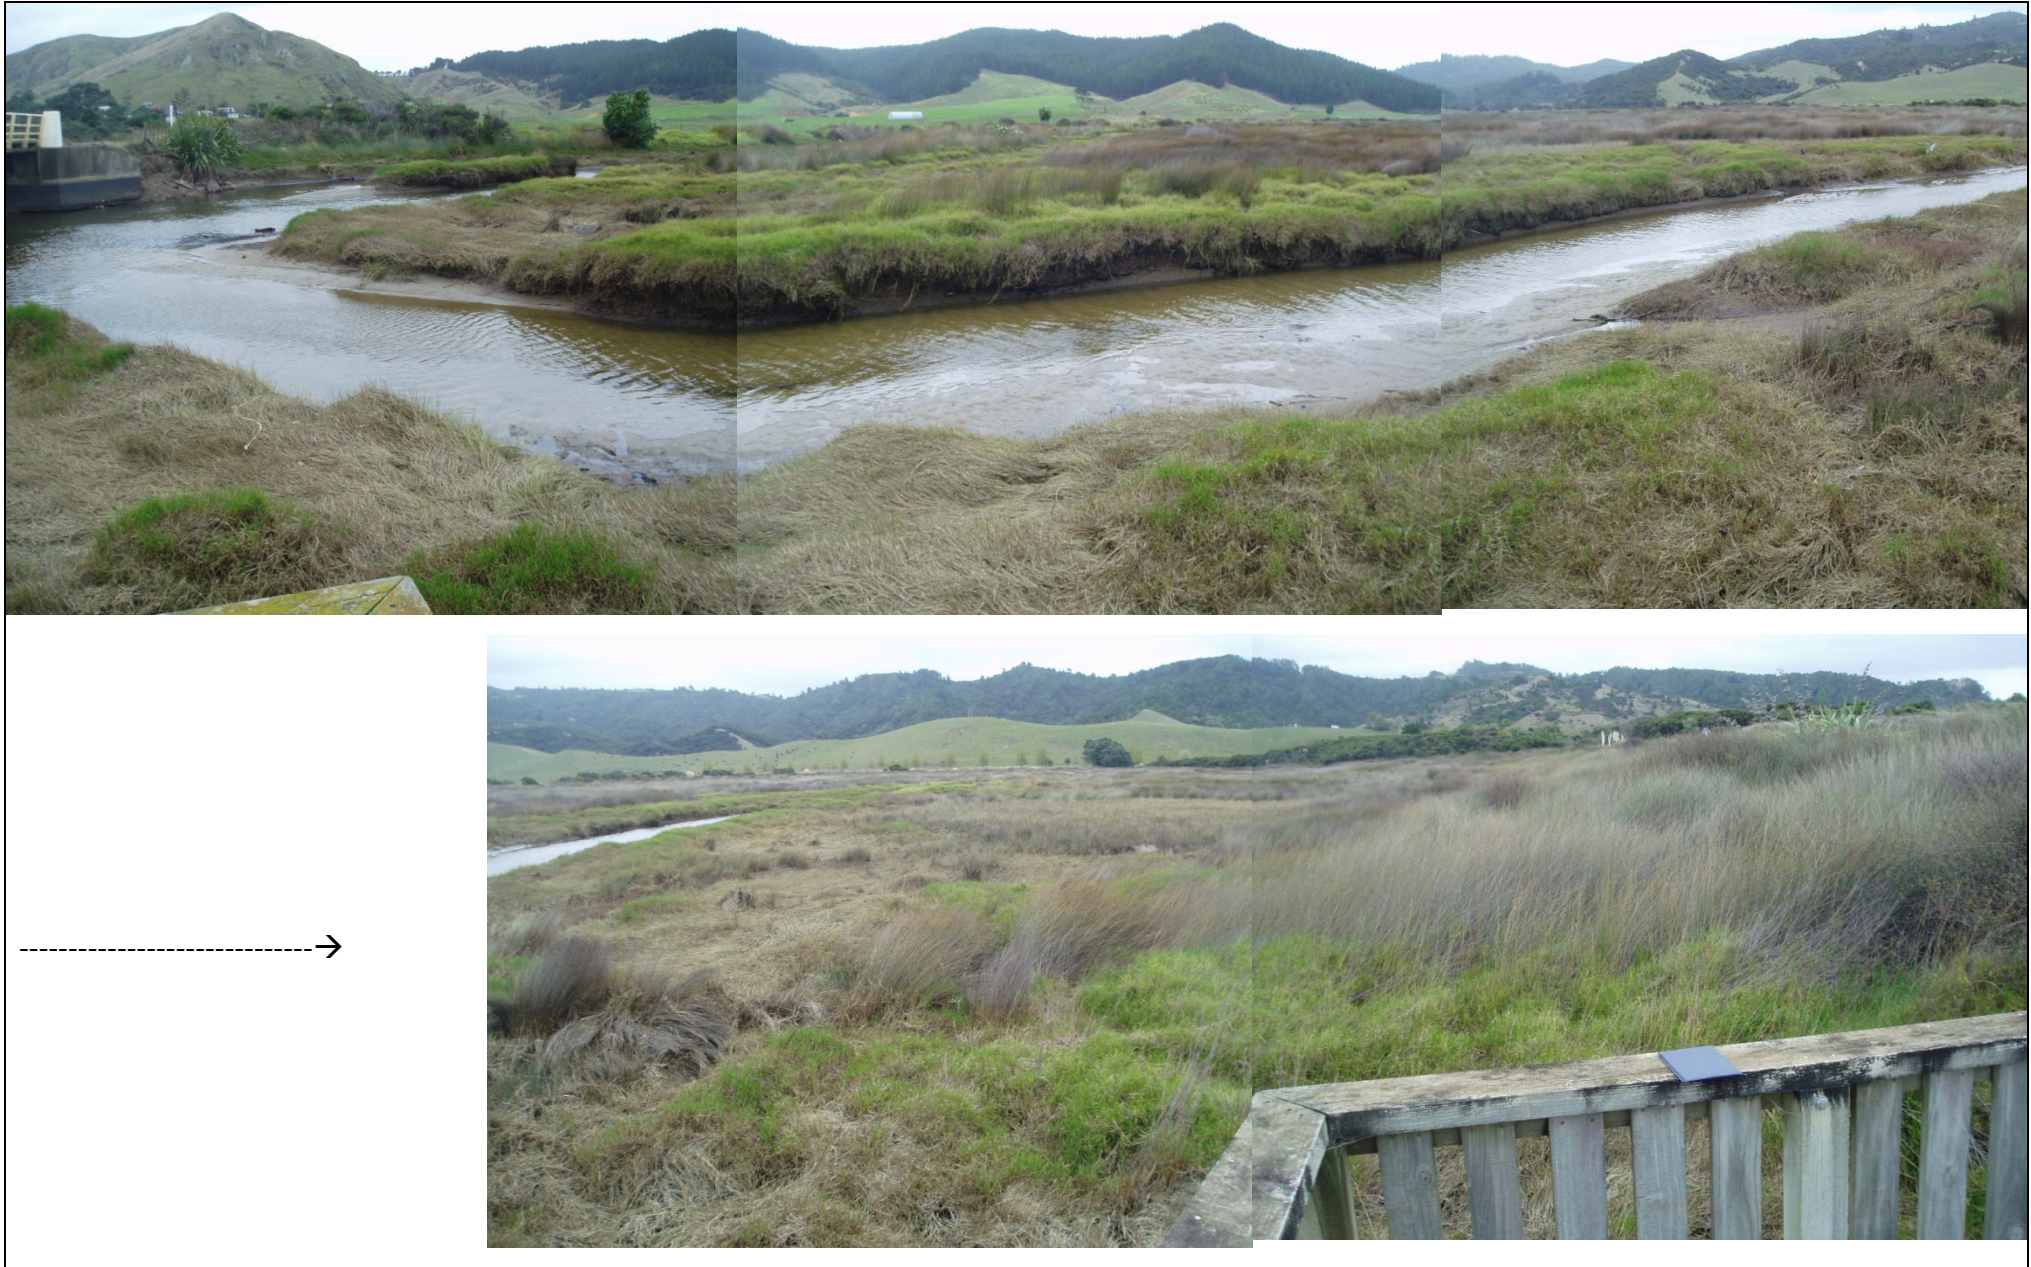
Figure 11: The upper Otama estuary from the roadside viewing platform (note the predominance of saltwater paspalum along the waterways).
