Estuarine vegetation survey – Raglan (Whaingaroa) Harbour

Prepared by:
Meg Graeme,
Natural Solutions – Marine and Terrestrial Ecologists Ltd

March 2012

Natural Solutions Contract Report 12/104

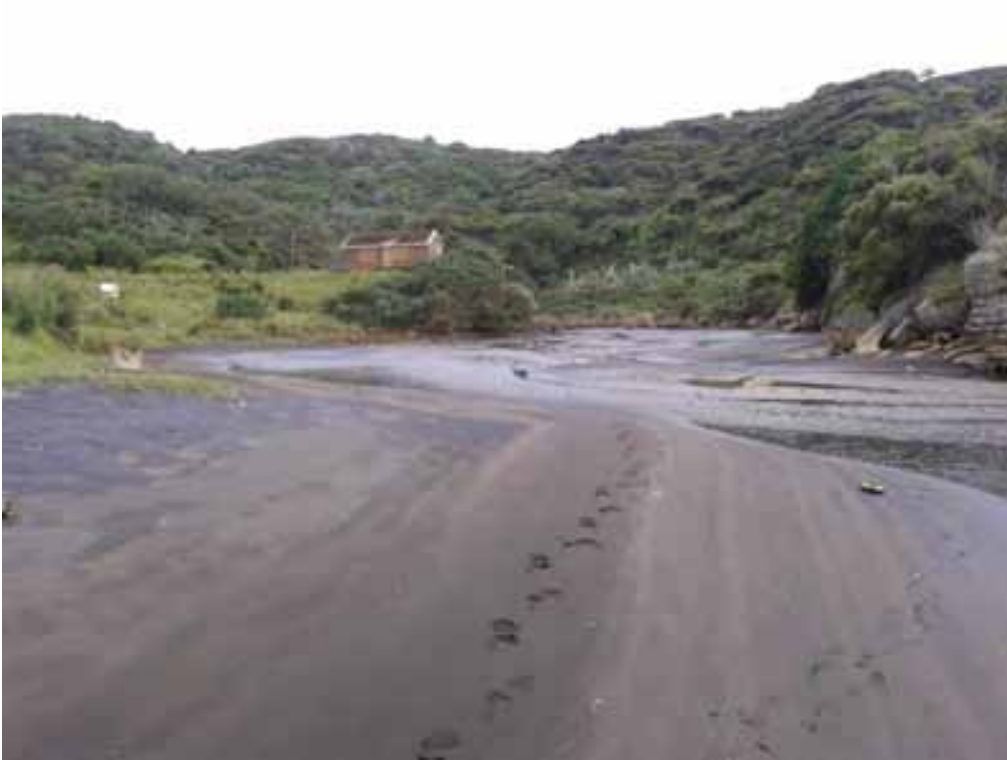
Figure 3: View looking into the head of Maratoka Point Bay with saltwater paspalum lining the left foreshore and more diverse native estuarine vegetation visible in the middle background.

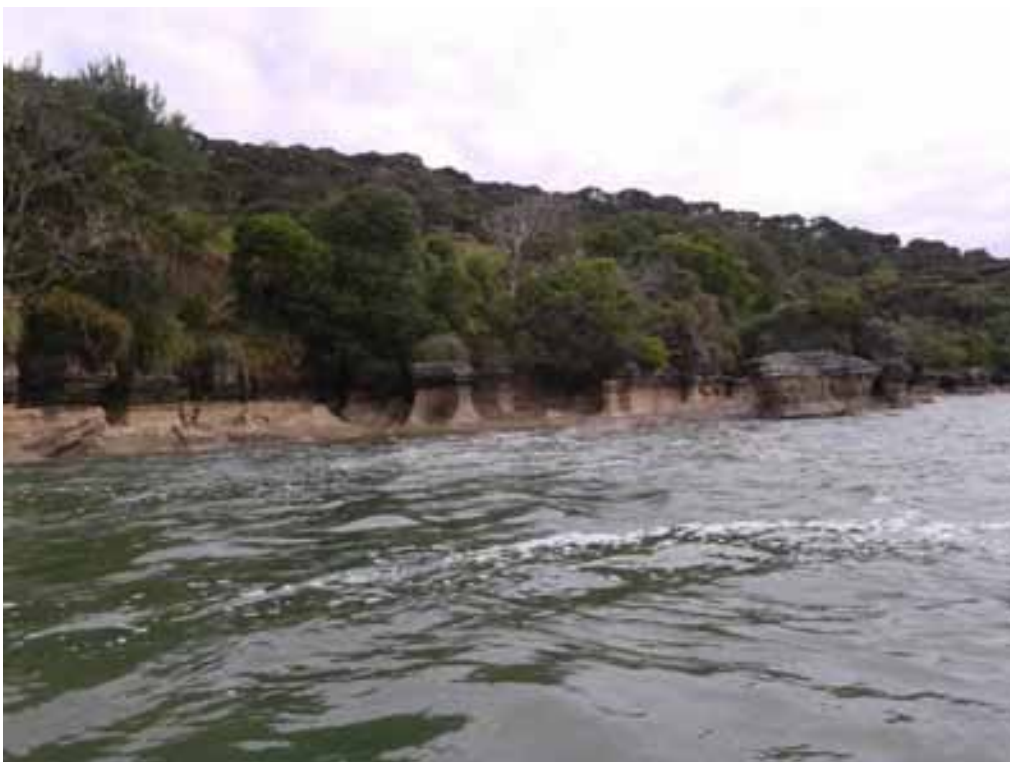
Figure 4: This view of remnant coastal forest along an exposed limestone coastline is similar to photo 2 in Graeme (2004). The limestone does not support any estuarine vegetation.

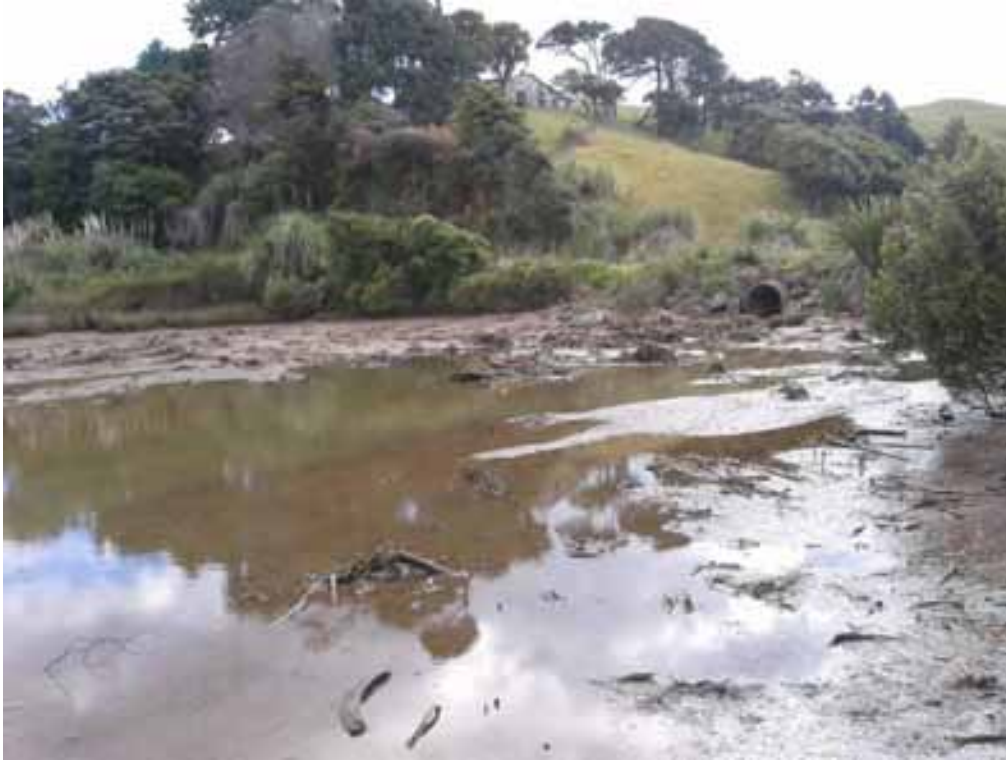
Figure 5: Raupo debris washed downstream onto the intertidal flats of Ponganui Creek.

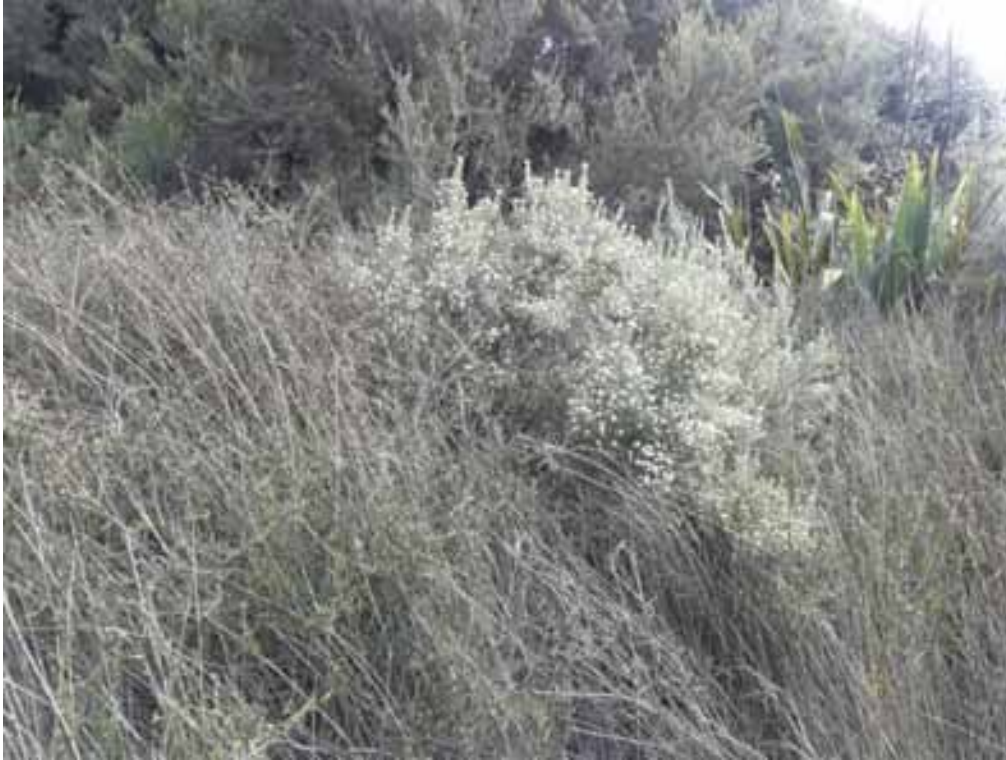
Figure 7: A flowering cottonwood surrounded by manuka, flax and coastal daisy behind and sea rush and saltmarsh ribbonwood in the foreground.

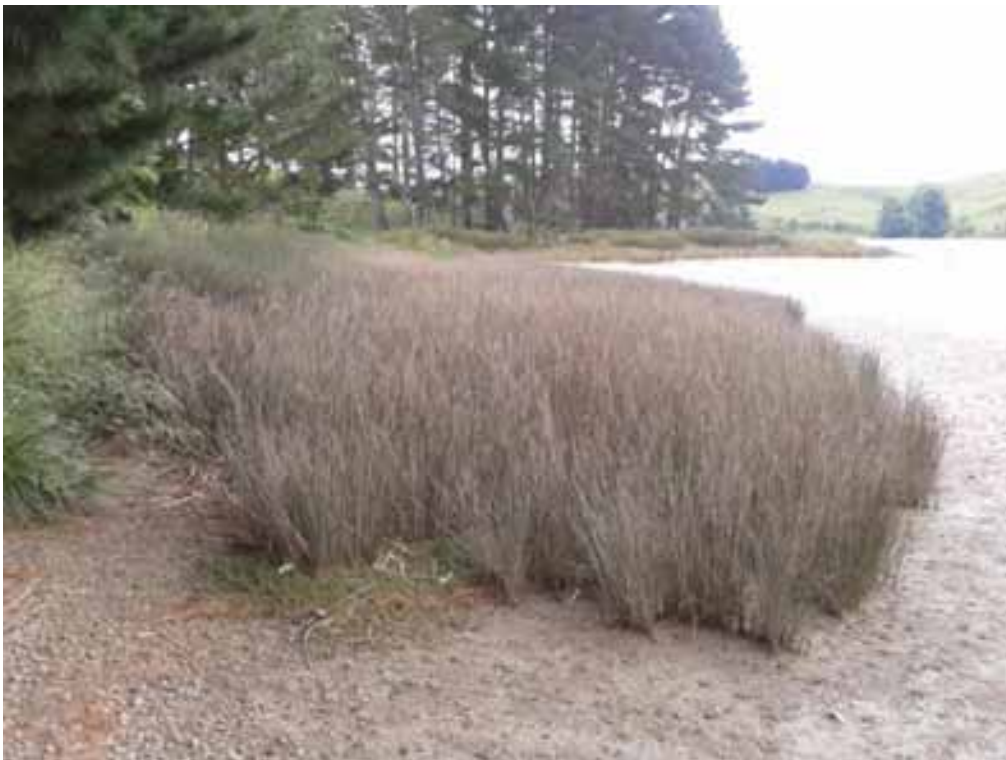
Figure 8: Sea rush fringing an indent along the TLB of Paihere Creek with a band of saltmarsh ribbonwood and some sea meadow and saltwater paspalum in behind.

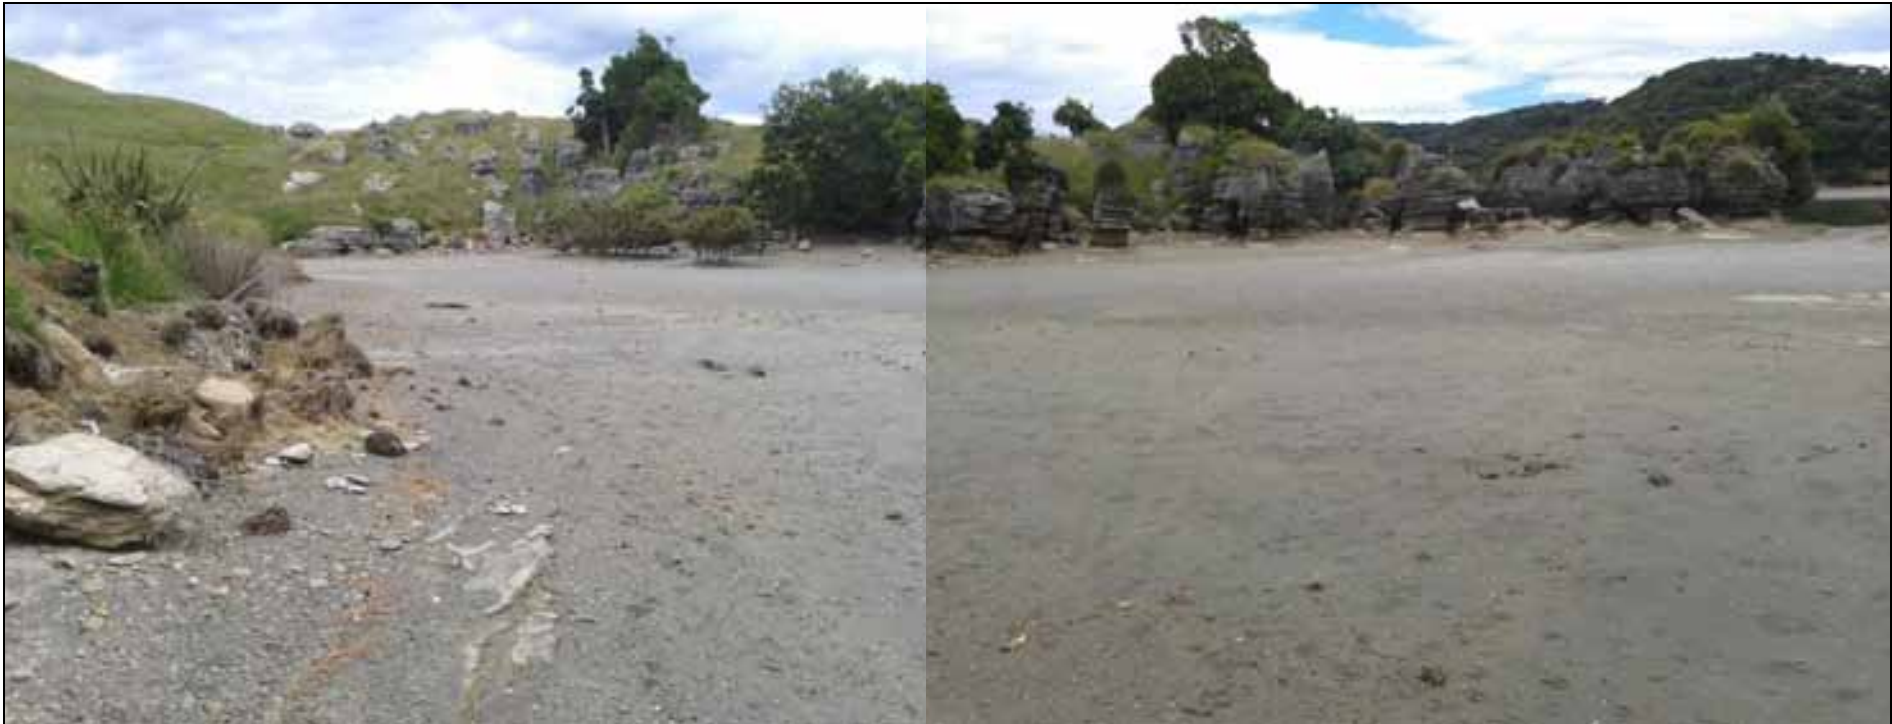
Figure 9: A small group of mangroves (~2m tall) in the lee of limestone rock stacks at the entrance to Paihere Creek. A slip is visible in the left foreground of the photo with an eroded edge of sea rush behind. Coast spear grass and glasswort occur amongst the rocks.

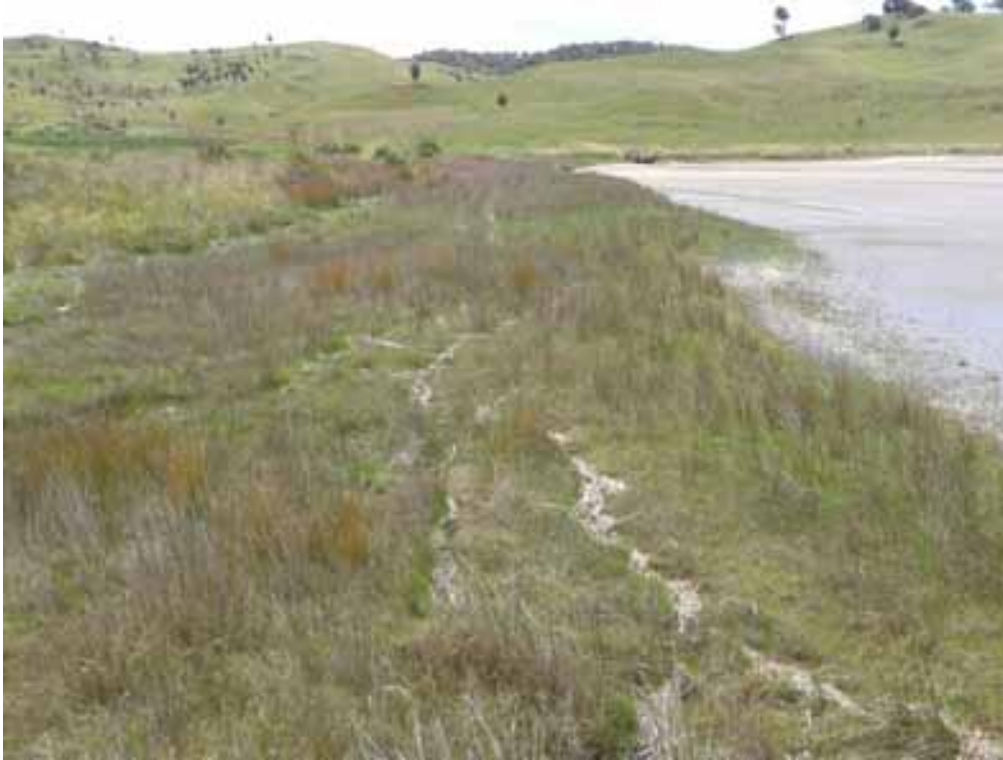
Figure 10: A view from a limestone block looking over sea rush and some oioi and three square, densely mixed with saltwater paspalum. Along the front is sea primrose, remuremu and sea celery. There is a fenced raupo wetland in the left background.

Patikirua Bay was characterised by a band of rushland and patches of sea meadow intermingled with saltwater paspalum at the head of the bay (Figure 10). Also of note was the large fenced raupo wetland further inland. Figure 11 shows good fencing along the coastal edge out towards the mouth of the bay. Large exposed rocky platforms extend out into the shallow flats of the bay from the eastern headland and pacific oyster beds were found in the mouth of Patikirau Bay.

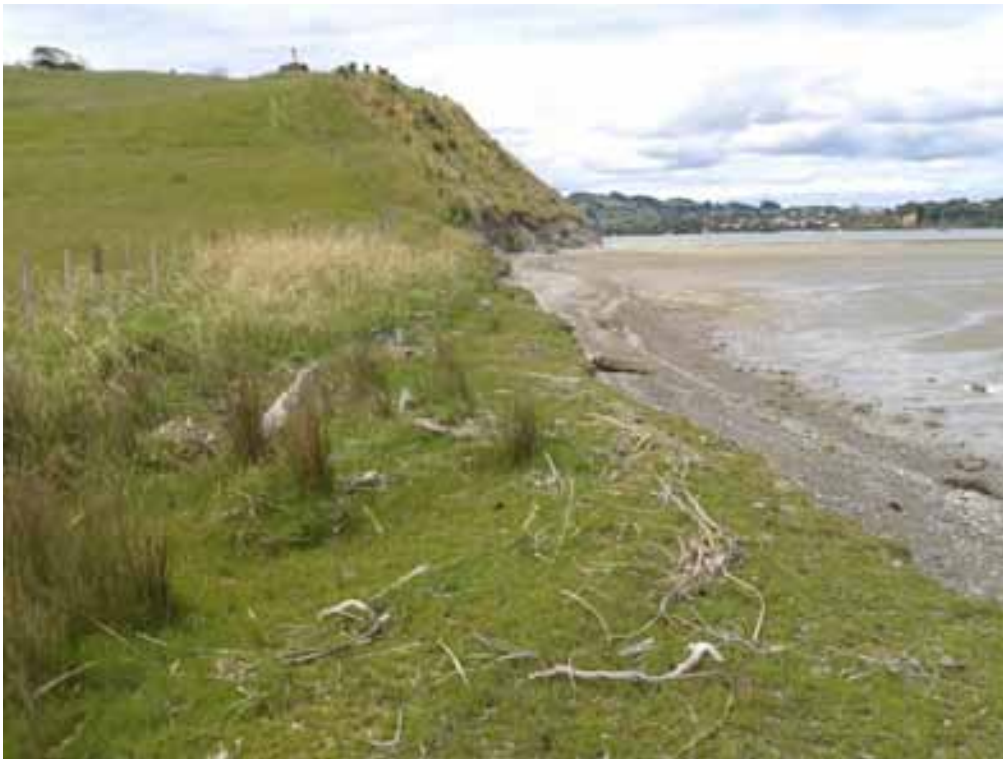
Figure 11: A view looking over a fenced coastal edge of Patikirau Bay towards the steep eroding headland dominated by pampas. In the foreground a saltwater paspalum sward includes three square, sea rush and native celery.

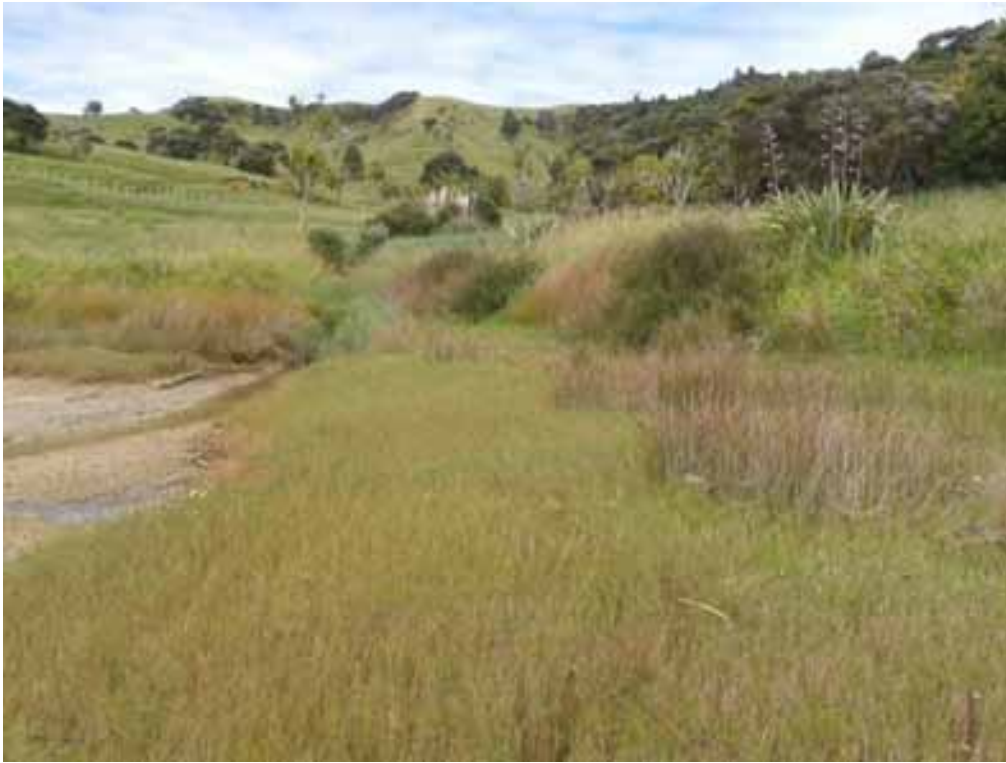
Figure 12: Saltwater paspalum dominates this band of estuarine vegetation at Waiwhara Bay. Other species present include sea rush and oioi, with a mangrove, saltmarsh ribbonwood and marsh clubbrush by the stream mouth.

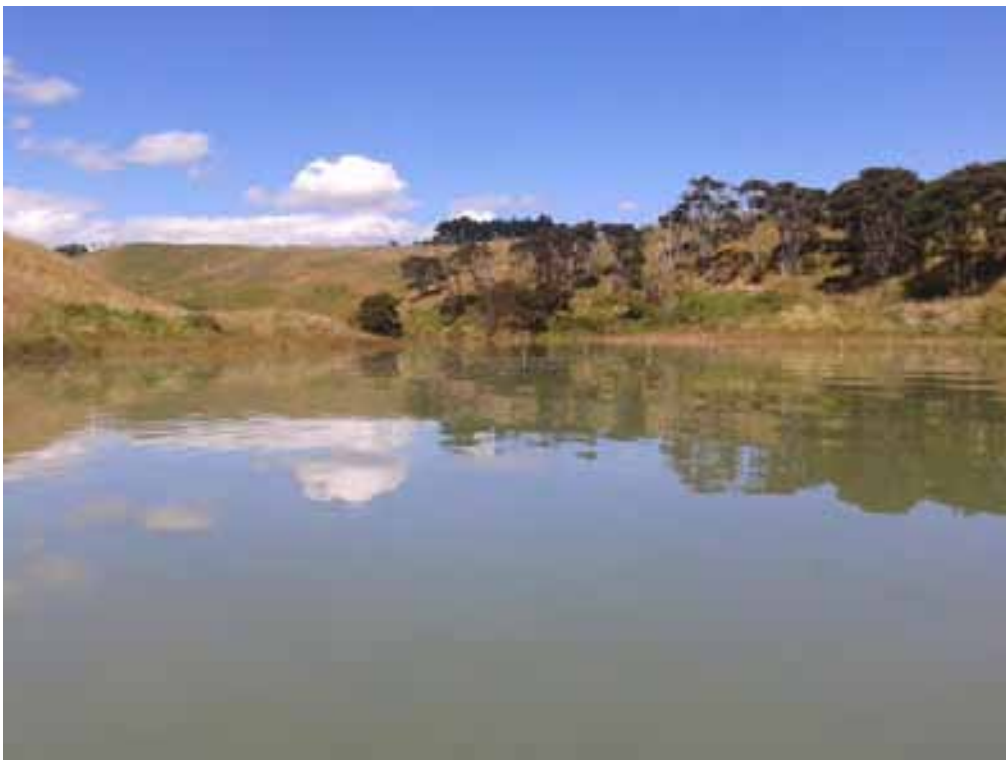
Figure 13: View showing an old fenceline in the CMA and foreshore dominated by saltwater paspalum intermingled with rushland. The riparian margin has now been fenced off to include some of the remnant kanuka.

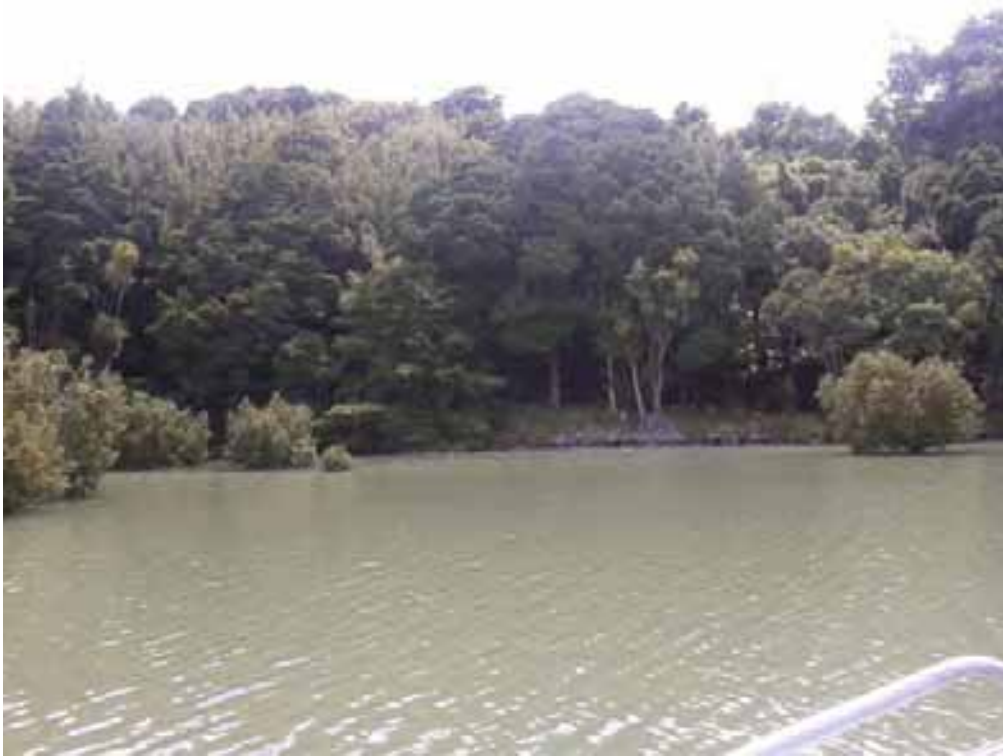
Figure 14: Mangroves here at the top of Te Tarata Creek bay are about 2m tall. Stock graze under the background riparian vegetation which is predominantly totara, tawa, karaka, cabbage tree and kowhai.

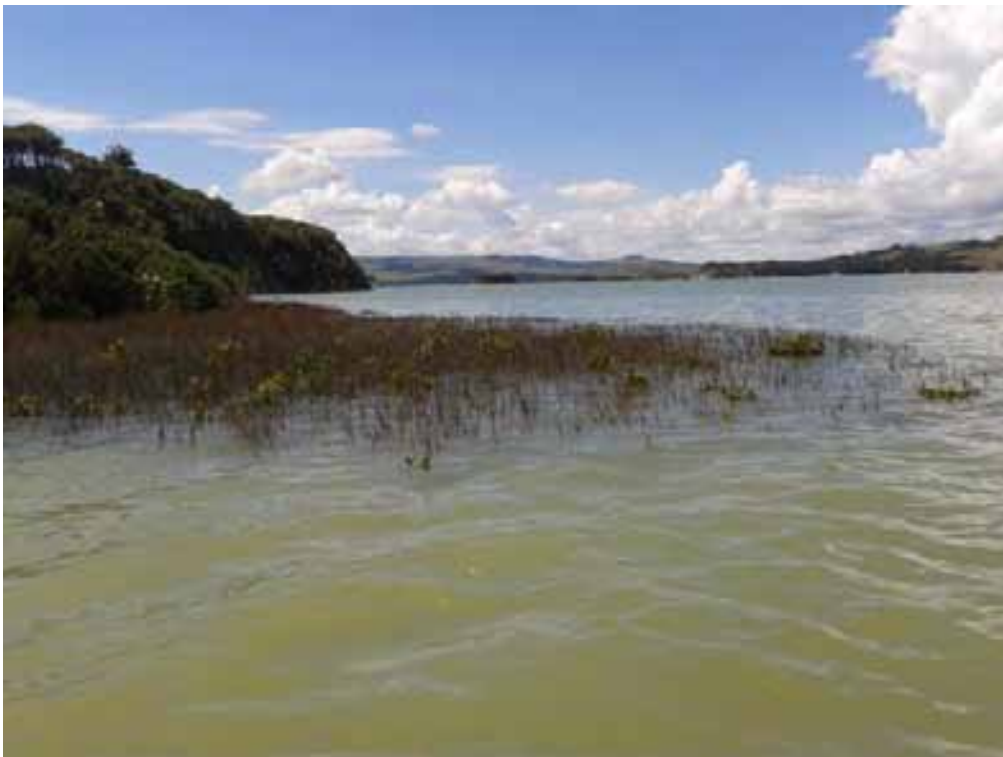
Figure 15: Looking out from Mokoroa Creek over sea rush with young mangroves established within the outer edge. Round Island is in the background.

Around into **Mokoroa Creek**, the coastal edge was fenced but there were holes in the fence and gates missing. Stock obviously had access to the CMA here as indicated by the pugging and dung. Saltwater paspalum was common in the back of the sea rush and oiioi band. Further around into the bay, rush/sedgeland and saltmarsh ribbonwood became the dominant communities. Further out along the TLB was an area of mixed sea rush and young mangroves (Figure 15).

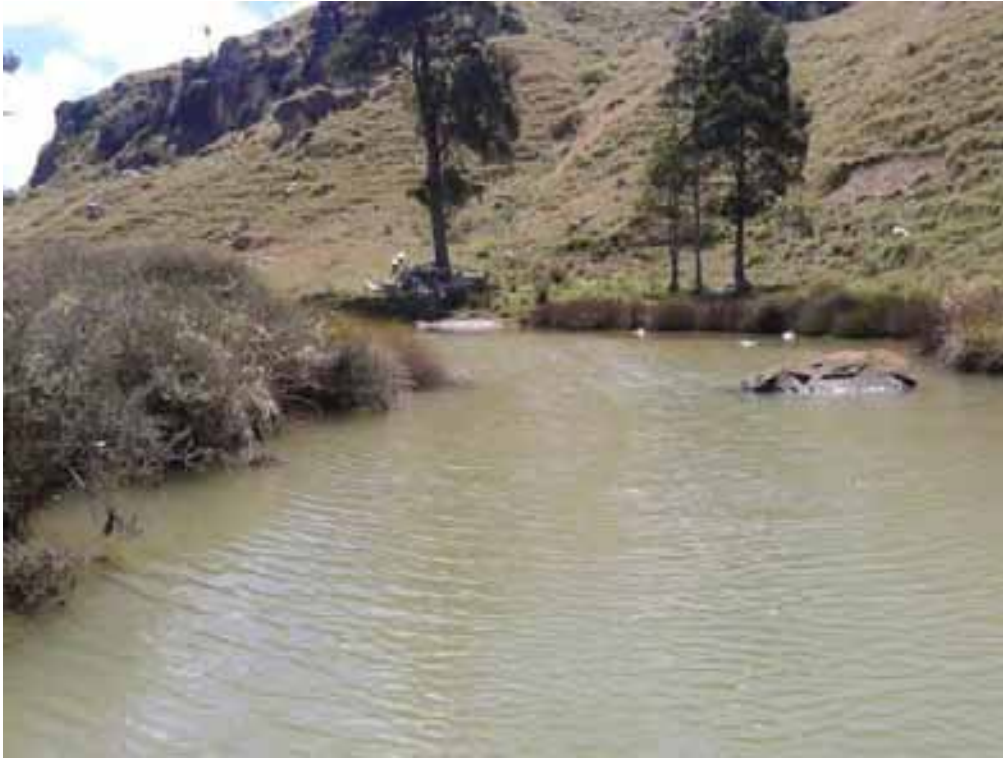
Figure 16: Saltmarsh ribbonwood and oioi along the upper tidal reaches of the Te Kotoku Stream. The riparian edge is not fenced and stock have access to the waterway.

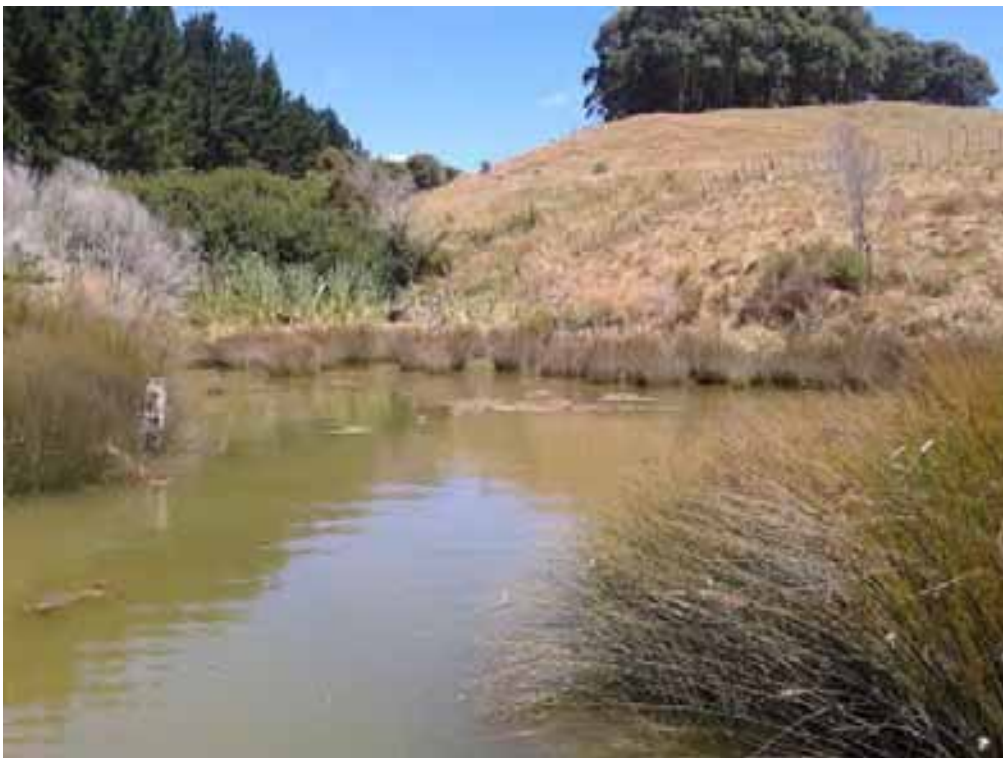
Figure 17: Stock have severely damaged the raupo at the back of the estuarine vegetation (sea rush, oioi, saltmarsh ribbonwood and saltwater paspalum). The riparian kanuka has been sprayed but not the willows invading the freshwater wetland.

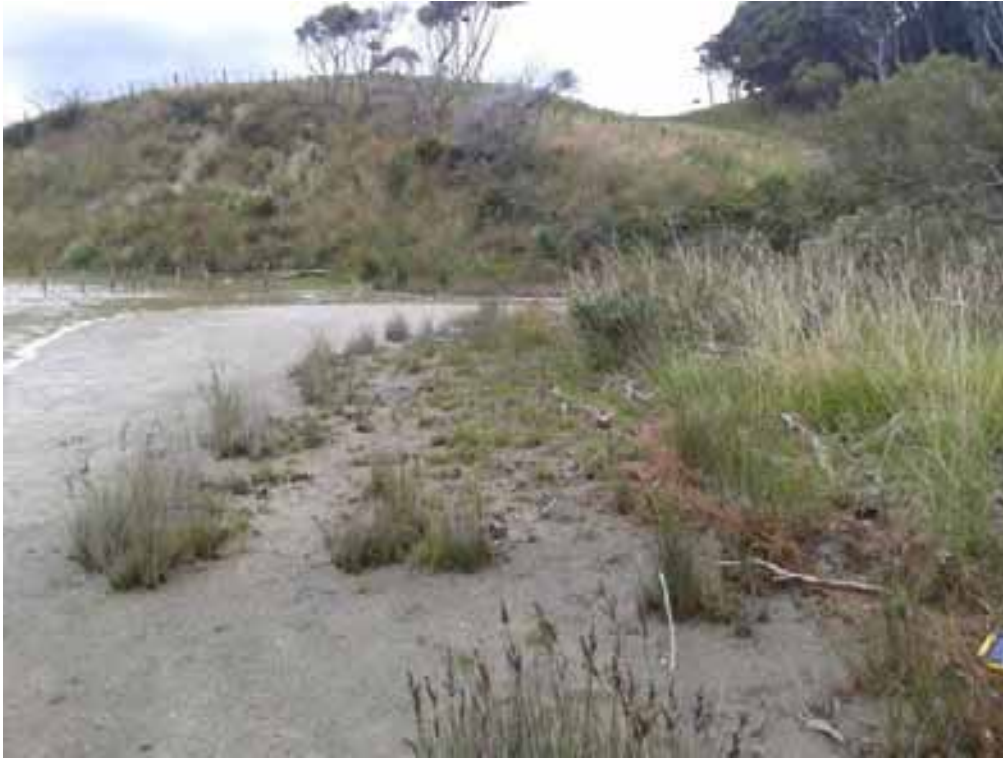
Figure 18: A view showing an area of mixed sea rush, sea meadow and saltwater paspalum up the Tawatahi River arm that appears to be pugged by stock or goats. Tall fescue and coastal daisy are present on the higher foreground. The coastal edge is fenced in the background.

The **Tawatahi River** arm was fenced to restrict stock access to the harbour except for the upper TLB. There was plenty of sign of goats along the outer TLB (Figure 18) and around the headland into Waingaro River arm. Figure 19 shows a wide band of rushland grading into native forest. Goat tracks were noted crossing the open flats. There were a lot of mud crabs and titiko (both adult and juvenile) present. Another side embayment with a thick band of rushland (south of Figure 18) was backed by coastal daisy and saltmarsh ribbonwood before grading into native forest. A number of patches of young oiioi were noted.

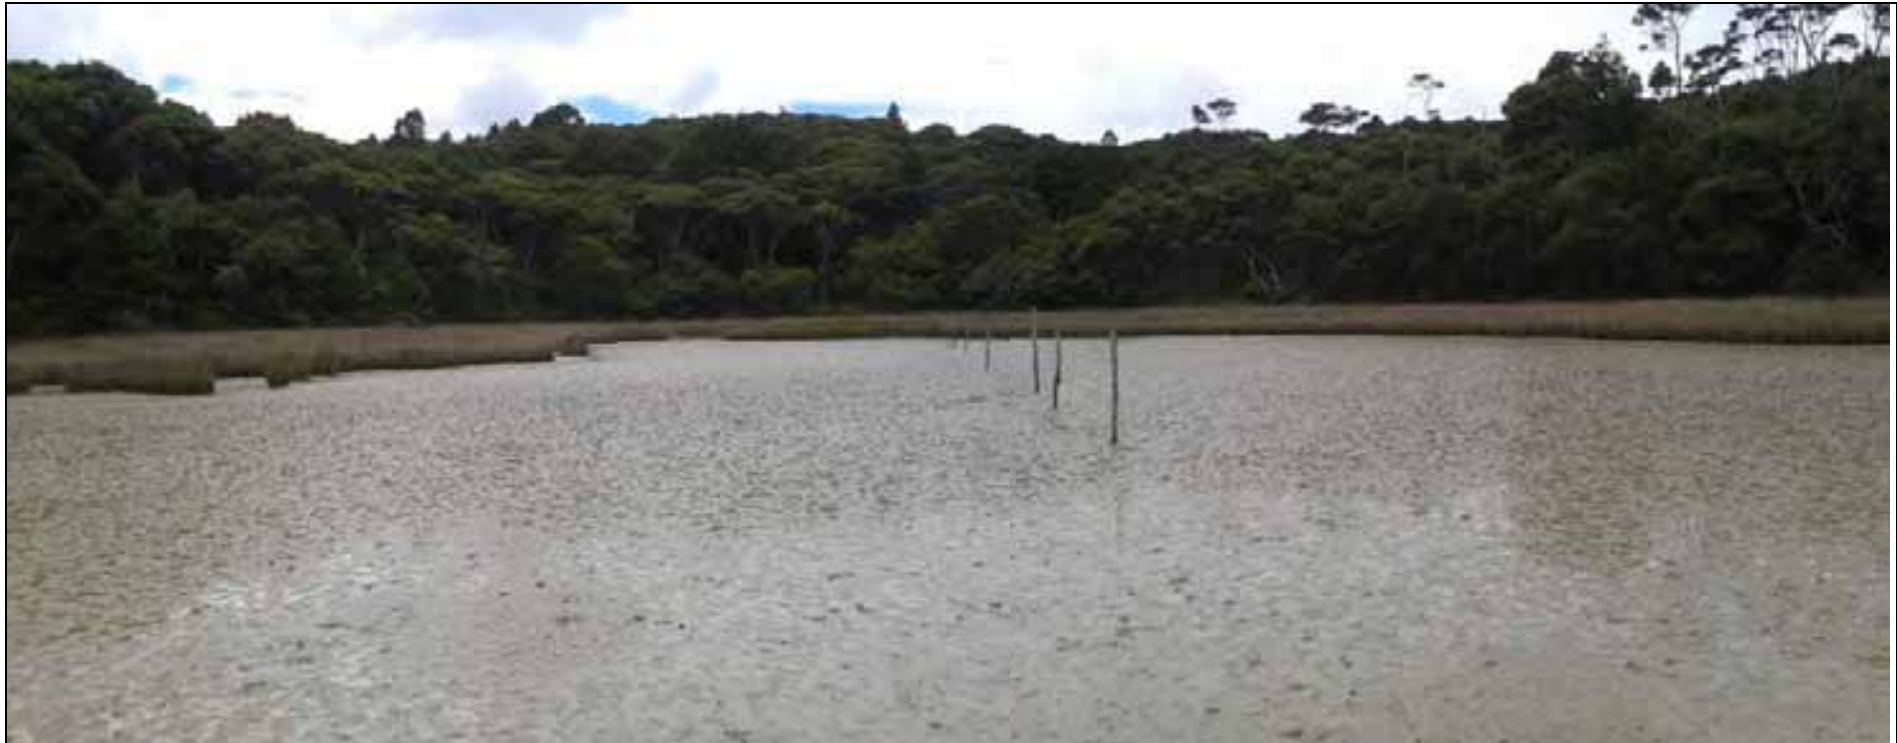
Figure 19: A wide rush band grading into native forest in the Tawatahi River arm. The rushland is predominantly sea rush except for a patch of oioi left of the fenceline.

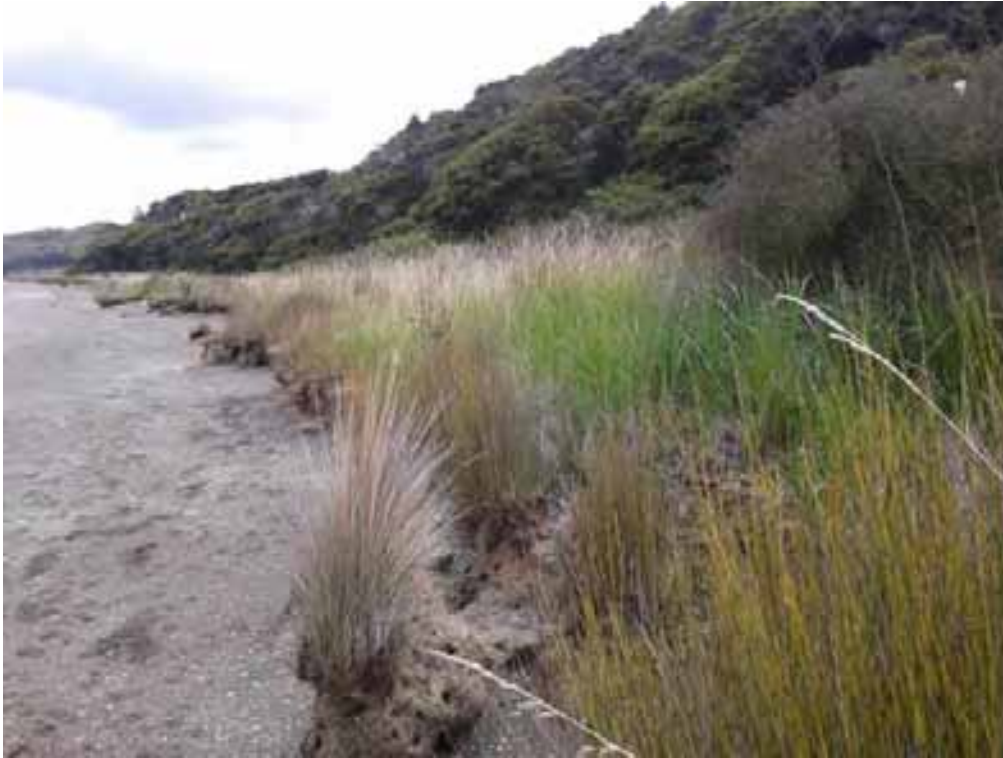
Figure 20: A narrow band of sea rush and oioi line the outer Tawatahi River coastline here with tall fescue, marsh clubbrush and saltmarsh ribbonwood in behind.

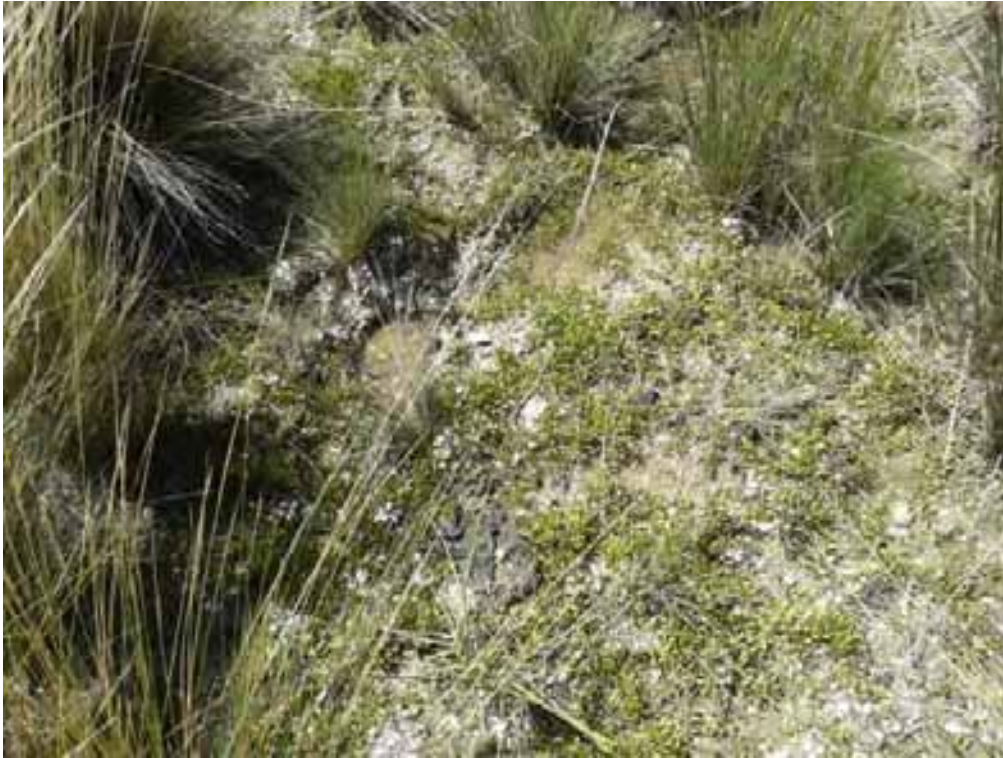
Figure 22: Pugging and dung amongst sea meadow on the sand spit in the Waingaro River arm.

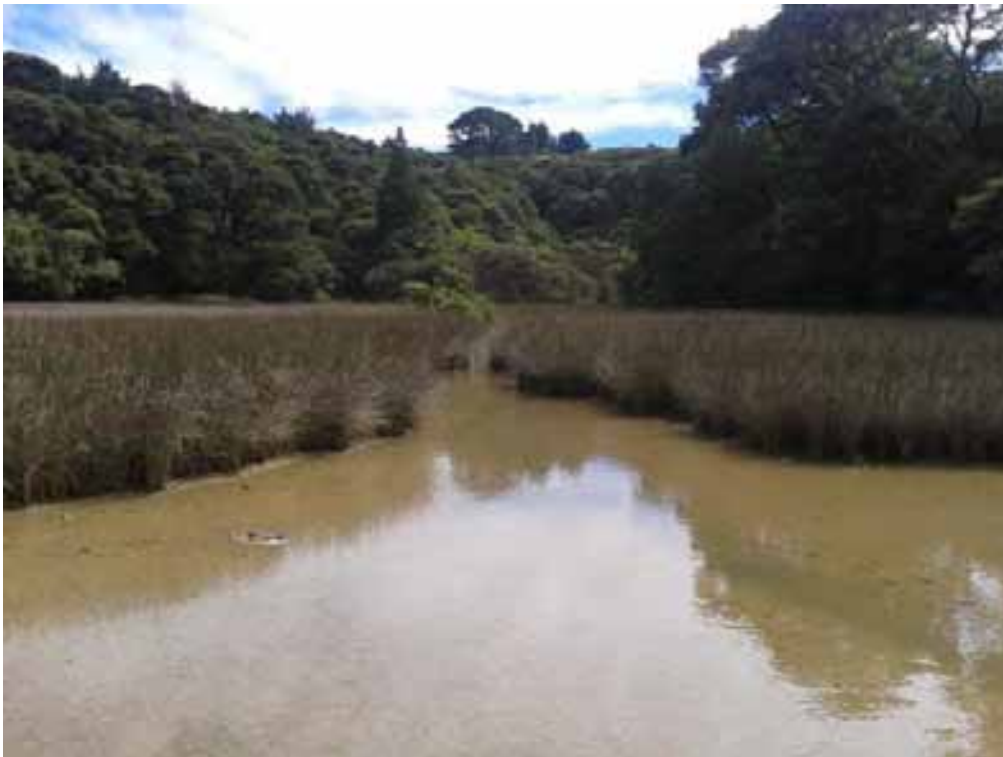
Figure 23: A single mature mangrove growing along a water course through a sea rush community.

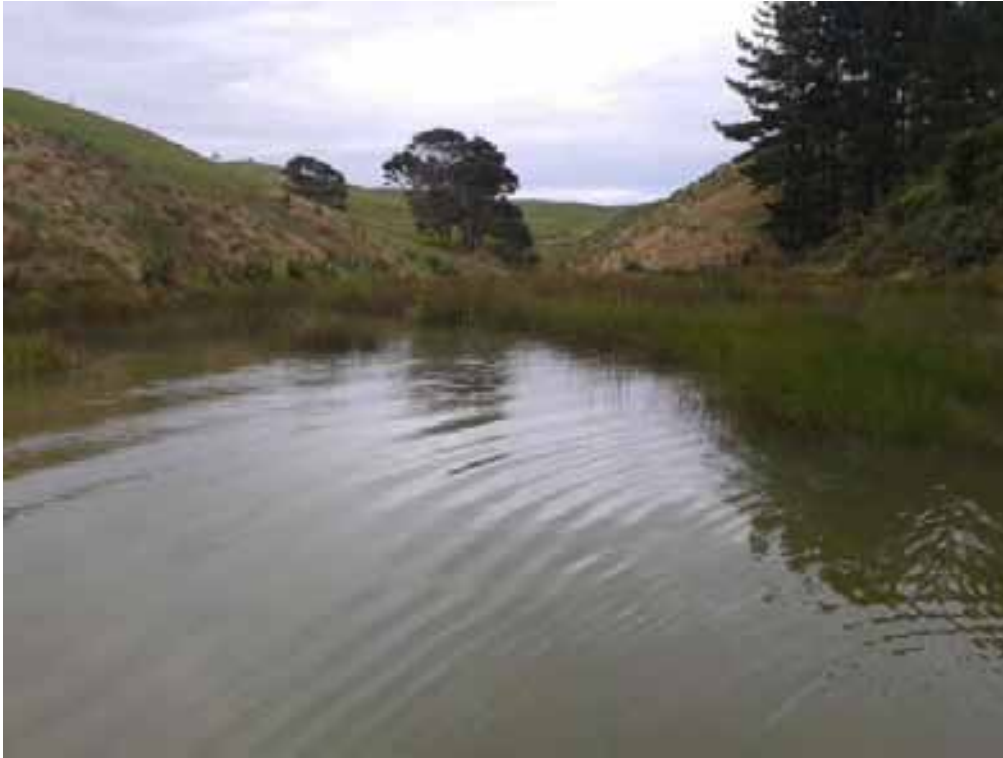
Figure 24: A view of the upper most embayment of the Kerikeri River arm on the TRB showing wide riparian margins fenced off and planted. Estuarine vegetation in the foreground includes a mosaic of oioi, some sea rush, short marsh clubrush (*Bolboschoenus medianus?*) and raupo.

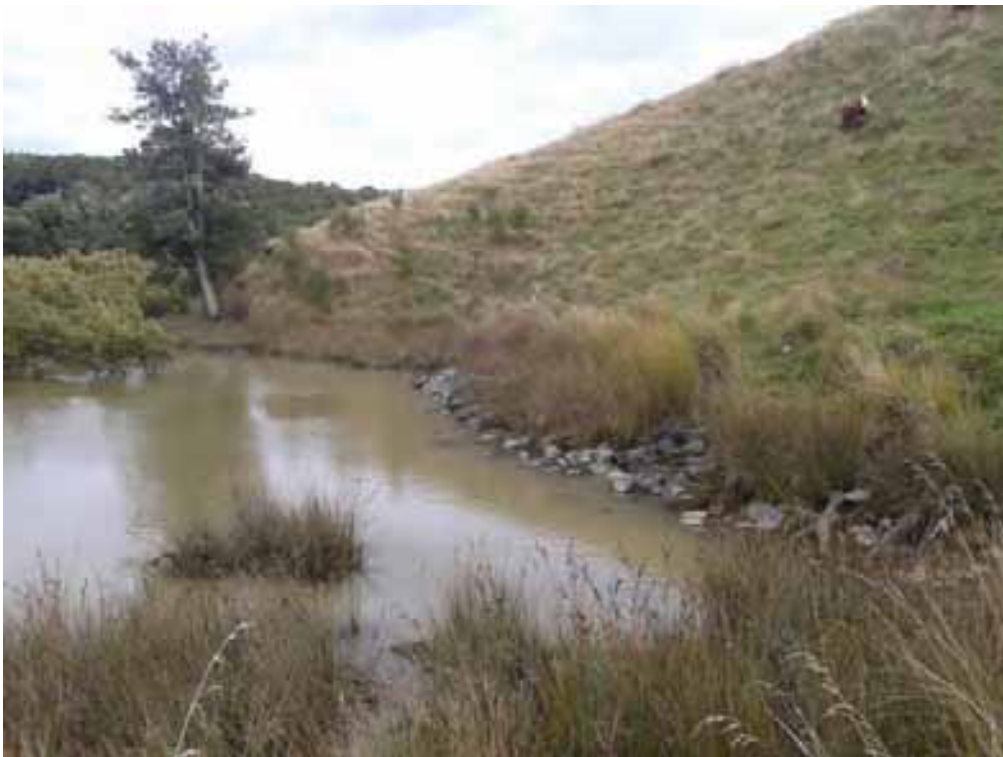
Figure 25: An unfenced margin along the TLB of the Kerikeri River arm with regenerating kanuka visible on toe of slope. A small area of saltwater paspalum is present in the pugged indent to the right of the photo.

There seemed to be no fencing along the TLB of the Kerikeri River arm upstream of the Waingaro River arm. There were quite a few freshwater seepage areas that would greatly benefit from fencing as they were severely pugged in many places. Bracken and kanuka seedlings were also noted on the steepest riparian slopes and would quickly help the regeneration of the riparian margin if fencing was put in place (Figure 25). A lot of dung and tracking along the grazed riparian edge was noted. Generally the middle reach of the TLB was characterised by a band of mangroves with a thin band of rushland in behind.

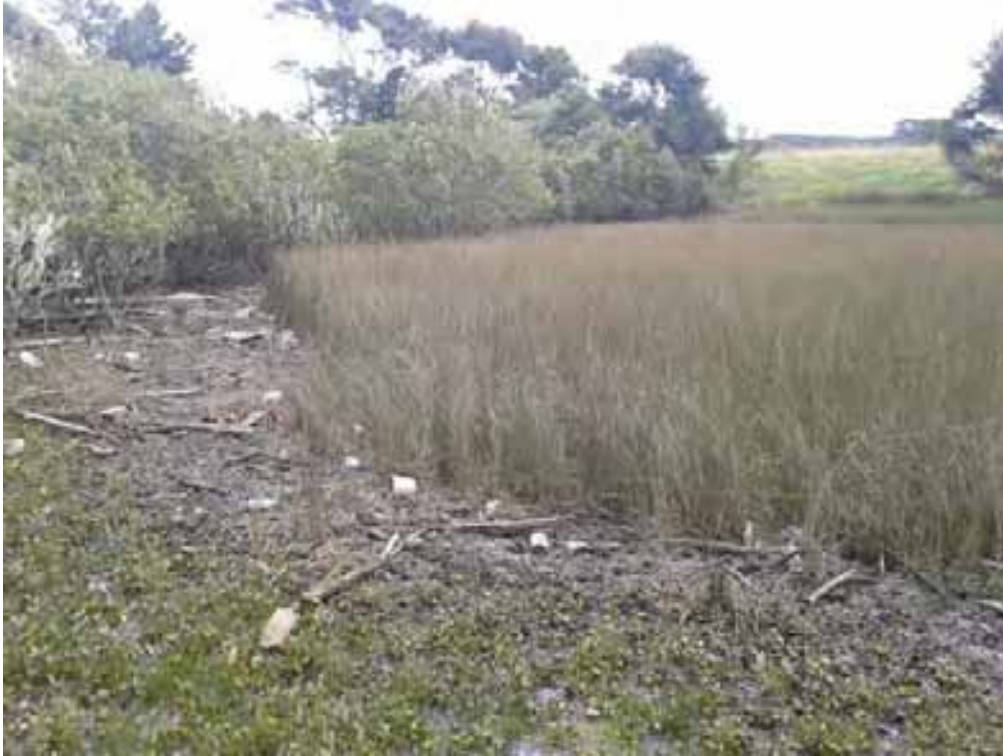
Figure 26: Goat tracks and rubbish are found between the rushland and mangroves in this photo. The sea meadow in the foreground is predominantly arrow grass and sea primrose mixed with mangrove propagules. The sediment in this area smells putrid.

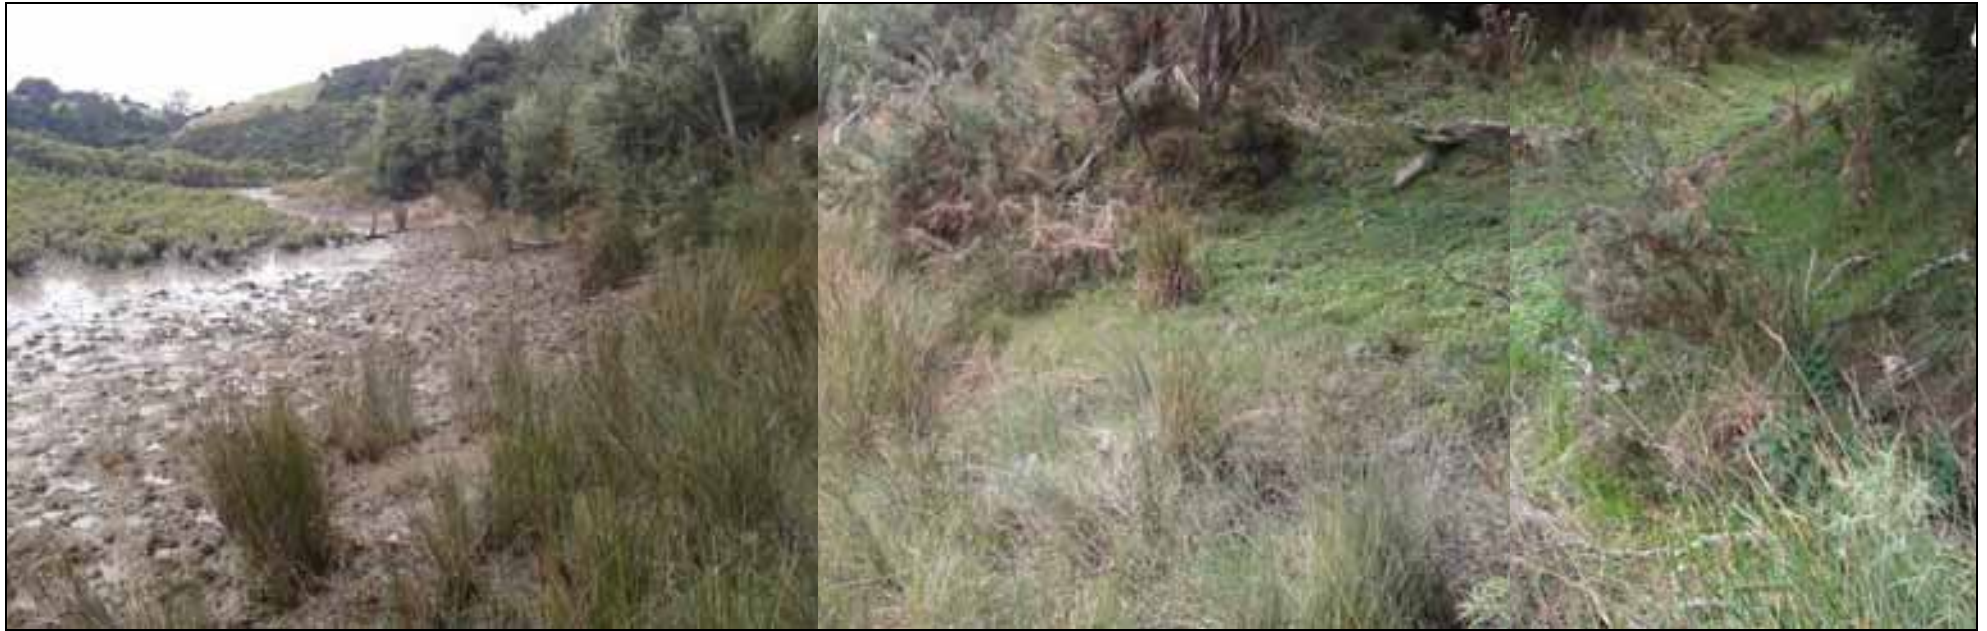
Figure 27: A stock access point to the harbour with associated pugging of tidal flats and browsing of mangroves. Saltwater paspalum is mixed with sea rush in the foreground. Larger mangroves are lining the creek edge with a smaller mangrove cohort landward.

arm. Occasional patches of healthy seagrass occurred either scattered just under mangroves or just inland of the mangrove band. The sediment was much firmer to walk on under the mangrove canopy than on the flats between the mangal and the banks. Numerous access points for stock and goats from grassed or forested land were found (Figure 27). Saltwater paspalum was quite often present where stock access along the CMA was noted (Figure 27 and Figure 28).

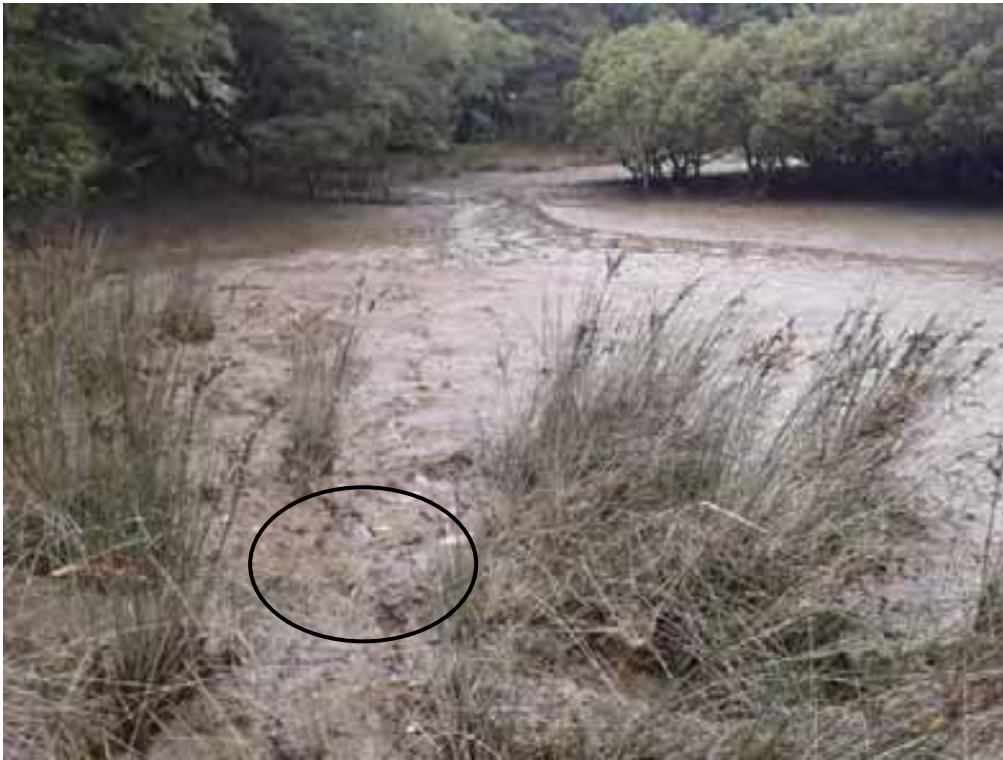
Figure 28: An area of sea rush with cattle tracking through it. A fragment of saltwater paspalum has established within the circled area.

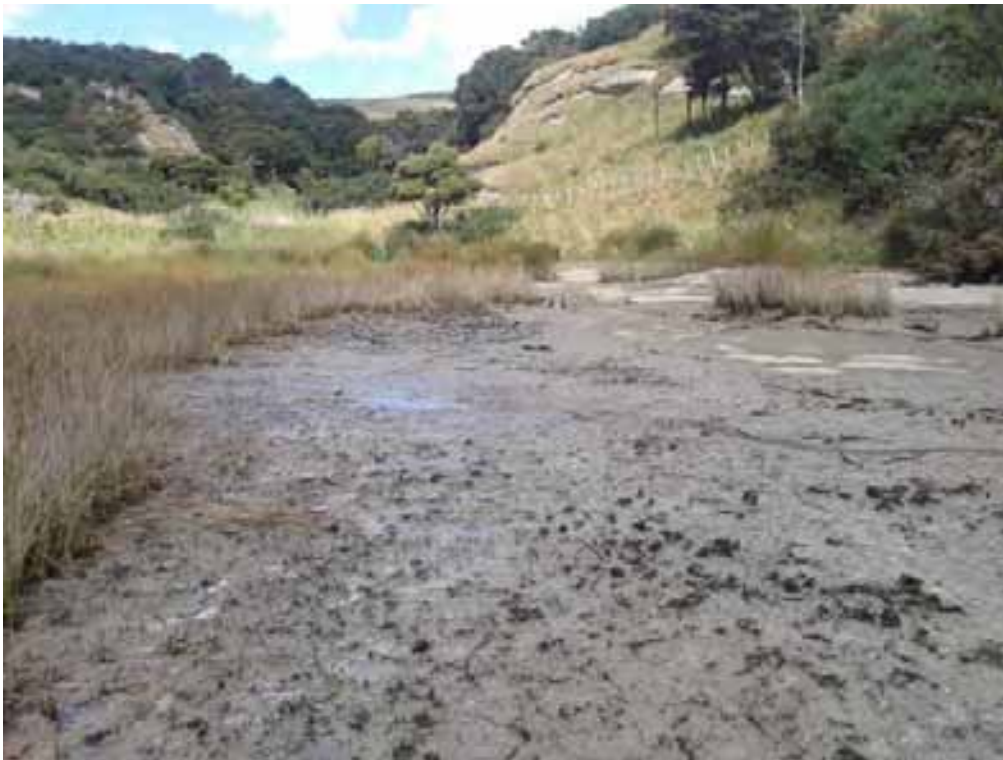
Figure 29: An area of sea rush die-back along the front of the rush band. A lot of goat prints were noted amongst the dead root masses.
