Estuarine vegetation survey – Raglan (Whaingaroa) Harbour

Prepared by:
Meg Graeme,
Natural Solutions – Marine and Terrestrial Ecologists Ltd

March 2012

Natural Solutions Contract Report 12/104

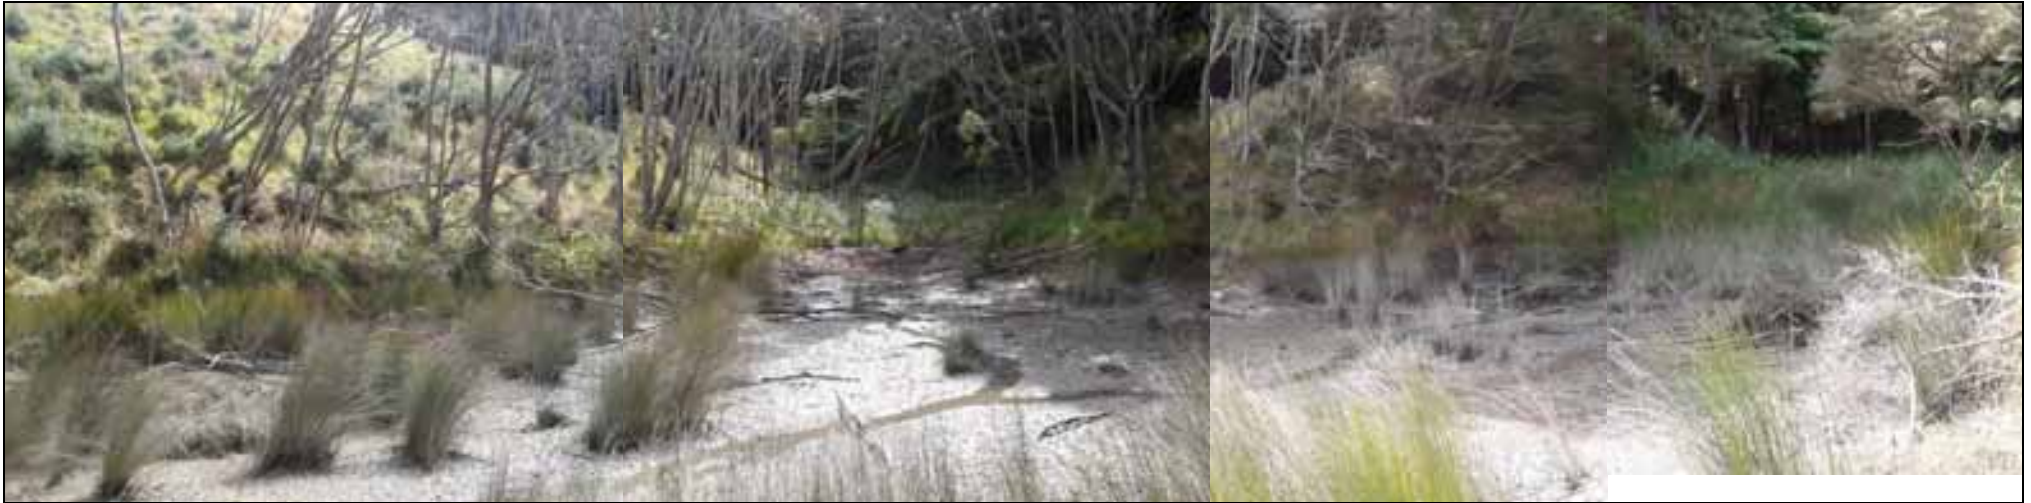
Figure 30: The head of a small embayment with riparian kanuka sprayed on the left and not on the right. No stock fencing.

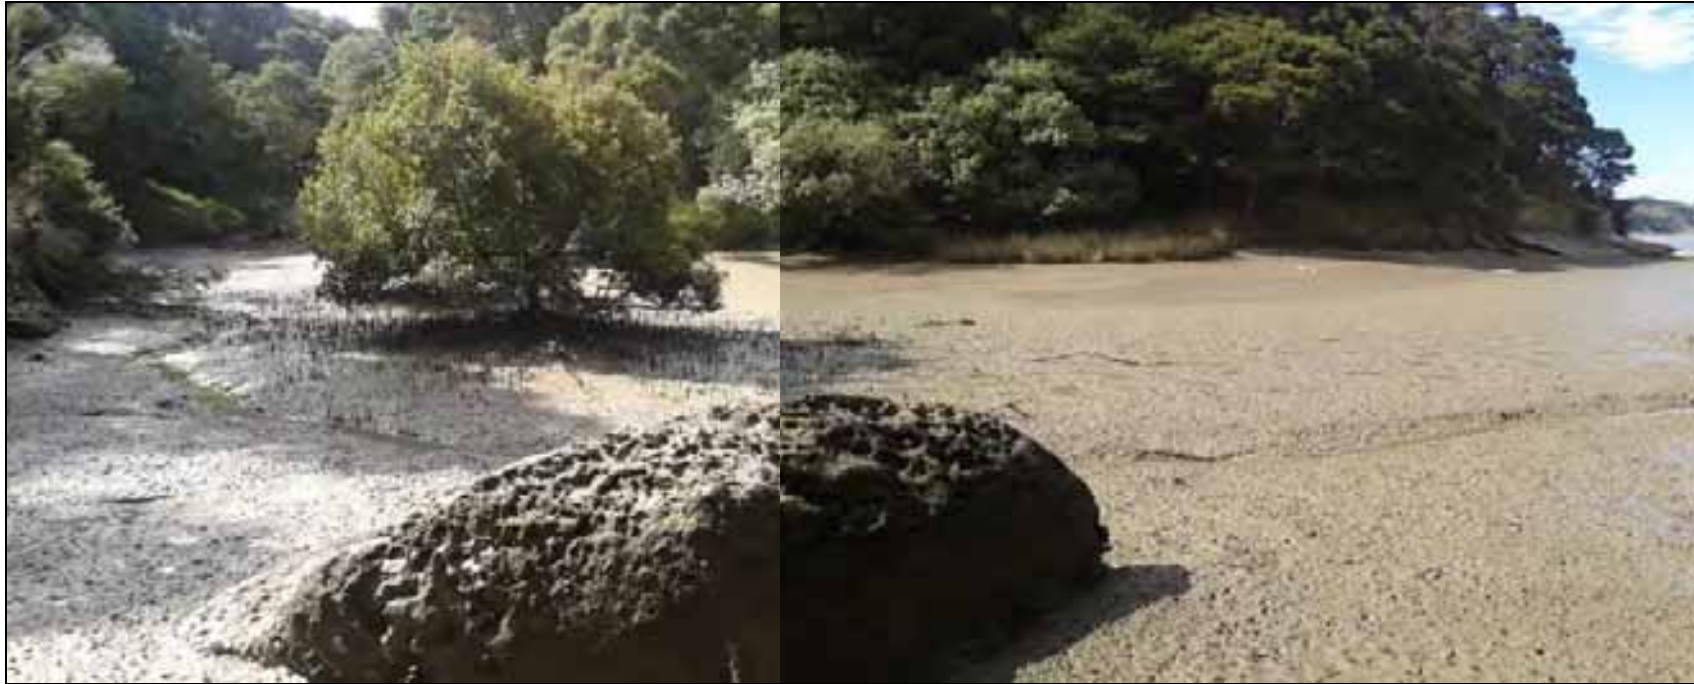
Figure 31: Two large mangroves (one behind the other) about 3m tall in a small embayment with sea rush some oioi and sea meadow (arrow grass, sea primrose, *Lilaeopsis novae-zelandiae* and *Leptinella dioica* in background.

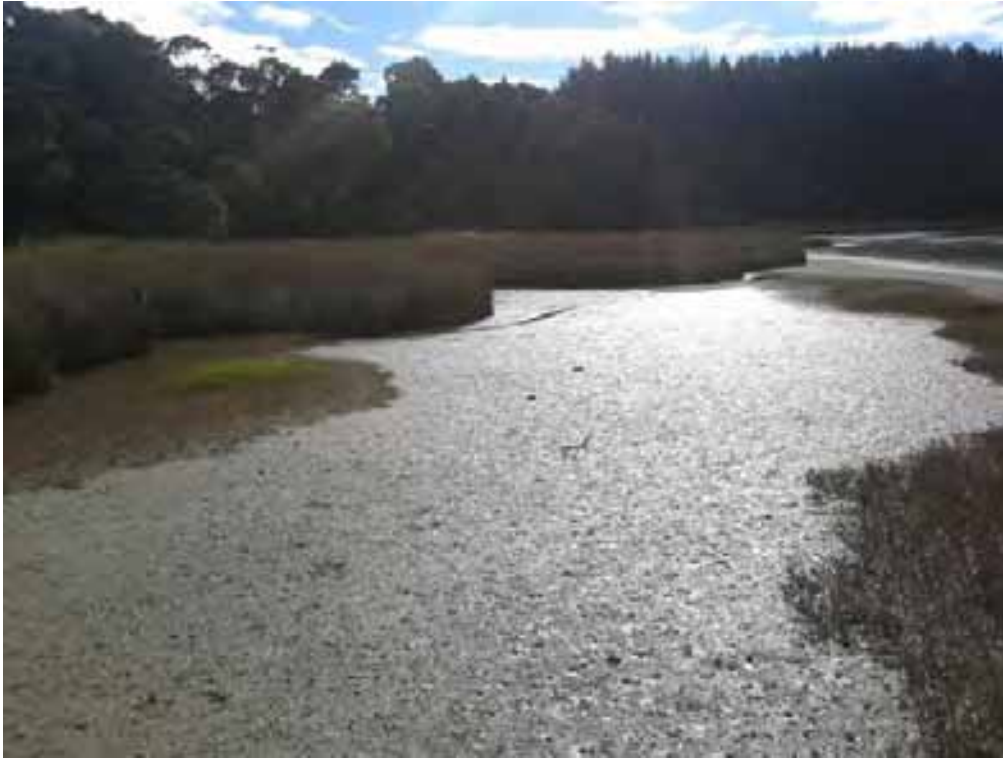
Figure 32: Sea rush backed by saltmarsh ribbonwood and coastal forest, and sea primrose and some arrow grass in front and on the sand spit (right of photo). Note the saltwater paspalum starting to establish (light green patch middle left of the photo).

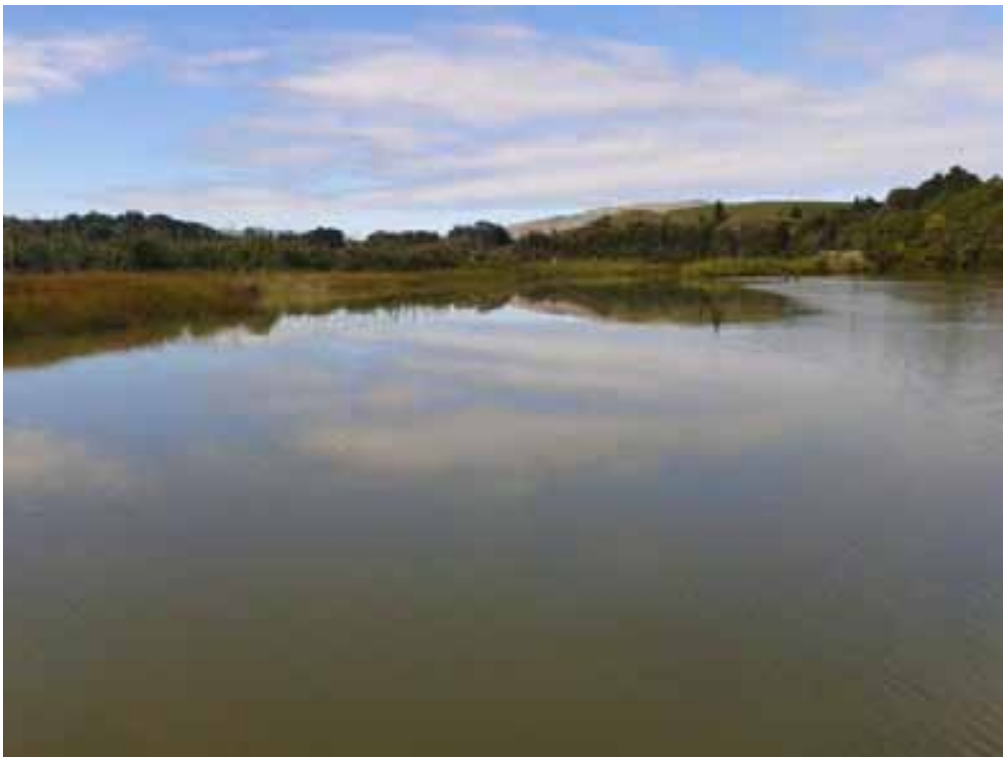
Figure 33: A view looking upstream along the TRB with a flax lined edge fringed with marsh clubrush and thin oioi frontage.

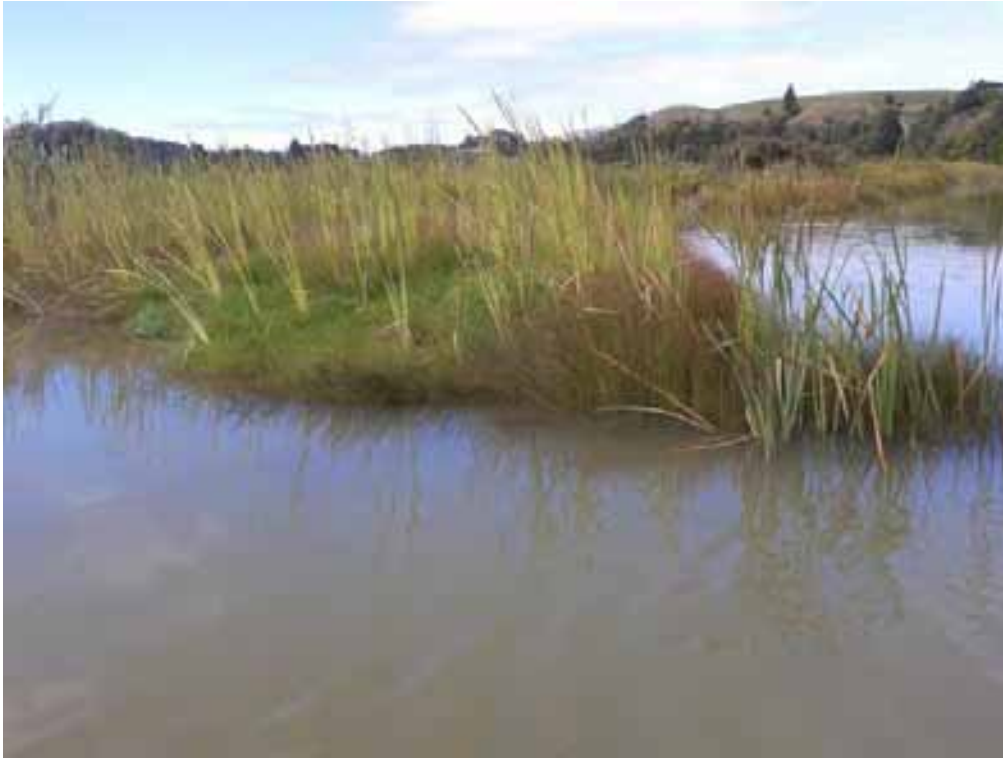
Figure 34: A patch of saltwater paspalum establishing amongst oioi and raupo along the TRB.

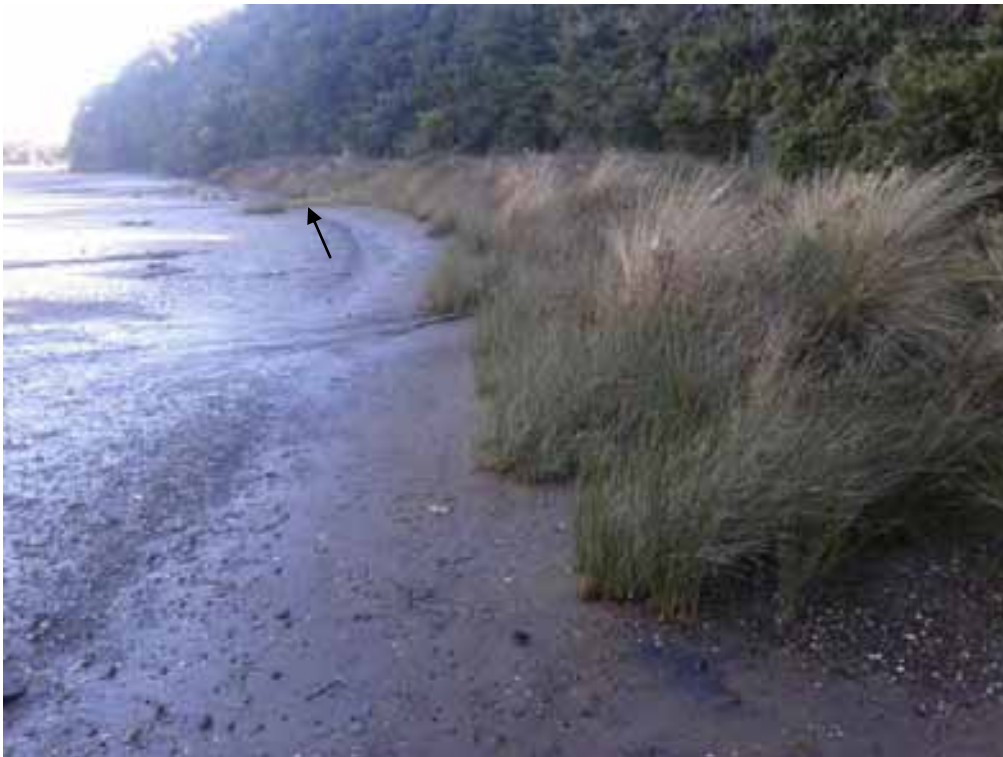
Figure 35: A view looking upstream along the eastern banks of Totara Point over a band of saltmarsh ribbonwood on a sandy ridge. Rushland and sea meadow (coast spear grass, sea primrose, glasswort and remuremu) are found along the seaward edge with a patch of saltwater paspalum establishing half way along (arrowed light green patch).

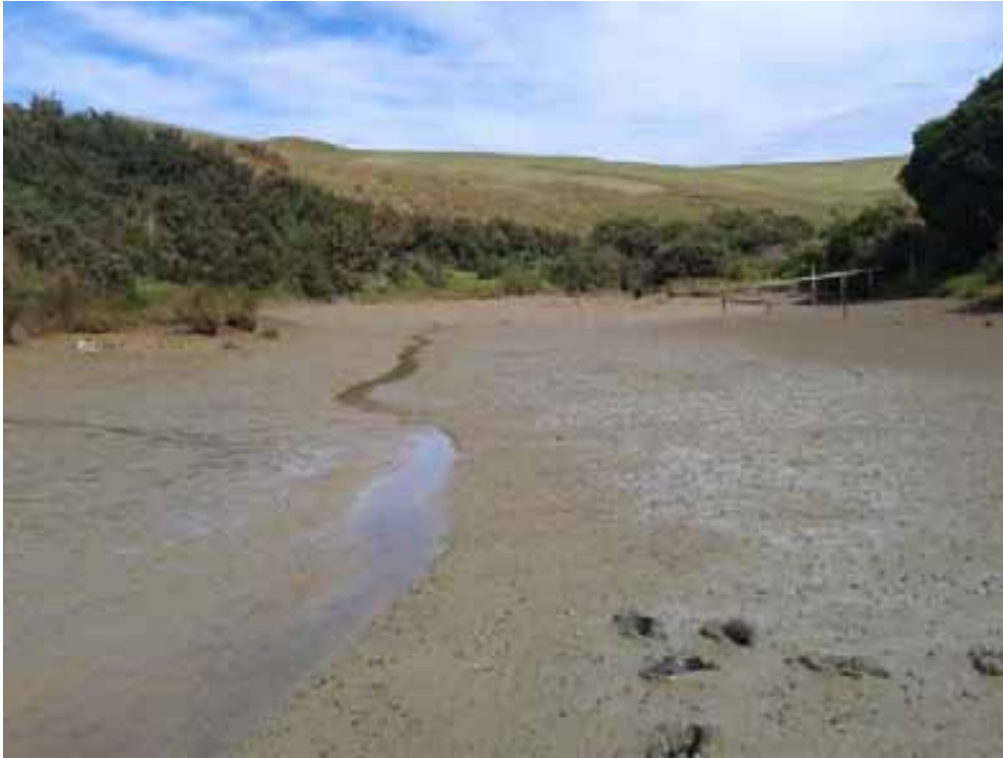
Figure 36: A repeat of photo 13 from the 2004 report. A similar thin band of sea rush with saltwater paspalum is present with gorse in the background. Mahoe is present along the TLB and help provide native seed to revegetate the gorse areas. Note the cow skeleton in the left of the photo.

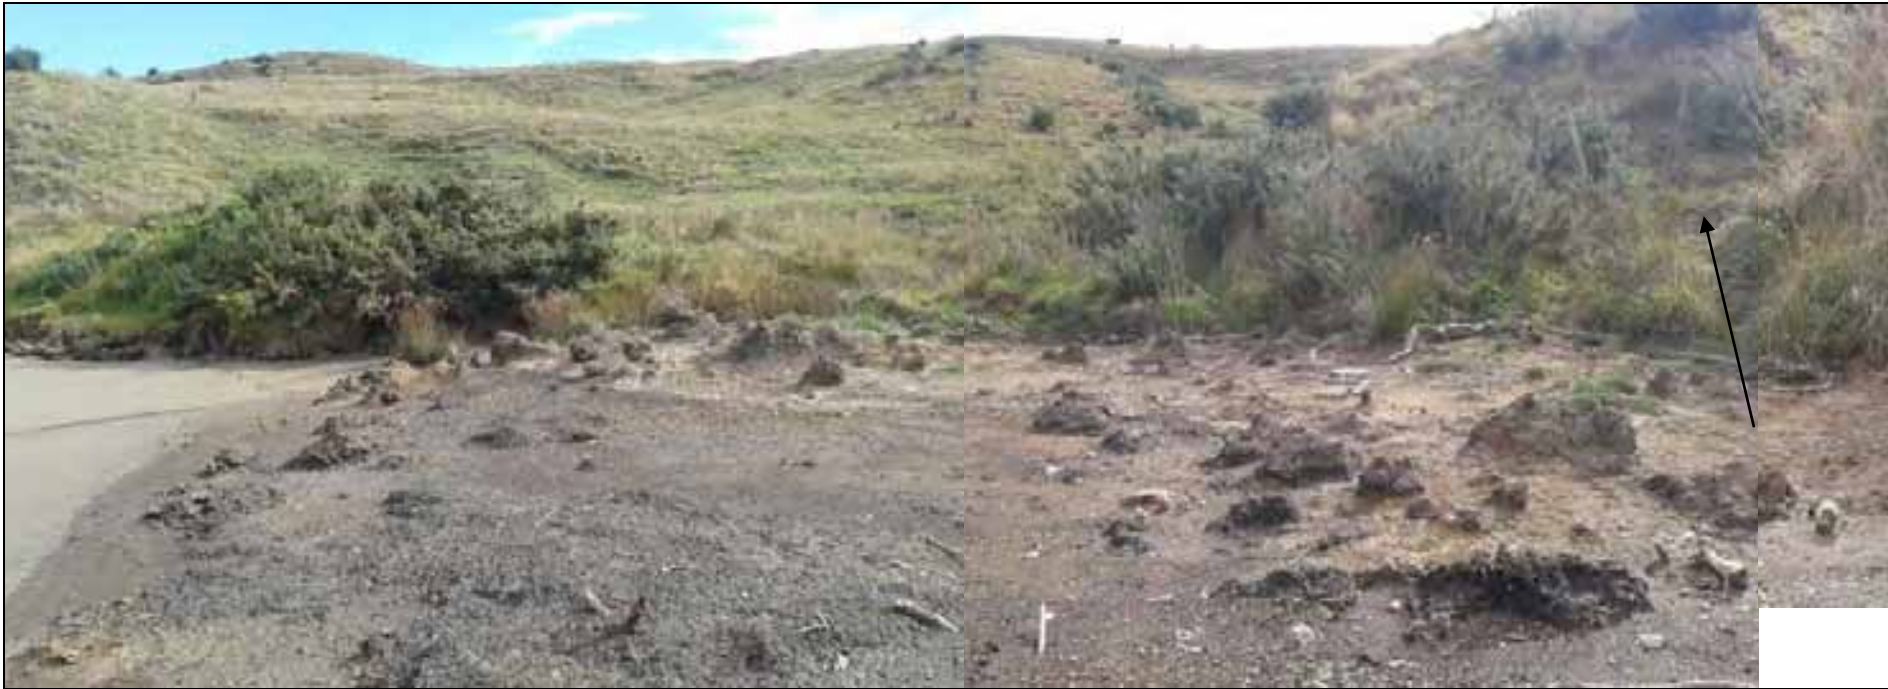
Figure 37: A washout area (?) where stock have accessed the CMA (pugging and dung present) via a dip in the land where the fence line crosses at height allowing stock access underneath (arrowed).

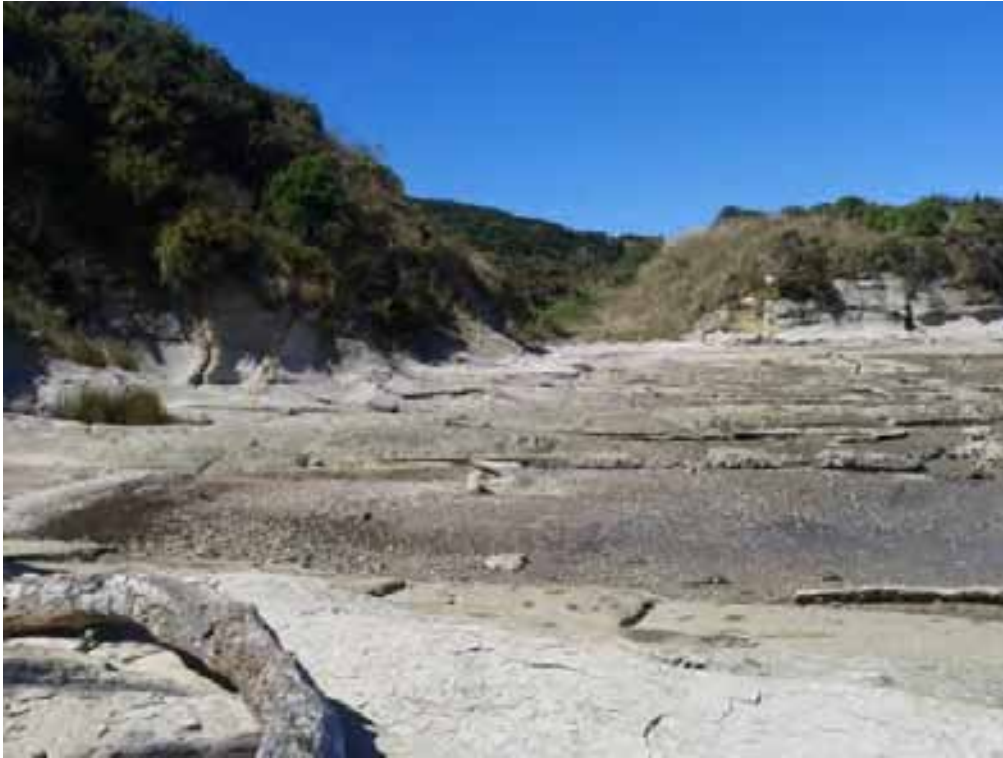
Figure 38: There is little opportunity for estuarine vegetation to establish along this exposed coastline. A small patch of oioi can be seen in the middle left of the photo and saltwater paspalum is growing in the middle background.

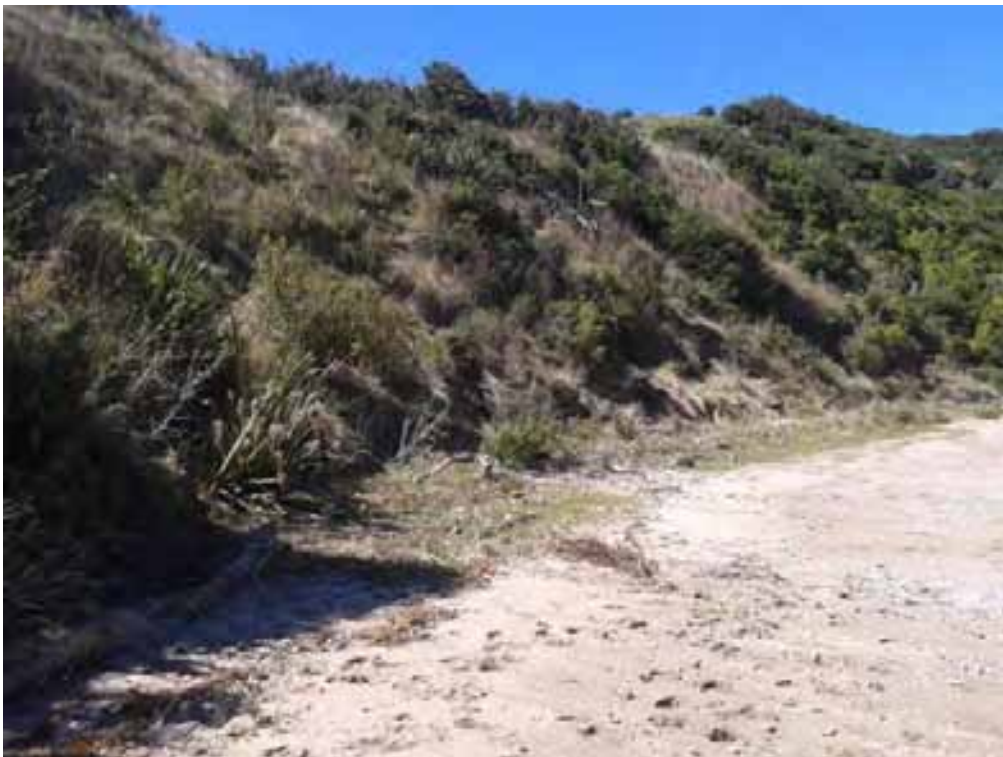
Figure 39: This photo shows cattle damage to a regenerating coastal bank. Dung was common along the foreshore as was tracking up through the bank. Flaxes and bushes were heavily browsed. Saltwater paspalum is visible along the foreshore.

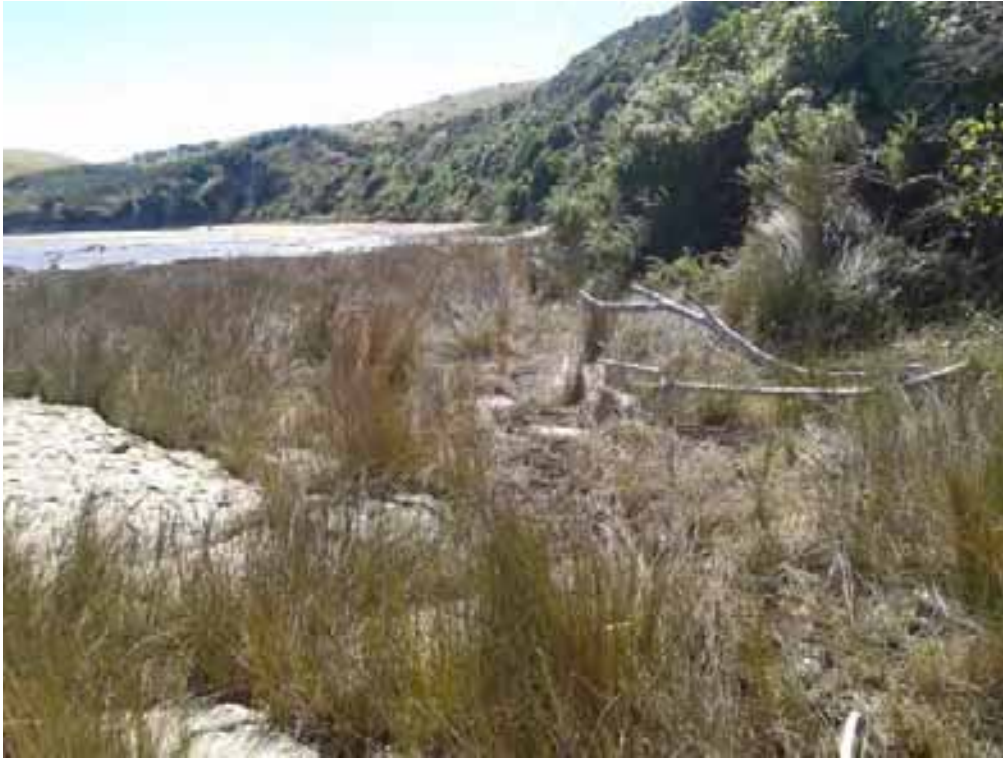
Figure 40: More dung and pugging at the back of a rush band. Saltwater paspalum is common along the back associated with the tracking.

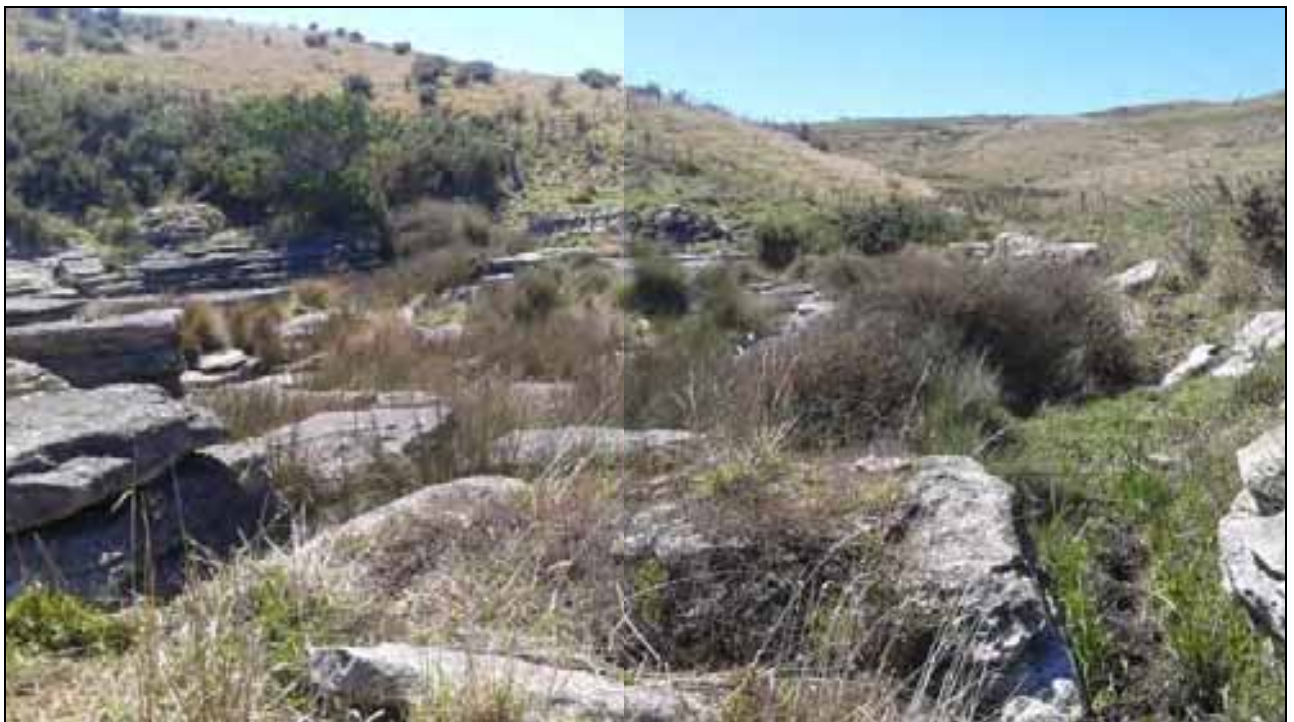
Figure 41: An area of limestone outcrops within Okete Bay that has saltmarsh ribbonwood, rushland, sea meadow and saltwater paspalum heavily tracked and grazed by cattle. Muehlenbeckia grows on the higher ground.

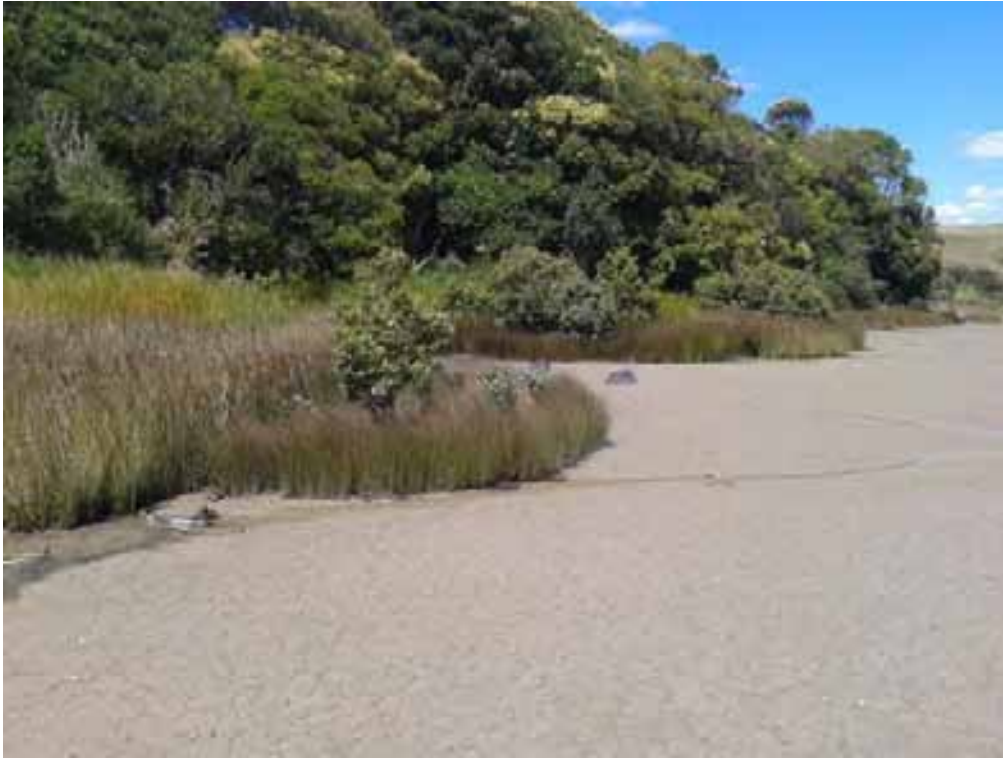
Figure 42: Mangroves along the seaward edge of sea rush with young oioi growing in front of the mangroves. Marsh clubrush grows in behind the sea rush.

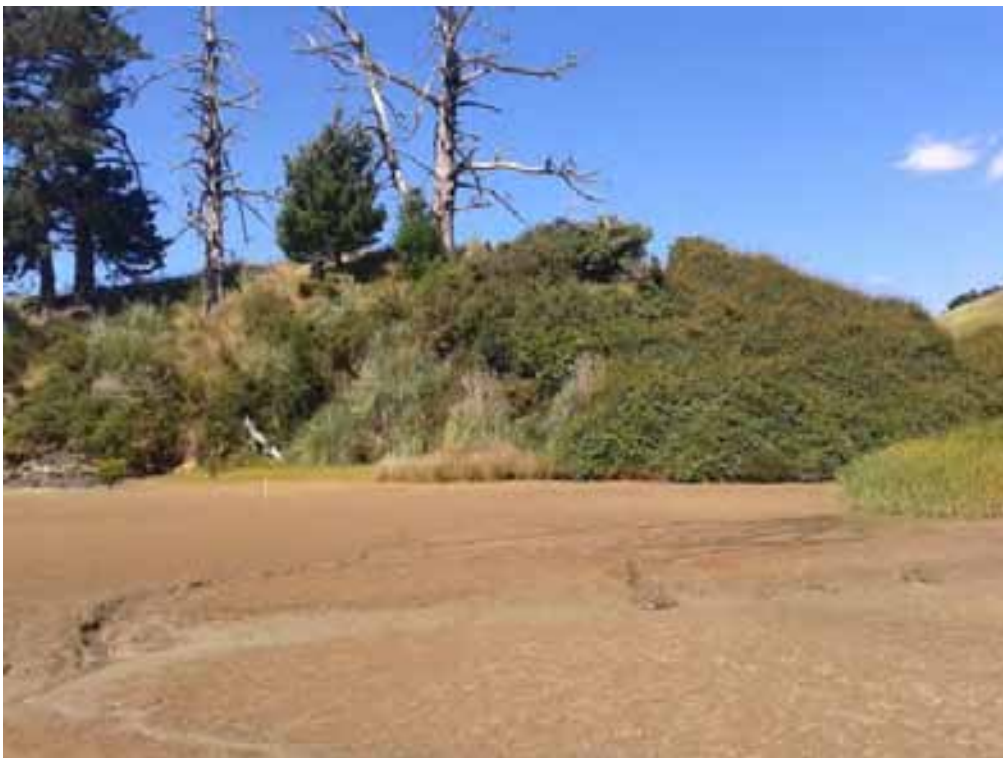
Figure 43: A repeat of photo 15 from the 2004 report with a white sediment monitoring pole visible. Still decaying spartina roots cover the flats with a mangrove, saltwater paspalum, sea rush, eleagnus and saltmarsh ribbonwood along the back foreshore and marsh clubrush to the middle right.

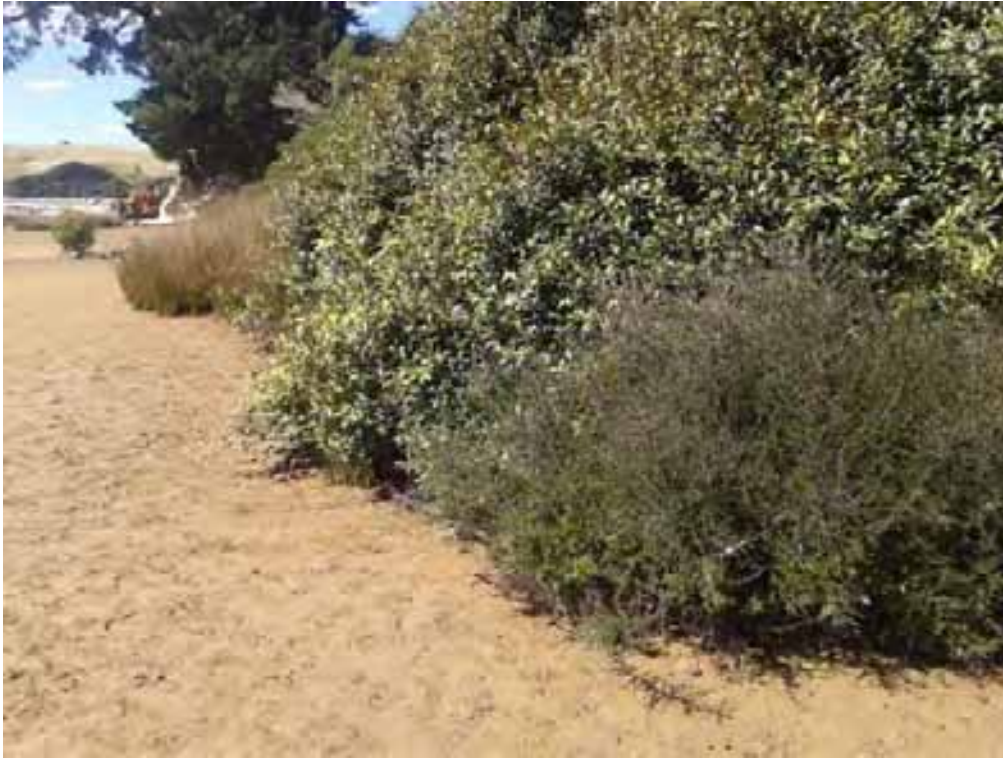
Figure 44: A close up view of the eleagnus growing out over sea rush and with a saltmarsh ribbonwood surviving in front.

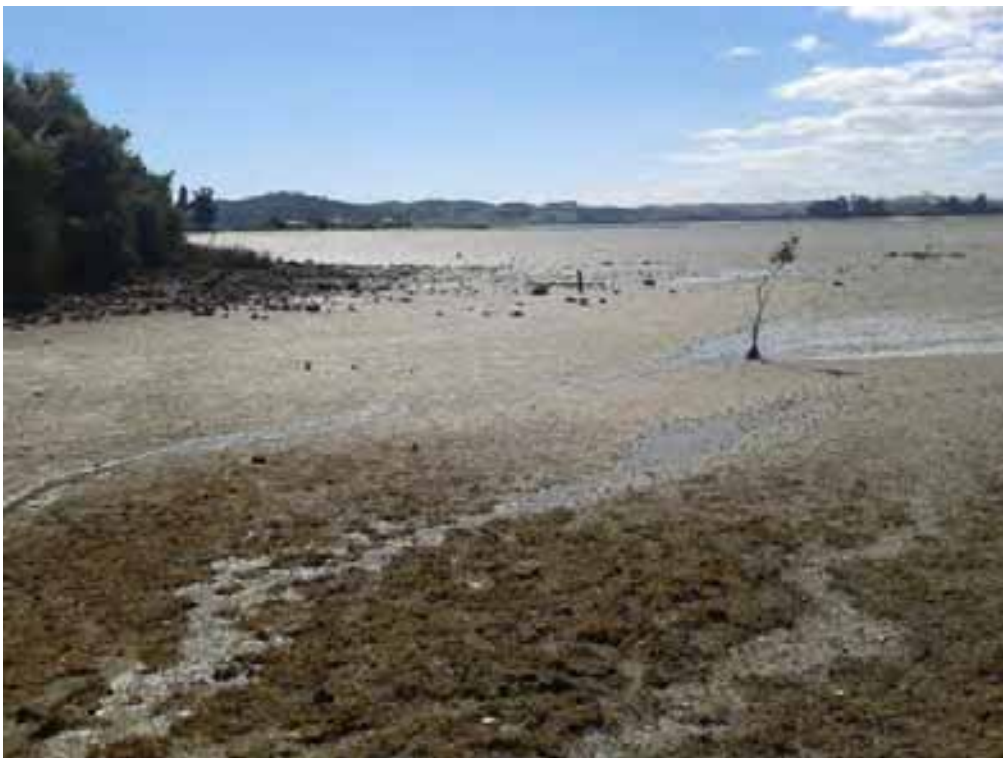
Figure 45: A lone mangrove with an exposed base seaward of a decaying spartina root base.

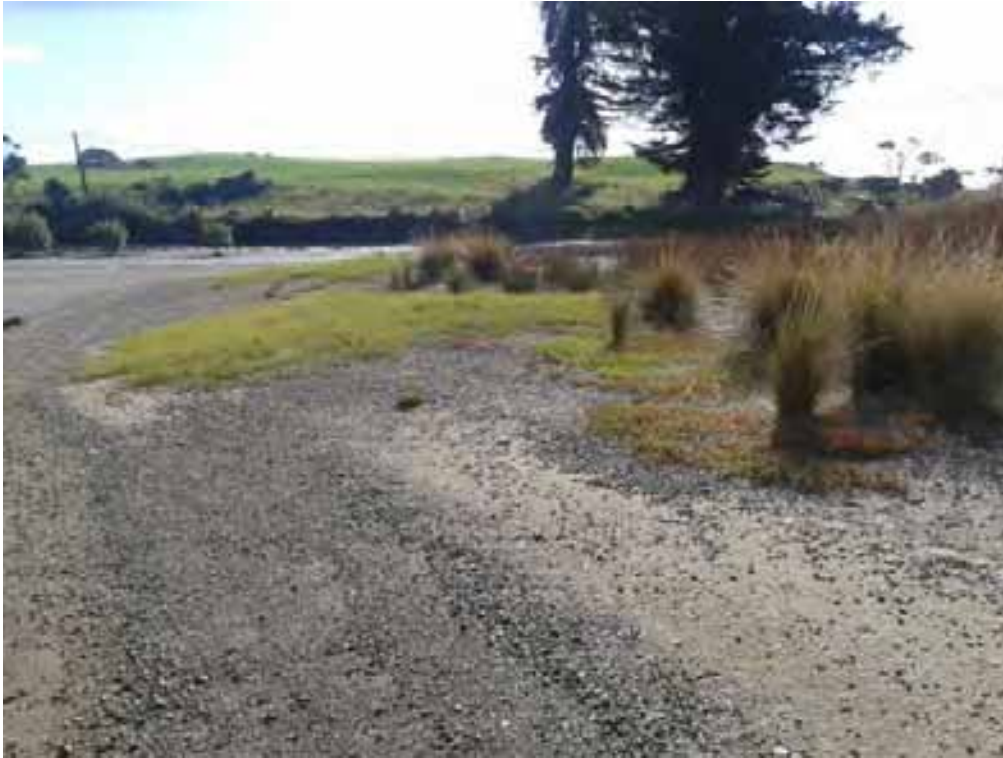
Figure 46: A view similar to that of photo 16 in the 2004 report looking over a chenier ridge with sea meadow and large patches of saltwater paspalum.

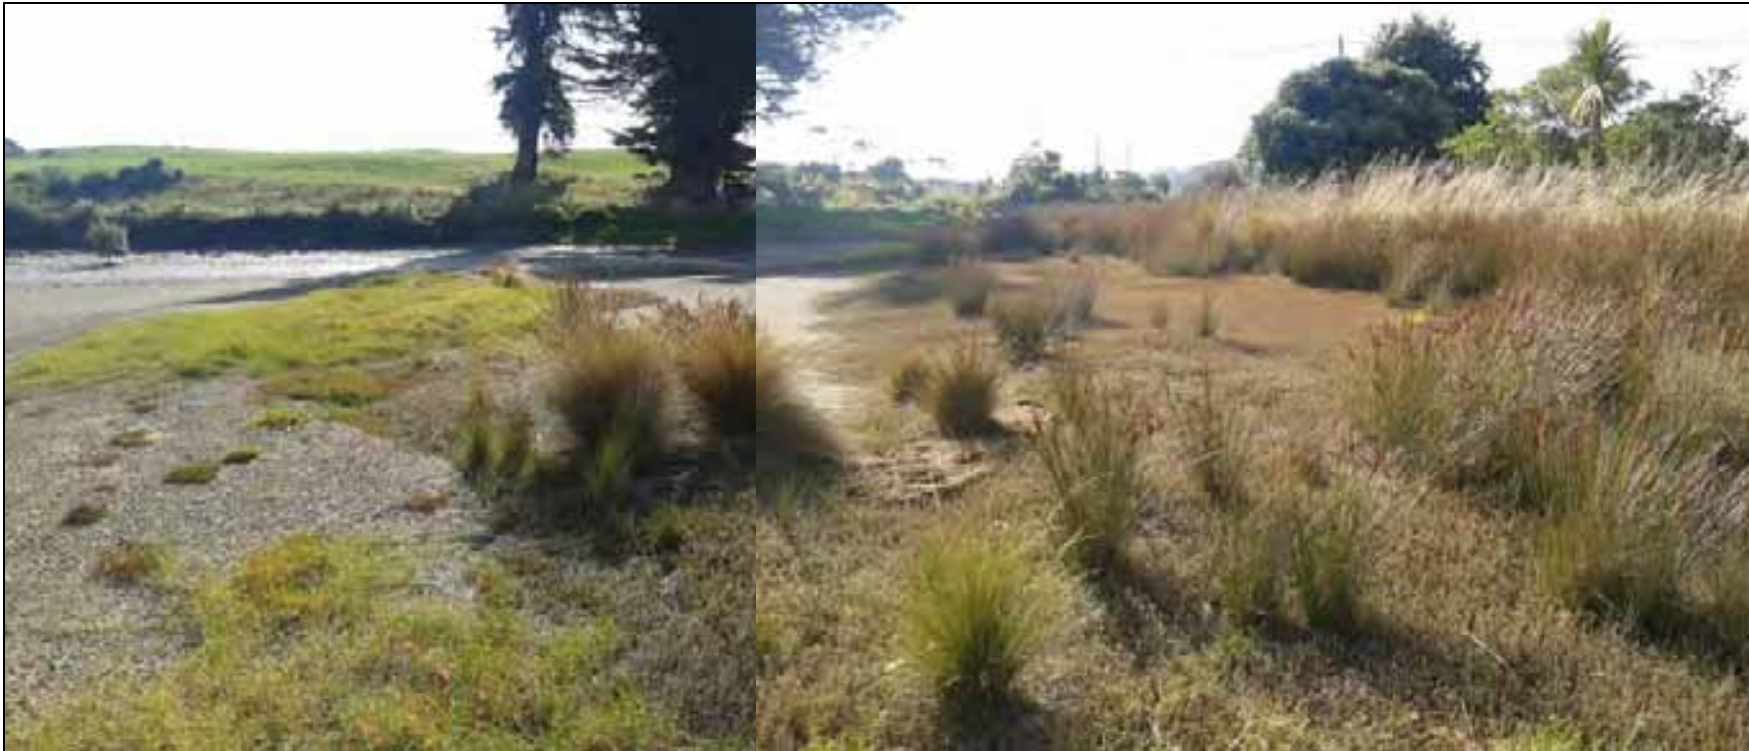
Figure 47: Another view over the shell spit and sea meadow community. Saltwater paspalum has invaded along the shell spit and small patches are establishing in the sea primrose next to the sea rush.

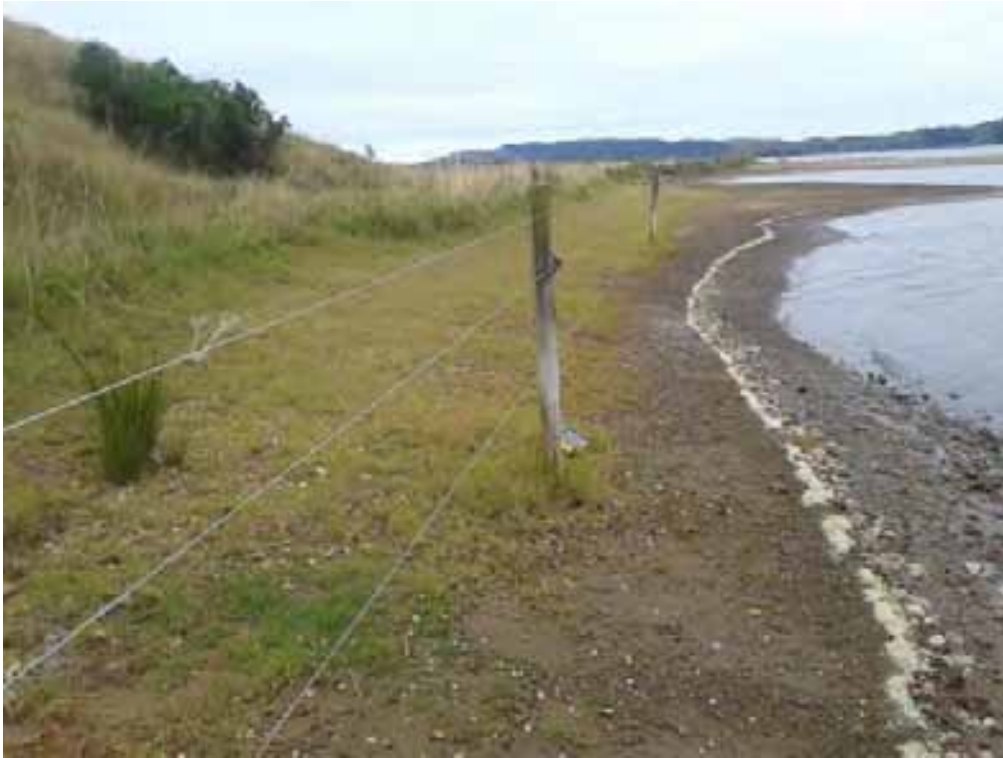
Figure 48: Poor fencing within the CMA. Little plants of glasswort are present amongst the saltwater paspalum band. The hooked sand spit is visible in the background.

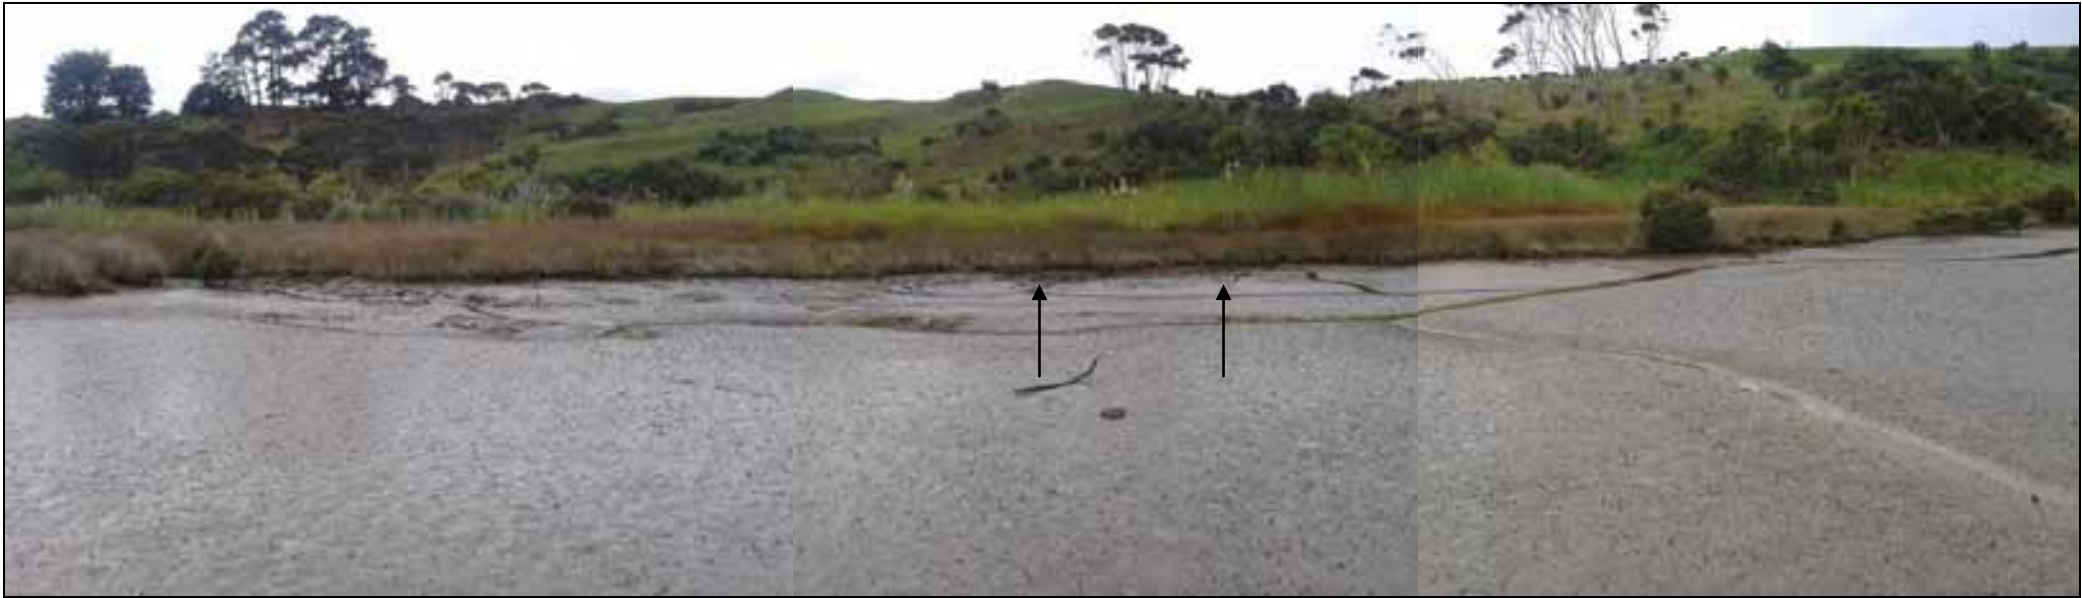
Figure 49: An area of dead sea rush roots and surviving small mangroves with eroded bases (arrowed). Healthy mangroves are present to the right of the photo.

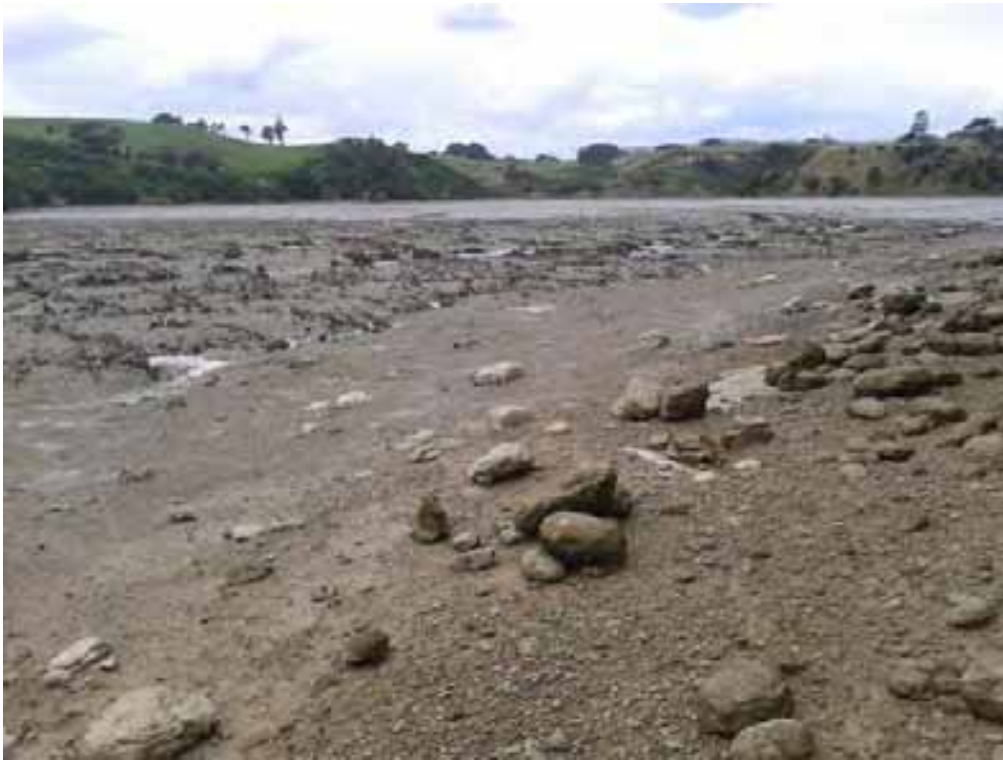
Figure 50: A view looking upstream from the end of the forest peninsula over a pacific oyster bed to great examples of retired coastal edges on TRB. Note the new house on the headland with associated native plantings.

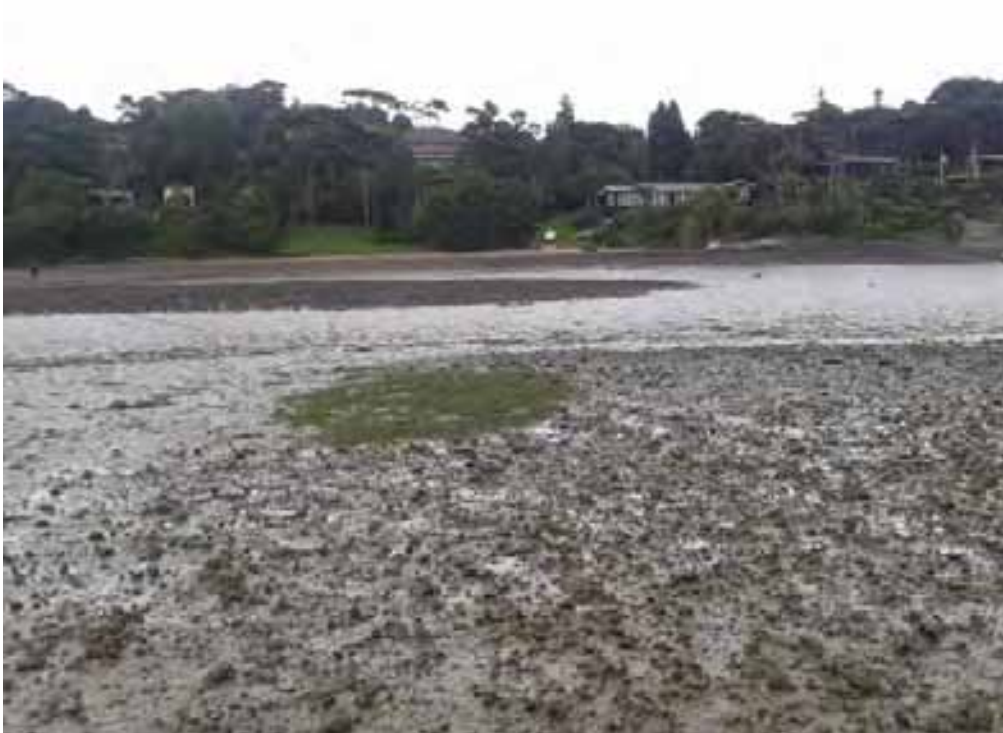
Figure 51: A photo of a seagrass patch on a rubble area. The inner rubble area visible supports blue tubeworms.

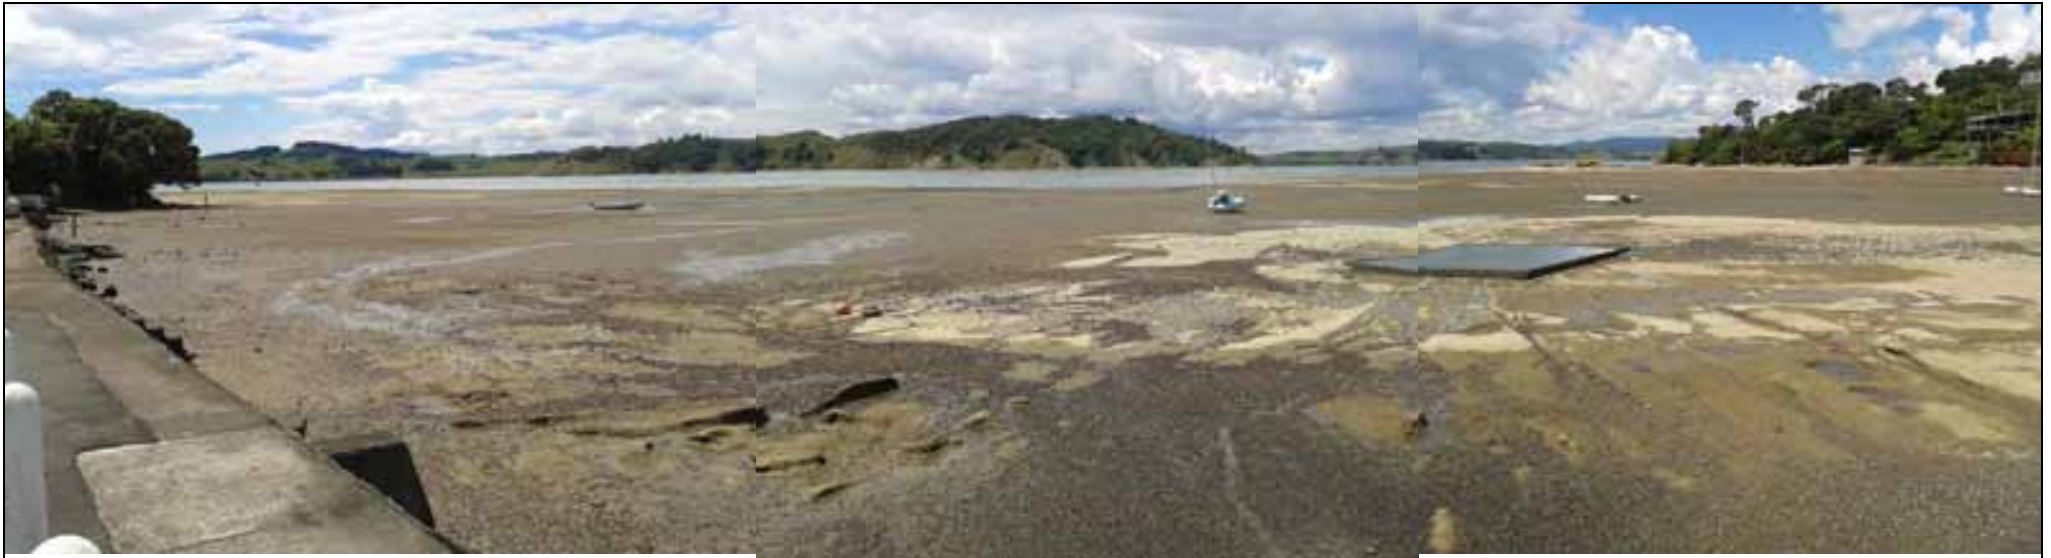
Figure 52: - Repeat of photo 21 from the 2004 report at Lorenzen Bay. Seagrass is just visible out past the pohutukawa on the left of the photo.

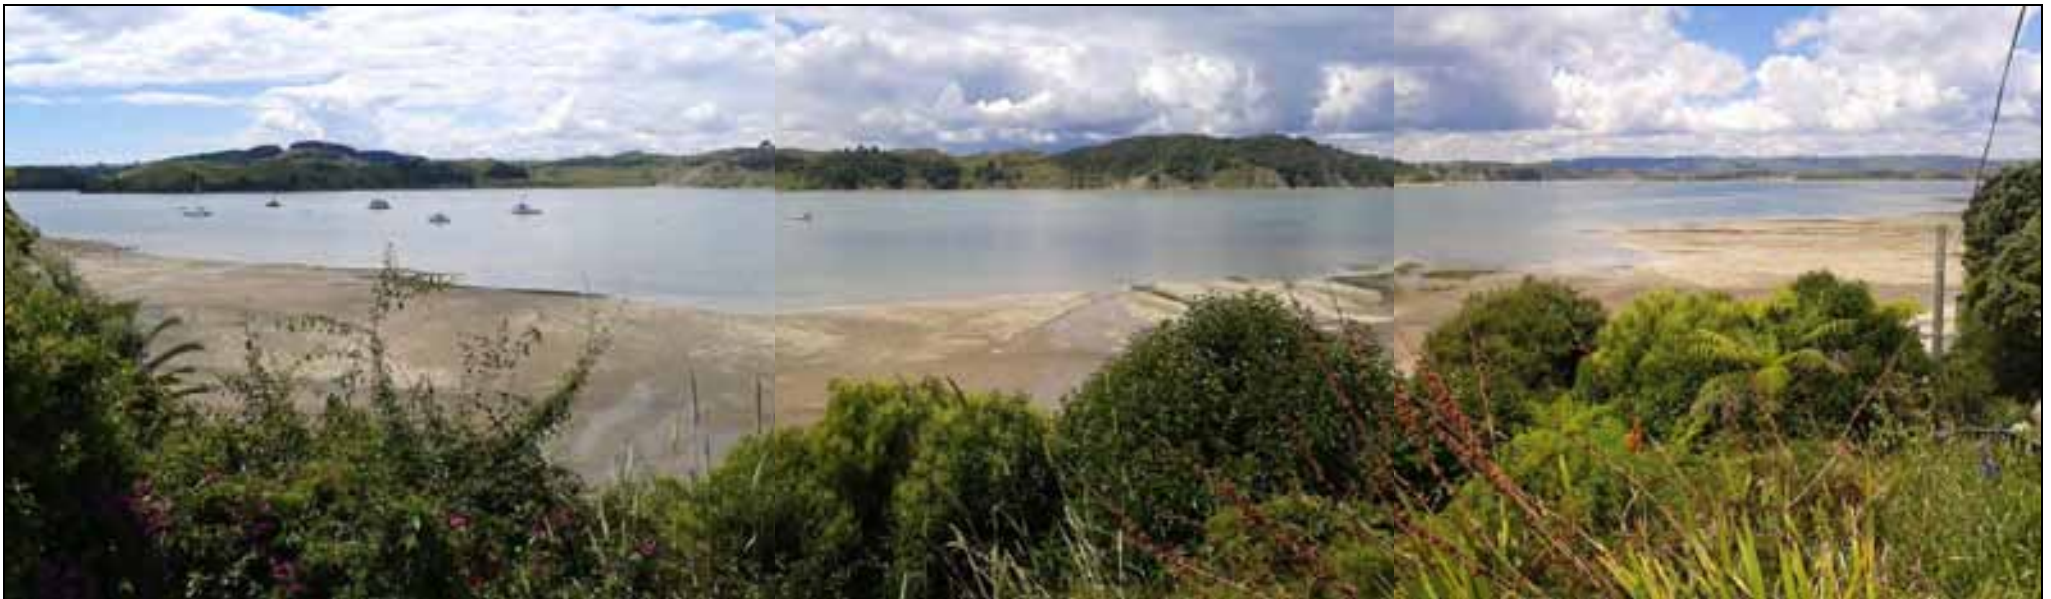
Figure 53: A view of seagrass on the flats from the top of the access stairs at Daisy Street with the tide mid way in.
