Estuarine vegetation survey – Raglan (Whaingaroa) Harbour

Prepared by:
Meg Graeme,
Natural Solutions – Marine and Terrestrial Ecologists Ltd

March 2012

Natural Solutions Contract Report 12/104

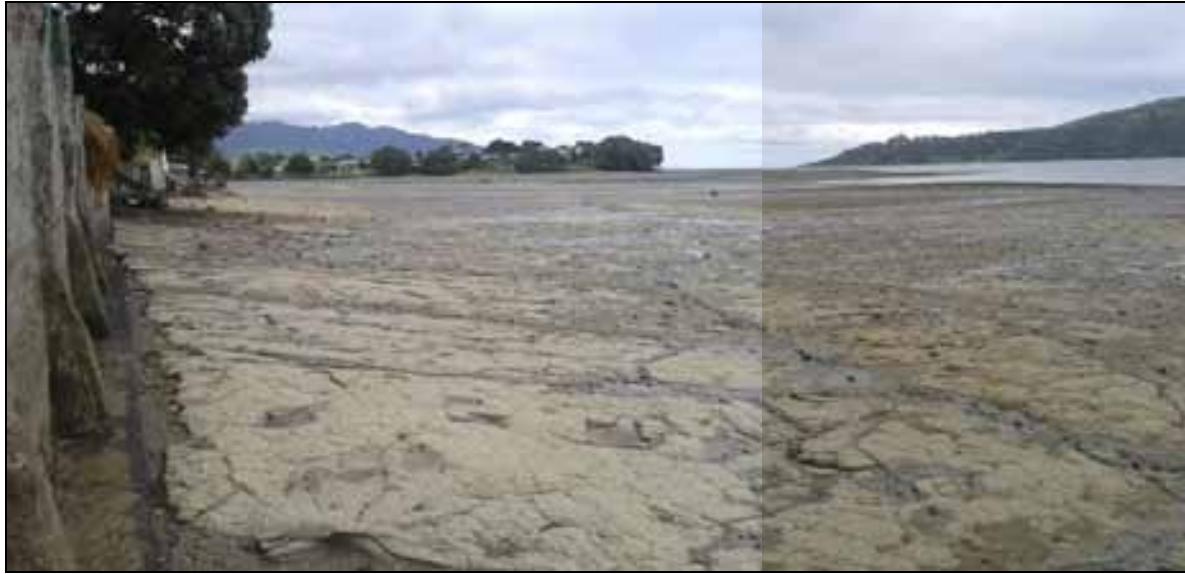
Figure 54: An armoured corner of Cox Bay showing varying styles of armouring and the natural coastal edge of the far side of the bay. Seagrass beds are visible in the middle ground and on the distant flats.

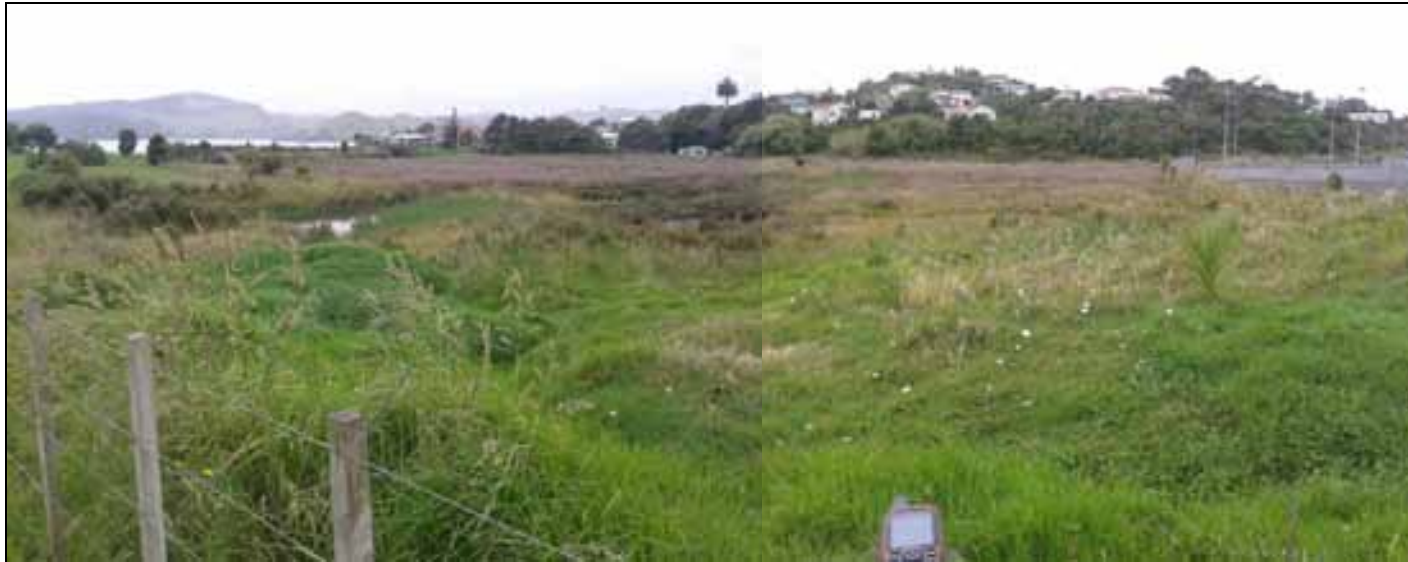
Figure 55: An overview of the causeway wetland with freshwater species dominating around the open water inflow area visible in the middle left of the photo.

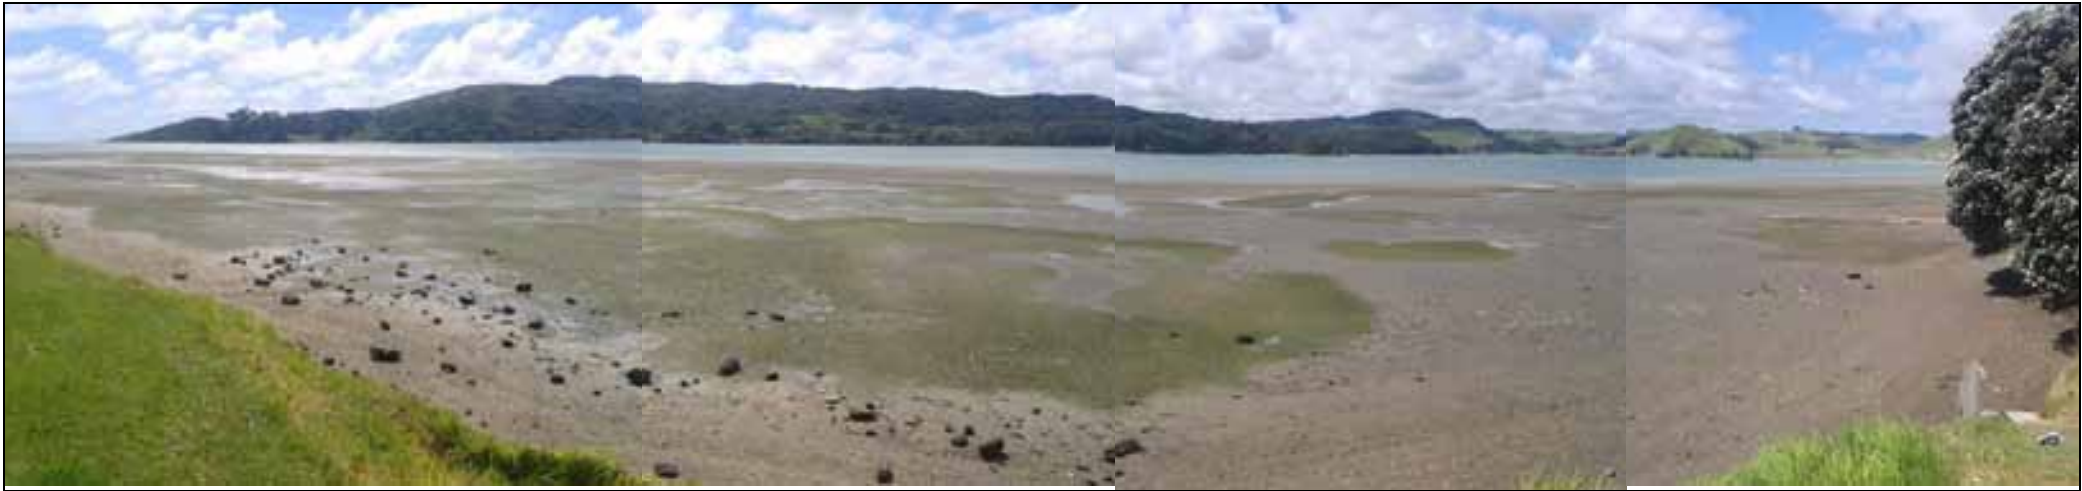
Figure 56: Another view over seagrass from reserve at the end of James Street.

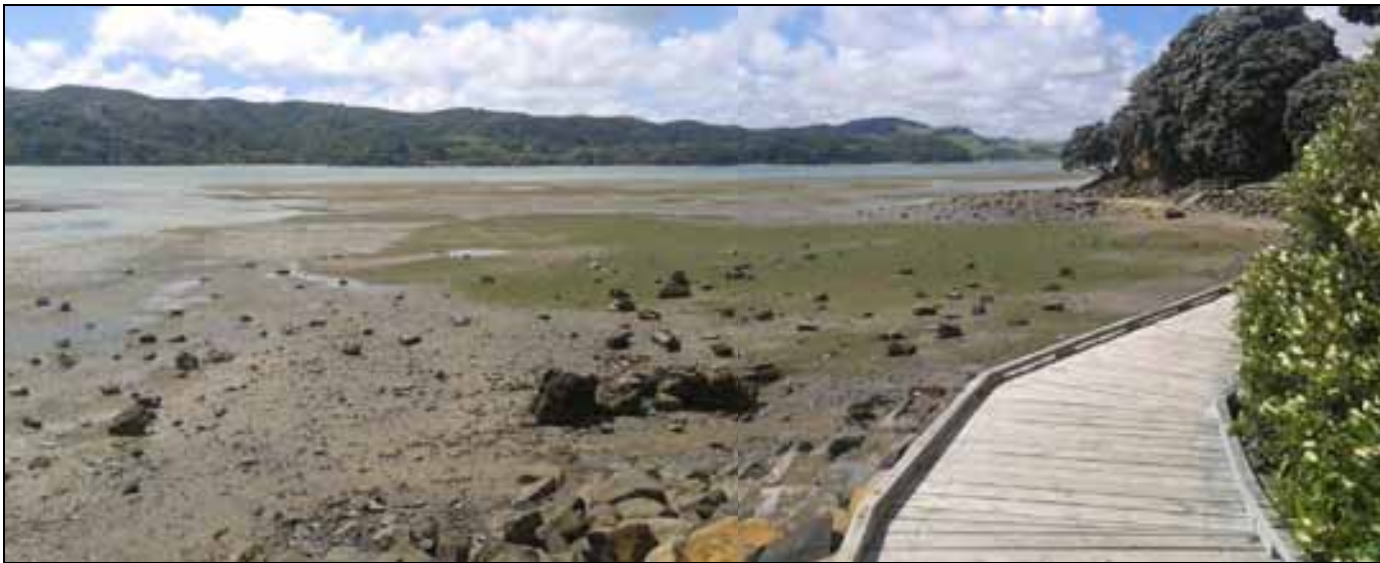
Figure 57: View of seagrass from town boardwalk

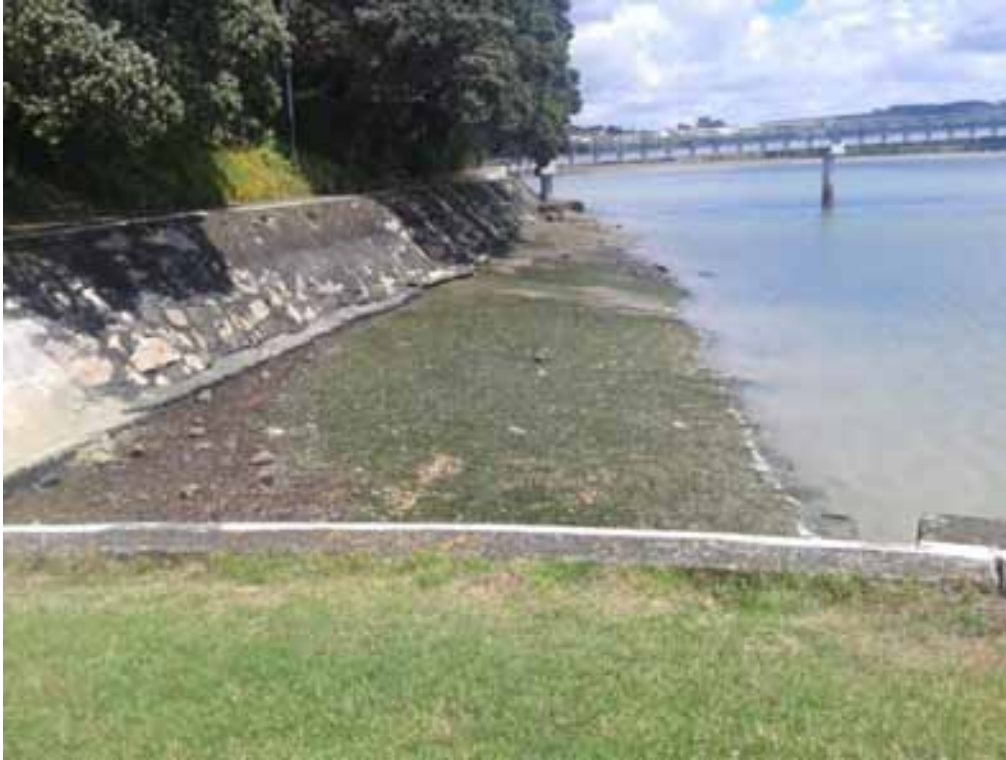
Figure 58: The view over thick seagrass from the picnic table at the fishing jetty reclamation looking towards the foot bridge

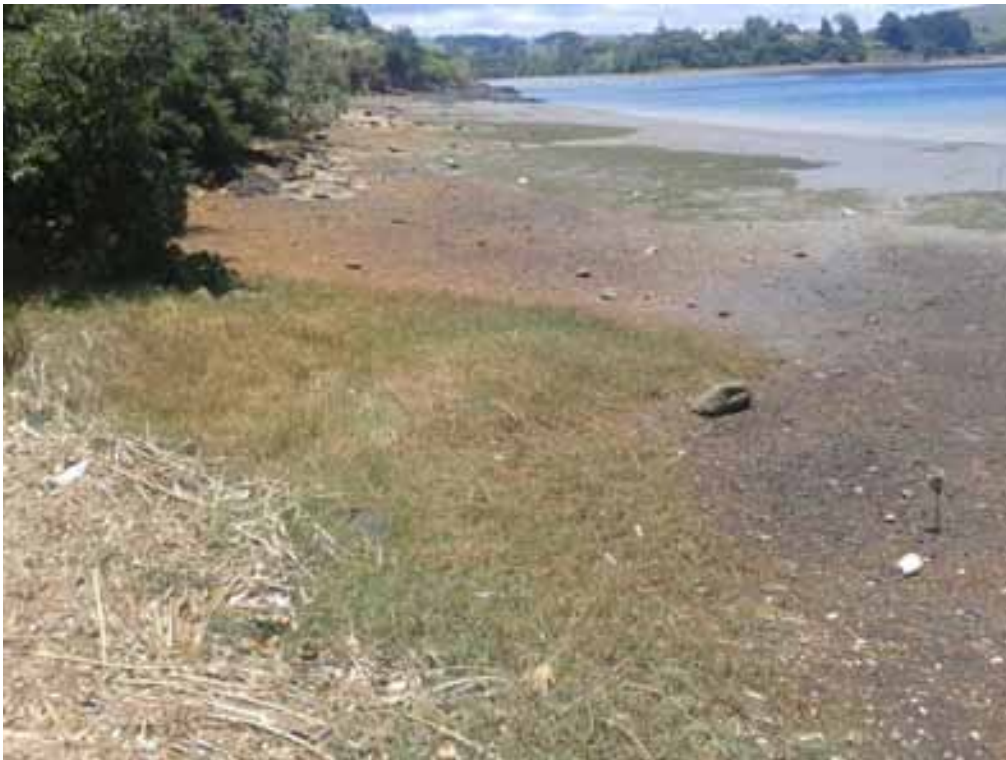
Figure 59: Saltwater paspalum in the upstream corner of the one-way bridge and seagrass patches extending up the TRB of the Oporuru River arm below the school.

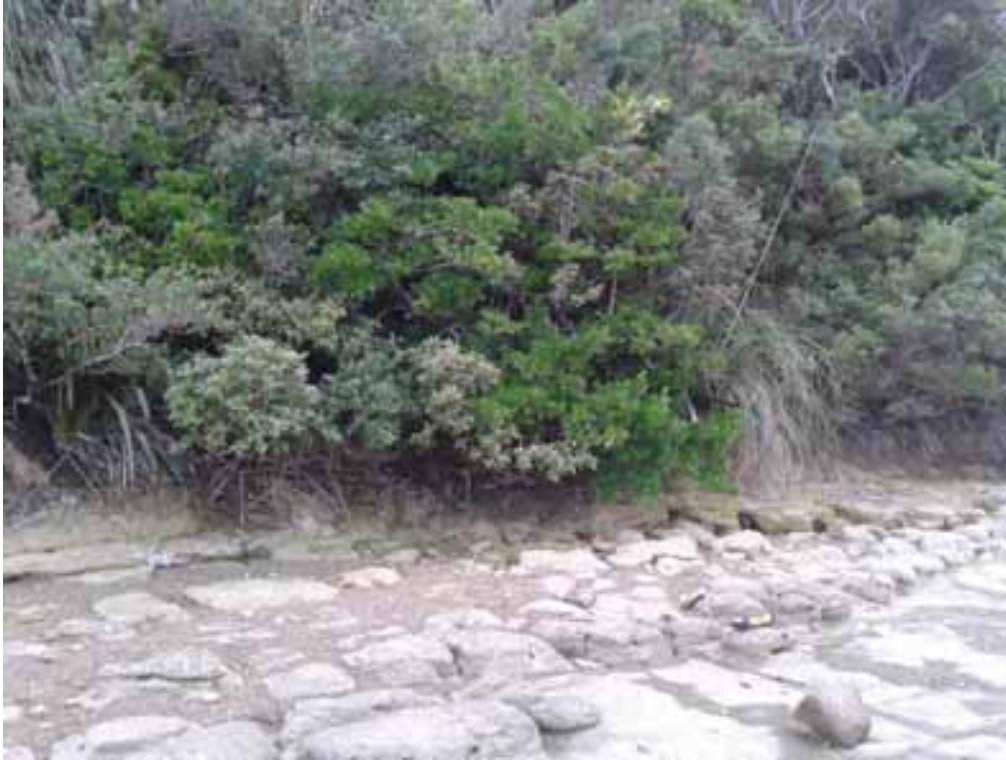
Figure 60: A large boneseed shrub along the coastal edge mixed with native species but also pampas, cotoneaster and tree privet. The exposed rocky upper intertidal zone doesn't support any estuarine vegetation.

Thin bands of rushland characterised the coastal edge along the TRB of **Kaitoke Creek** bay. There was a forested edge with a public walkway along much of this northern side. Weeds noted were a little bit of ginger and Japanese honeysuckle, pampas, asparagus fern, cotoneaster, tree privet and a large boneseed bush (Figure 60). At the head of the bay was a significant area of rushland and extensive saltmarsh ribbonwood which grades into some remnant freshwater wetland. A few mangroves were found along the outer edge of the rushland. Saltmarsh ribbonwood extended out along the TLB of the bay and included some patches of sea meadow. The sediment was relatively firm on this side of bay (more exposed) and there were lots of crabs and titiko. The estuarine vegetation was reduced to thin bands of rushland and sea meadow along the outer half of the bay. Another large patch of eleagnus (3-4m high) was found extending 7-8 m out into the harbour completely eliminating the potential for any native coastal edge vegetation. Opposite the school point there were scattered dead trunks sticking up out of the mud with eroding bank in behind them (suggesting that the coastal edge had eroded more than 10m inland?).

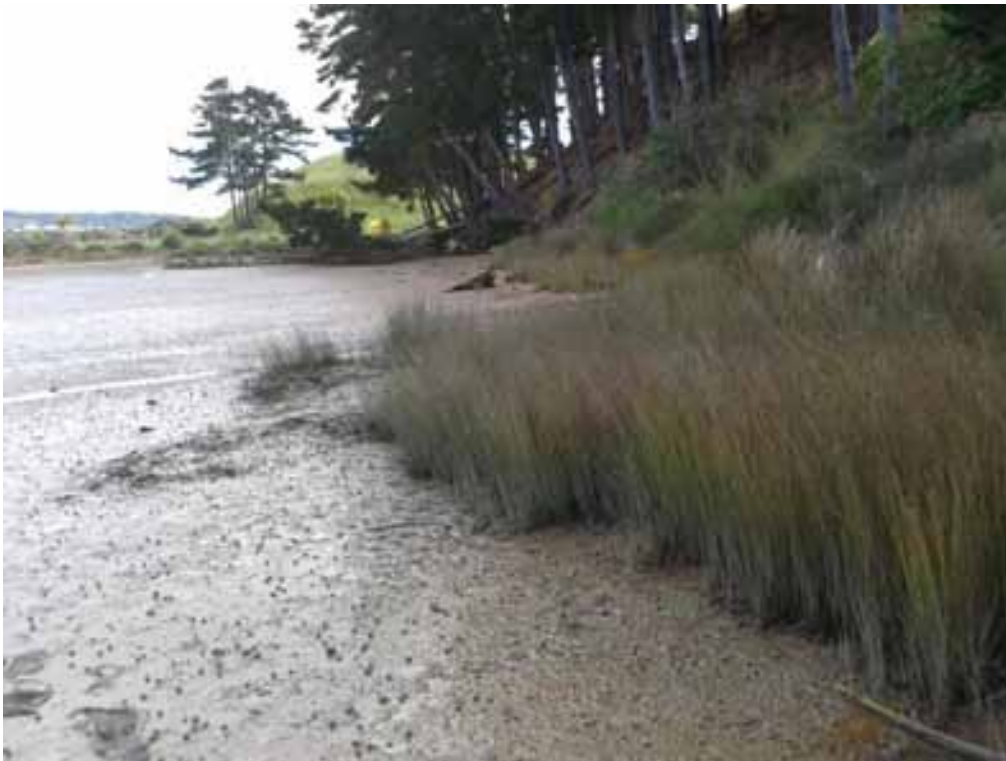
Figure 61: A patch of oioi that has receded at its point. The end of an extensive band of rushland and saltmarsh ribbonwood is visible in the background.

Along the TRB of the main **Oporu River** arm there was a large patch of rushland backed by dense saltmarsh ribbonwood which narrows down to thinner bands of rushland (Figure 61) and sea meadow before reaching a narrow point of the river arm. Sea meadow was common in a thin strip further up along the coast (Figure 62) until a small embayment was reached which supported a mixture of rushland and saltwater paspalum. Out near the head of the bay was a wide rush band with saltwater paspalum common along the landward edge. The next embayment was also characterised by rushland mixed with saltwater paspalum and areas of sea meadow. The last embayment along the TRB had larger intact areas of rushland with mangroves common along the seaward edge. Only two small areas of saltwater paspalum were noted here.

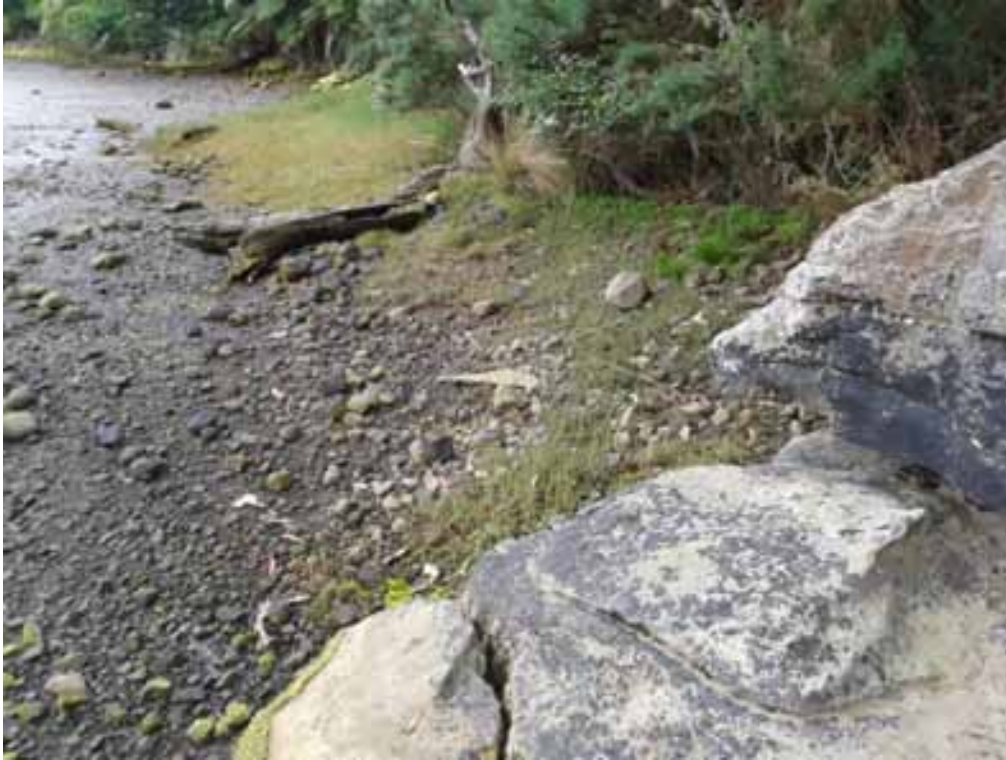
Figure 62: Sea primrose with glasswort, slender clubrush, remuremu, coast spear grass and *Leptinella dioica* above. Saltwater paspalum is invading the sea primrose in background.

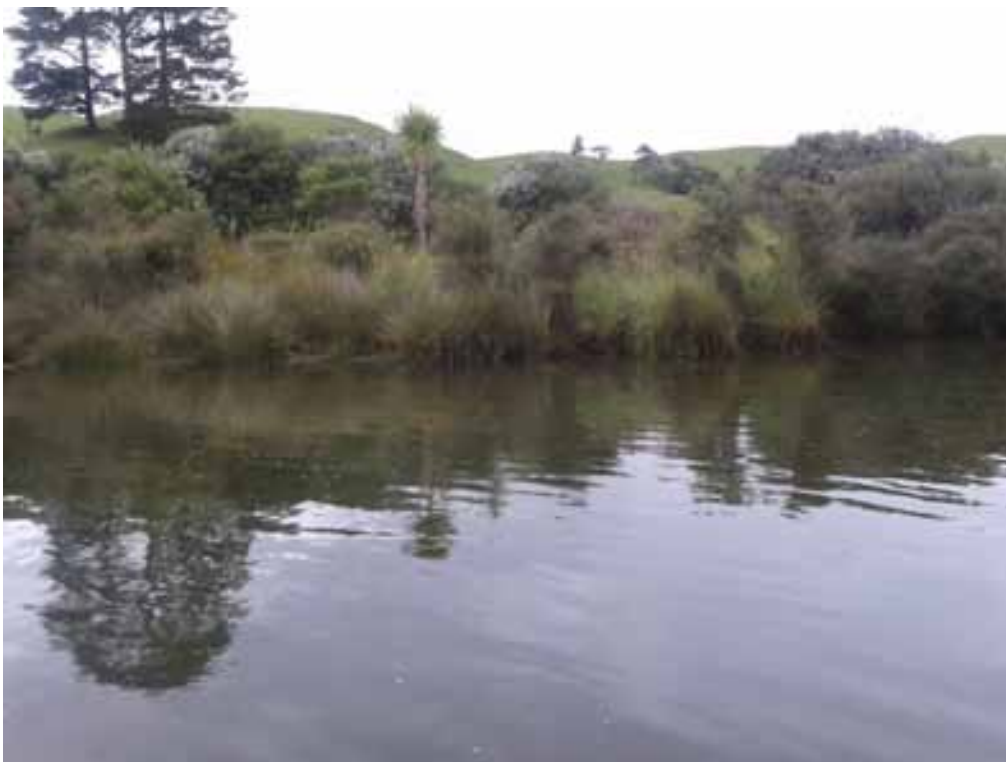
Figure 63: The upper estuarine influence is restricted to thin bands of oioi along the river banks with stands of *Coprosma propinqua* (darker bushes) and manuka behind.

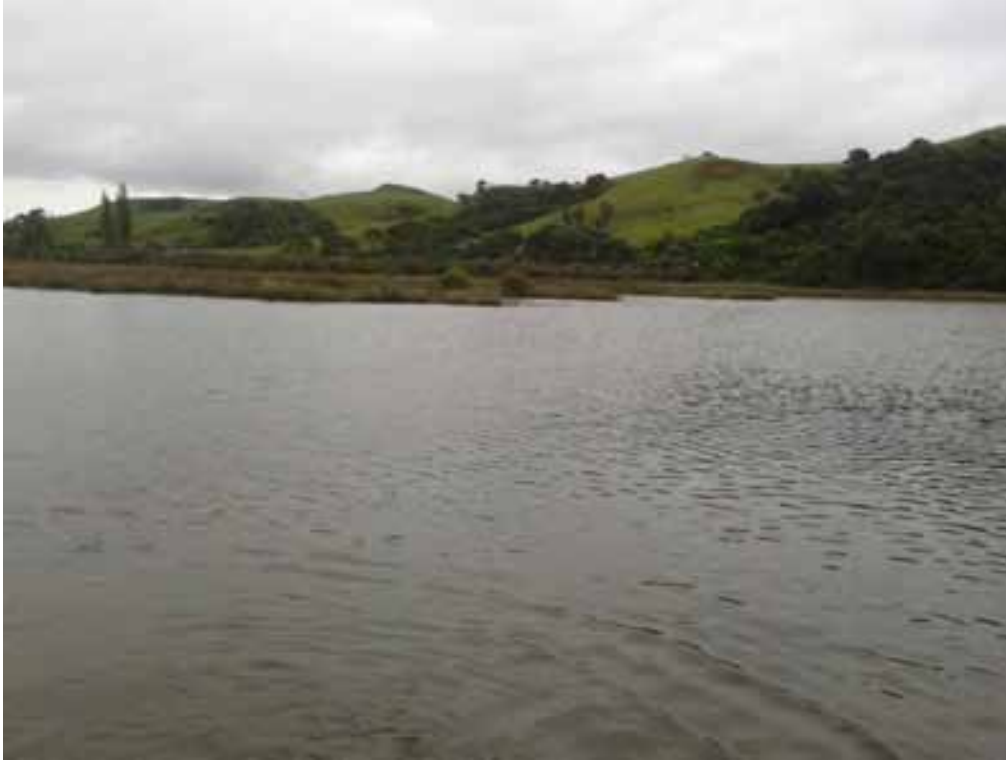
Figure 64: A couple of mangroves have established in front of a wide oioi and sea rush community at the mouth of the Opotoru River (TRB). In the background is a *Coprosma propinqua*/manuka wetland coastal forest remnant.

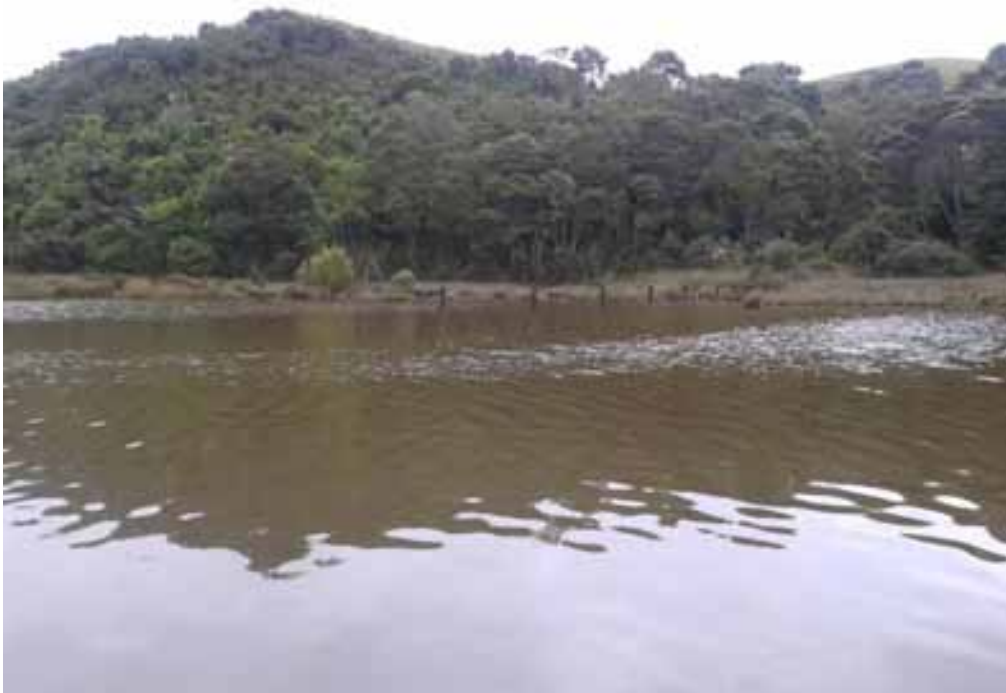
Figure 65: Two mangroves are visible out in front of a small fringe of sea rush and oioi backed by some raupo, coastal daisy and manuka and then kanuka, rewarewa, mahoe, kowhai, matipo and lancewood.

Up at the head of the river arm, a bittern was disturbed in saltmarsh and flew off into raupo. There were a couple of large mangroves present. Sea rush and oioi lined the river banks with bits of saltmarsh ribbonwood and tall fescue also on the islands at river mouth. *Coprosma propinqua* became common along the TRB with coastal daisy, manuka and cabbage trees behind (Figure 63). The saltwater influence stopped before a small rapid in the Oporu River. Oioi and some remuremu and celery were the last estuarine species noted. Moving away from the river mouth, a wide oioi band extended out around the TLB with some sea rush and the occasional mangrove present (Figure 64). A large *Coprosma propinqua*/manuka wetland and coastal forest remnant adjoins the rushland. Figure 65 shows a closer view of the coastal forest remnant with a fringe of sea rush and oioi.

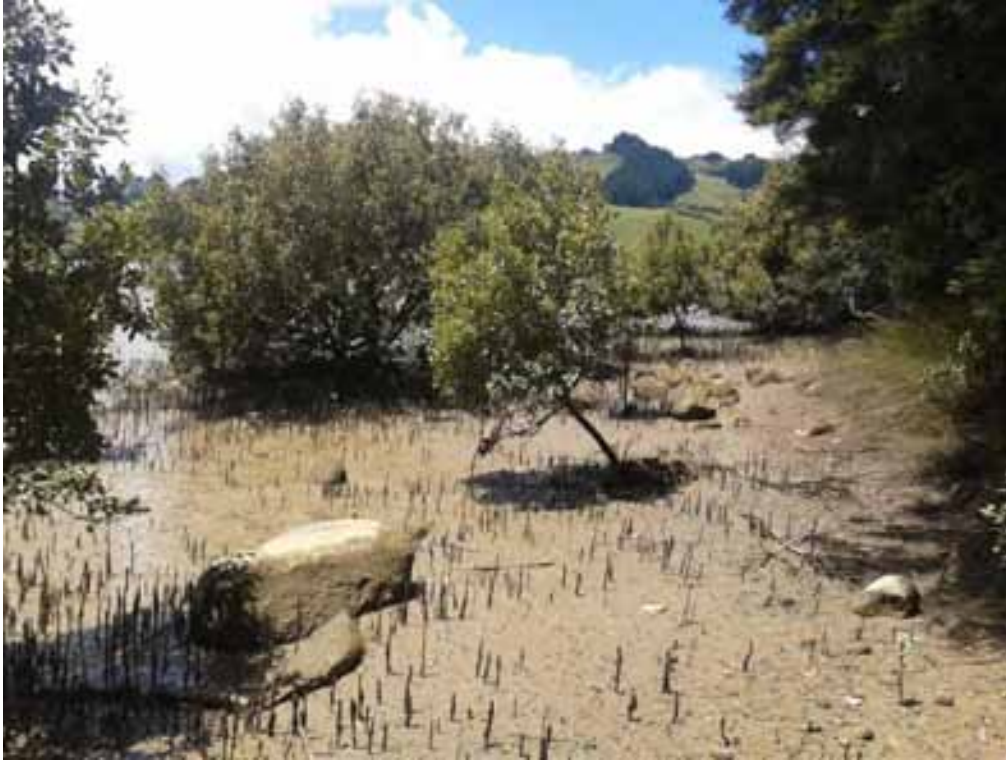
Figure 66: A band of large mangroves about 3m high

Further along the TLB the coastal edge was characterised by a group of mangroves (Figure 66) and then thin bands of rushland, saltwater paspalum and sea meadow (Figure 67). The upper harbour was very muddy and there were quite a few large beds of pacific oyster in and beside the channel. Titiko and crabs were common.

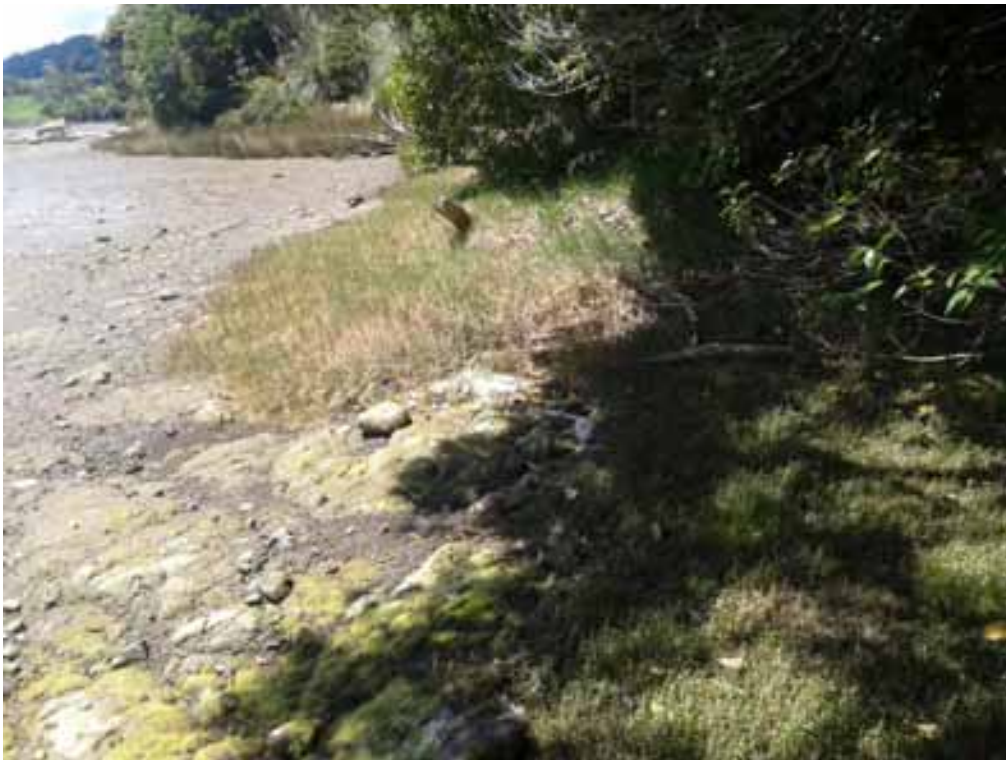
Figure 67: This view looking upstream shows a mosaic estuarine vegetation margin with sea primrose and slender clubrush in the foreground, saltwater paspalum in the mid-ground and then sea rush in the background.

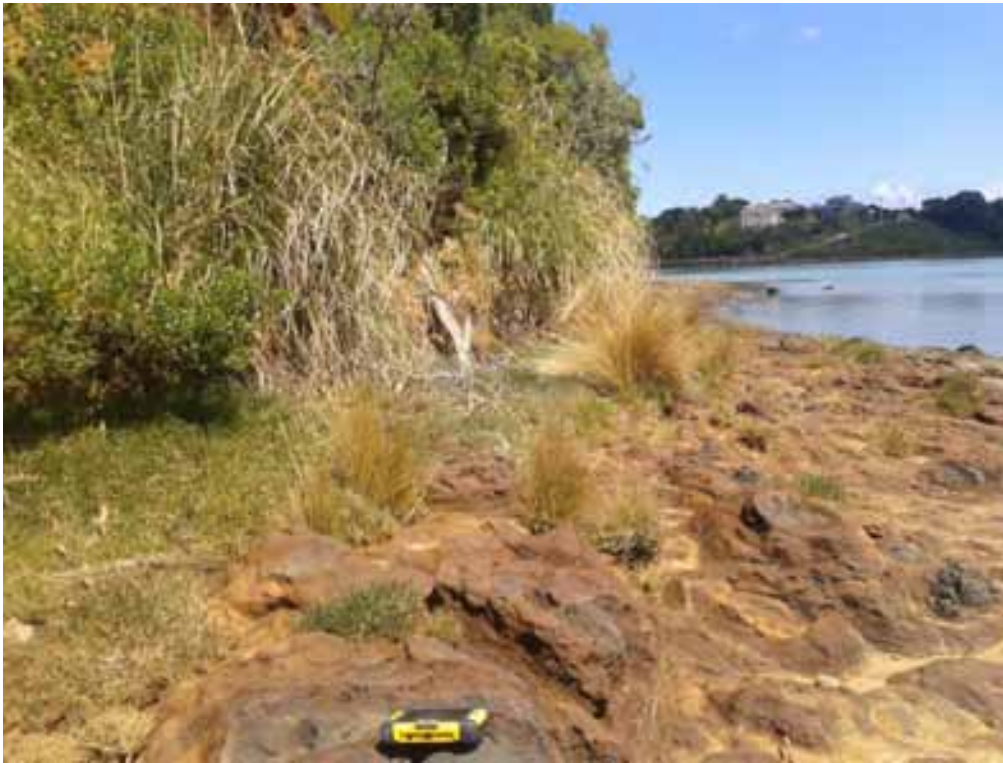
Figure 68: Coast spear grass and glasswort along the rocky intertidal platform near the causeway point with boneseed, wattle and pampas dominating the coastal forest edge.

The coastal edge was very weedy along the small peninsula at the end of the tidal causeway. Boneseed, asparagus fern, tree privet, cotoneaster, wattle and banana passionfruit were noted. The estuarine vegetation however was dominated by native sea meadow species – including coast spear grass, glasswort, sea celery and sea primrose (Figure 68).

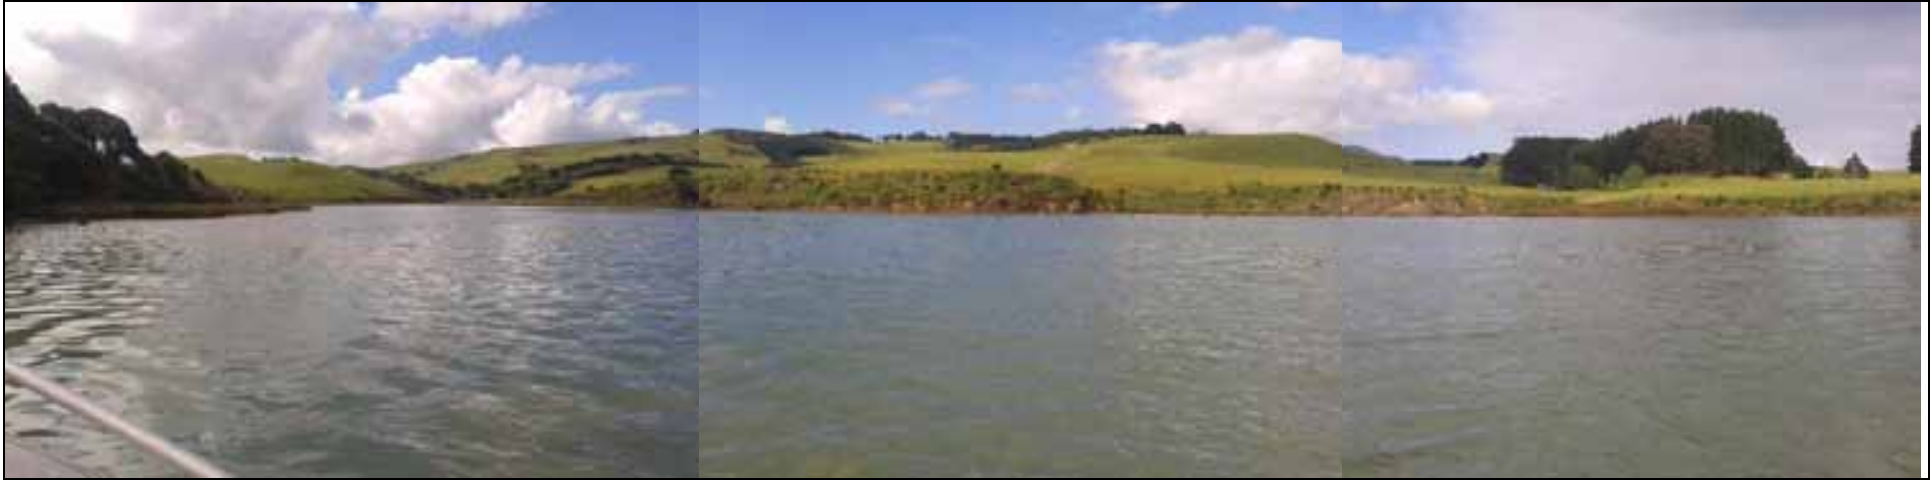
Figure 69: Extensive riparian fencing and planting around head of bay.

head of the arm (Figure 69). A kotuku was seen here. The coastal edges were all fenced off as are the seepage areas. There were remnant kanuka, totara and other native shrubs along the riparian margin. Near the golf course the gorse had been sprayed within the fenced riparian area (Figure 70). A small amount of Japanese honeysuckle was noted in the coastal forest edge in a small embayment below the golf club rooms. Tree privet was also present in the forest edge.

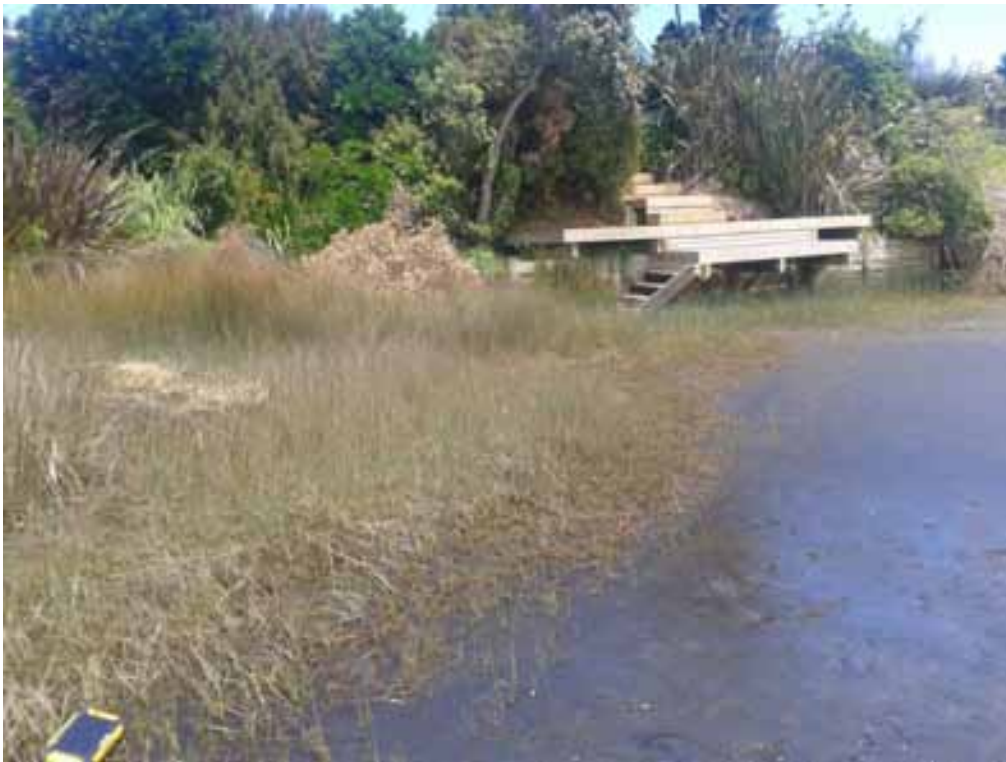
Figure 71: Saltwater paspalum growing amongst three square sedge.

Downstream of the tidal causeway, the estuarine vegetation along the TLB widened slightly and became more mixed with saltwater paspalum present again (Figure 71). Rushland still dominated (oioi, sea rush and three square) and the extensive seagrass beds covering the main tidal flats extended in to the coastal edge in places.

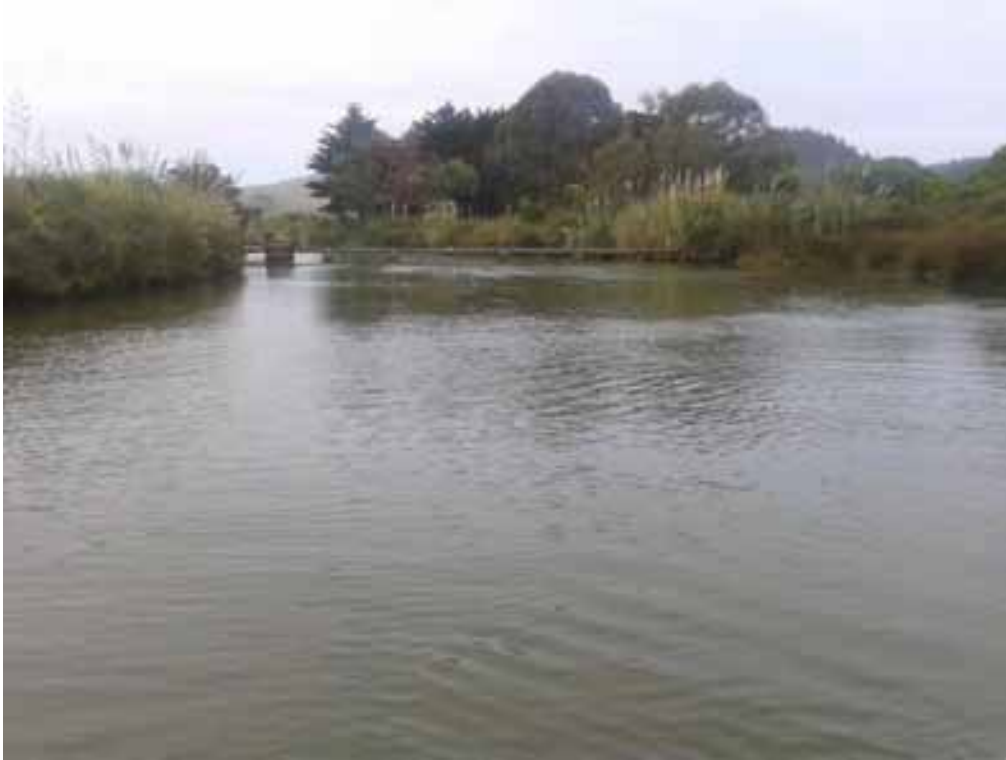
Figure 72: Extensive saltmarsh ribbonwood lines the TRB (left of photo with flax in behind. Oioi lines the lower TLB with estuarine vegetation becoming sparser along the banks upstream of the pipe line. Coastal daisy, karo, flax, pampas and gorse are the common riparian species.

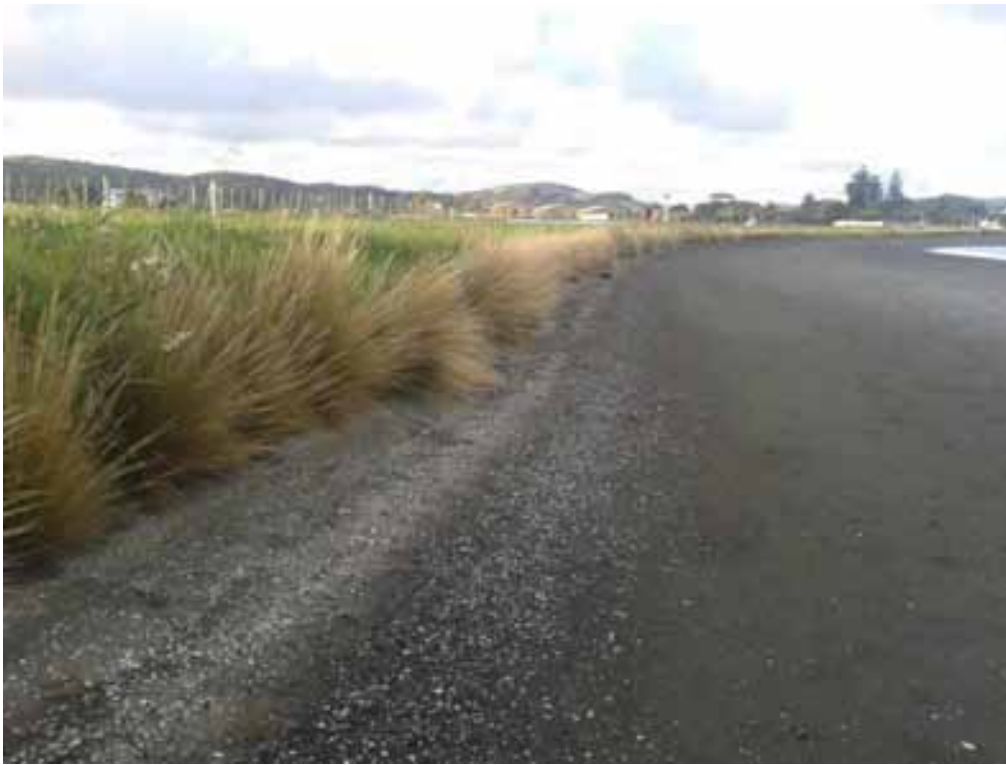
Figure 74: Coast spear grass lines the coastal edge along the campground/airfield road.

Downstream of the bridge there was a little bit of saltwater paspalum and sea rush near the bridge but otherwise the estuarine edge was characterised by a band of sea meadow including glasswort, remuremu, bucks horn plantain, sea primrose, and then a solid strip of coast spear grass out to the boat ramp (Figure 74). The occasional mown pohuehue plant was noted above the coast spear grass. The last estuarine vegetation mapped along the TLB were bands of seagrass patches that extended along the low tide mark upstream and downstream of the boat ramp.
