# Waipa morphological modelling study Phase 3: Analysis and modelling

Phase 3: Analysis and Modelling

NIWA CLIENT REPORT No: CHC2015-073  
Report date: June 2015  
NIWA Project: EVW14502

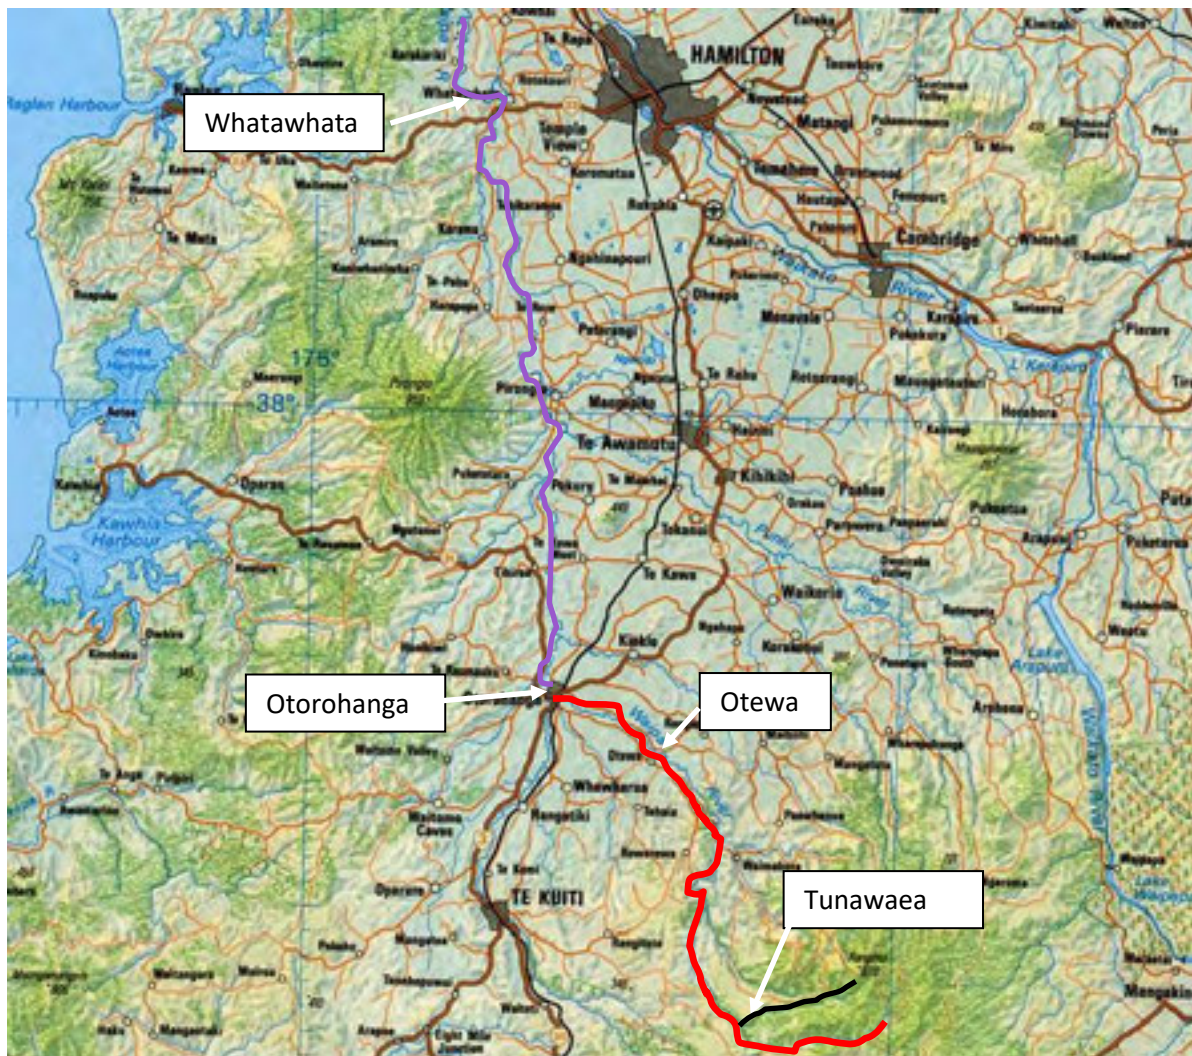
**Figure 1-1:** Map showing the location of the Waipa River and Tunawaea confluence upstream of Otorohanga. Note the location of the Otewa, Otorohanga and Whatawhata flow and suspended sediment monitoring stations.

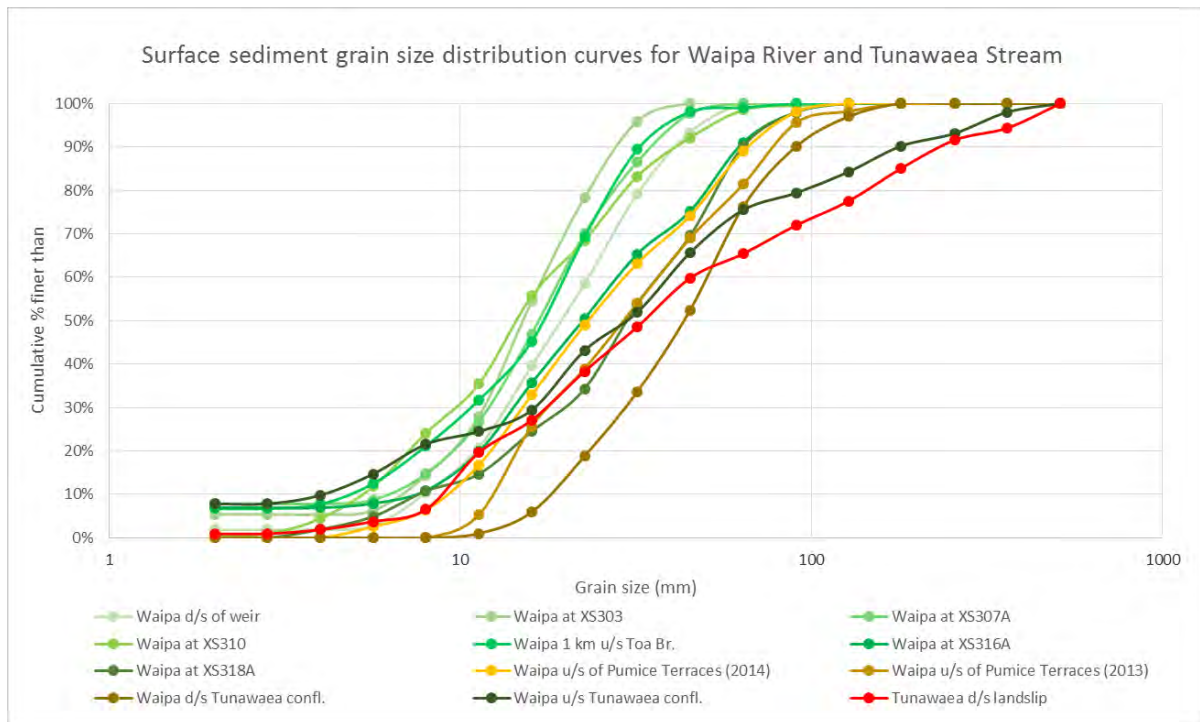
Figure 3-2: Surface sediment grain size distribution curves for Waipa River and Tunawaea Stream.

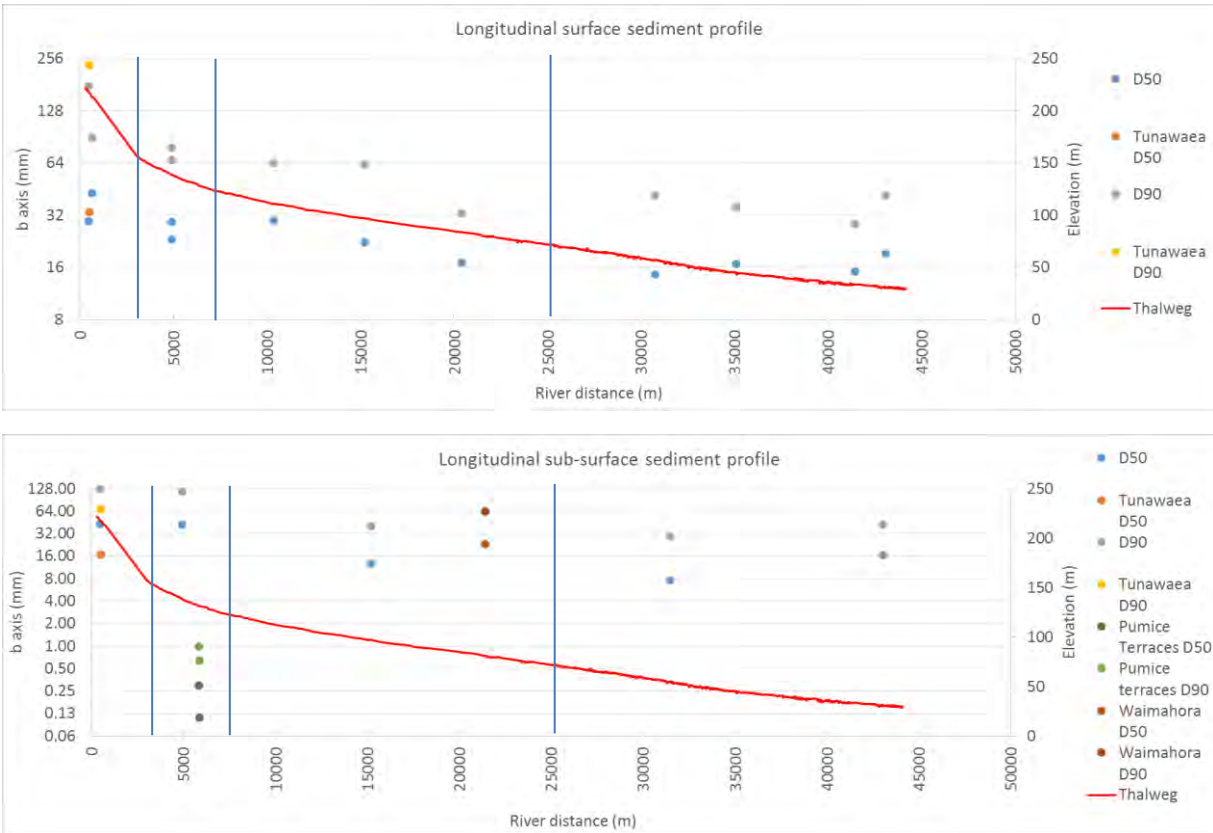
**Figure 3-4: Surface (top) and sub-surface (bottom) sediment sampling sites overlaid on the long profile.** The long profile is split into sections at around 4000, 7000 and 25000 m based on changes in long profile gradient.

To assign a grainsize distribution to the surface and subsurface at each cross section, the approach we used was to examine the long profile of the Waipa River and split it into sections based on changes in gradient (Figure 3-4). The cross sections falling within each of these sections were then assigned an initial surface and subsurface grain size profile based on the average of the sediment distributions sampled within that section. For example, the cross sections falling between river distances 7 and 25 km were assigned a surface grain size distribution based on the average of the three samples taken in that section of river (i.e. Waipa 1km u/s Toa Br, Waipa at 316A and Waipa at 318A) and the sub-surface grain size distribution was assigned the distribution sampled upstream of Rewarewa access, as this was the only sub-surface sampling site in the Waipa River in that section of river.

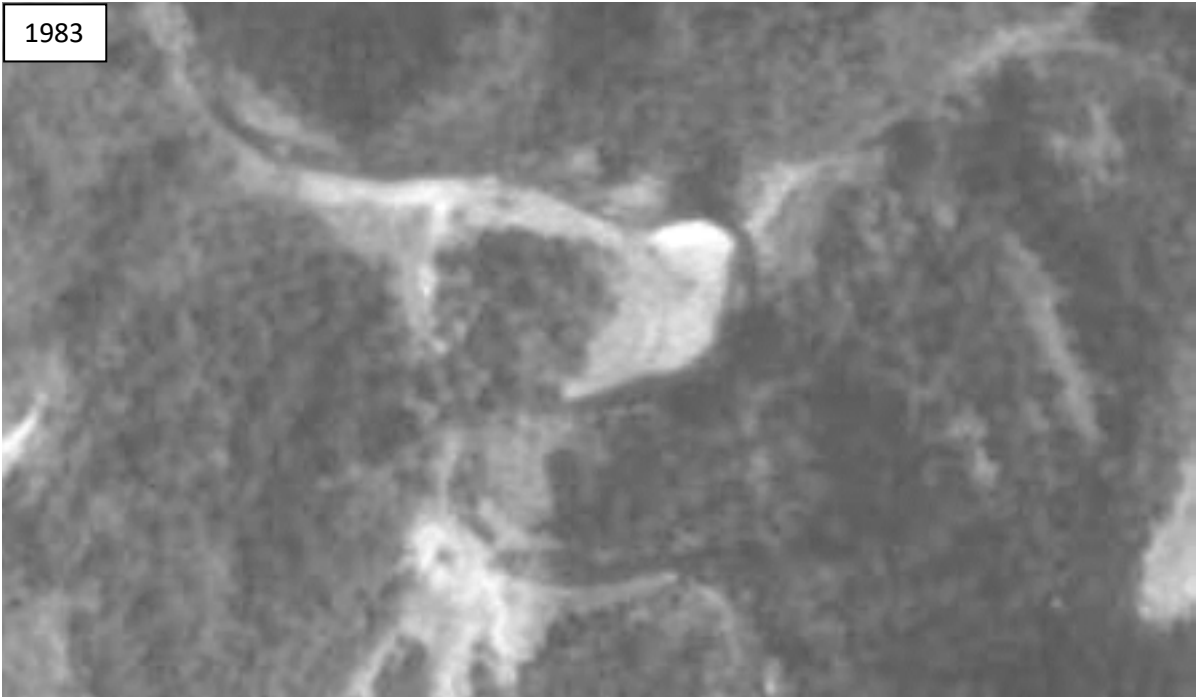
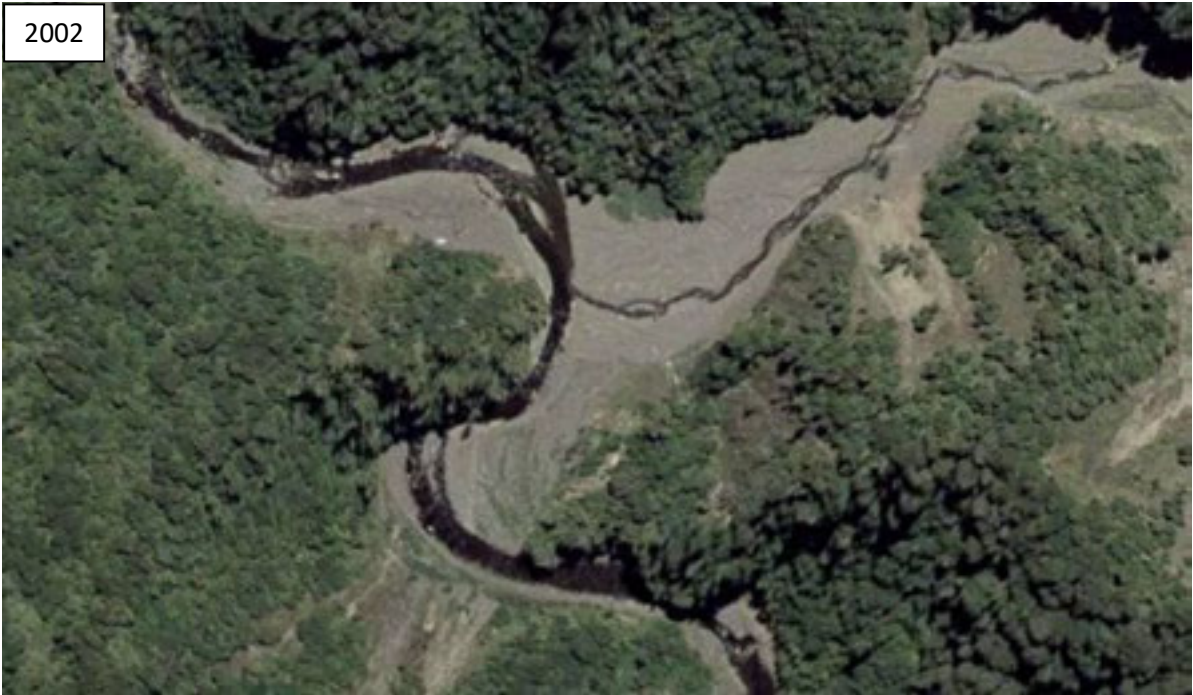
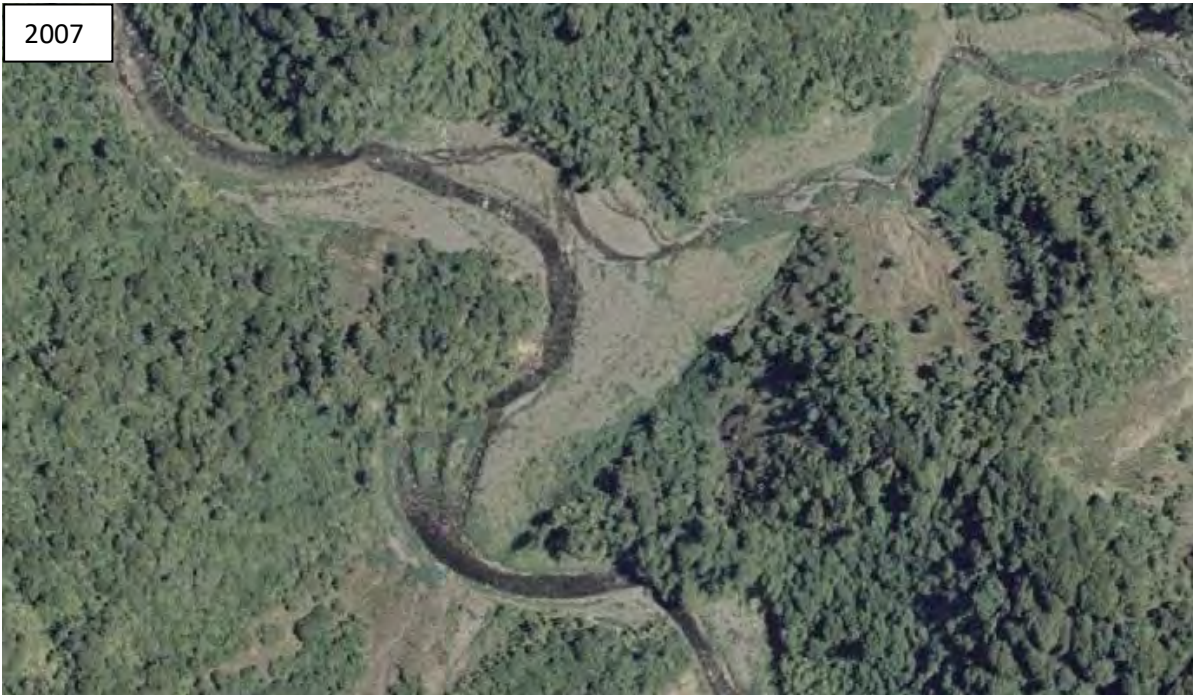
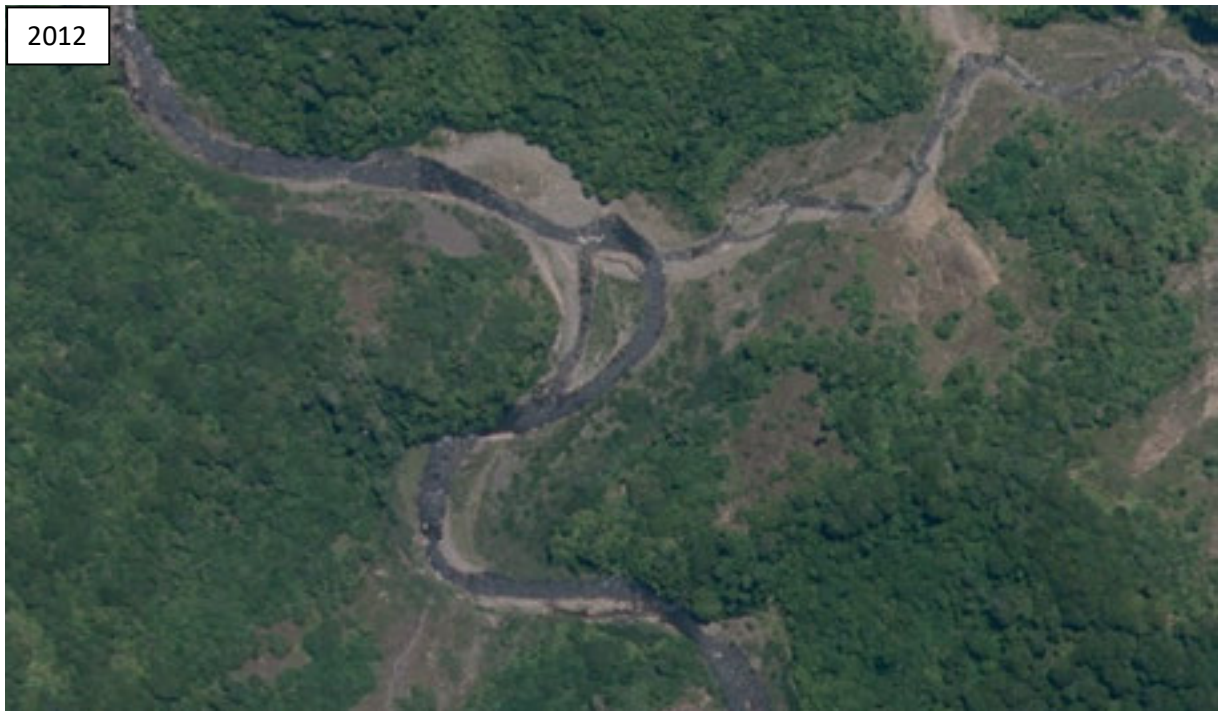
**Figure 4-1:** Aerial photographs showing changes in the upper Waipa/Tunawaea confluence sub reach. Note flow in the Waipa is from bottom to top, with the Tunawaea joining on the true right bank.

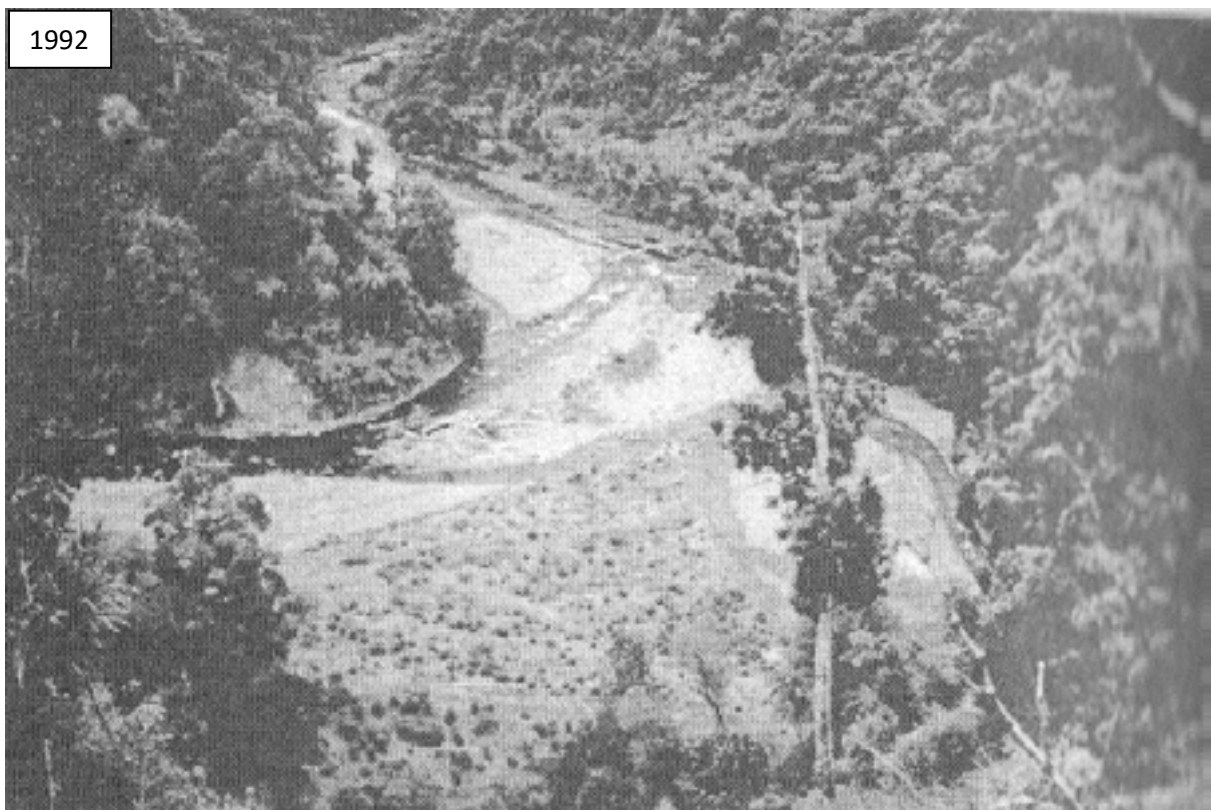
**Figure 4-2:** Waipa/Tunawaea confluence 44 days after the Tunawaea Landslide dam collapse. Note the view is looking downstream from the left bank of the Waipa with flow in the Waipa entering from the left of the photograph and flow from the Tunawaea entering from the right of the photograph. From Riley et al. (1993).

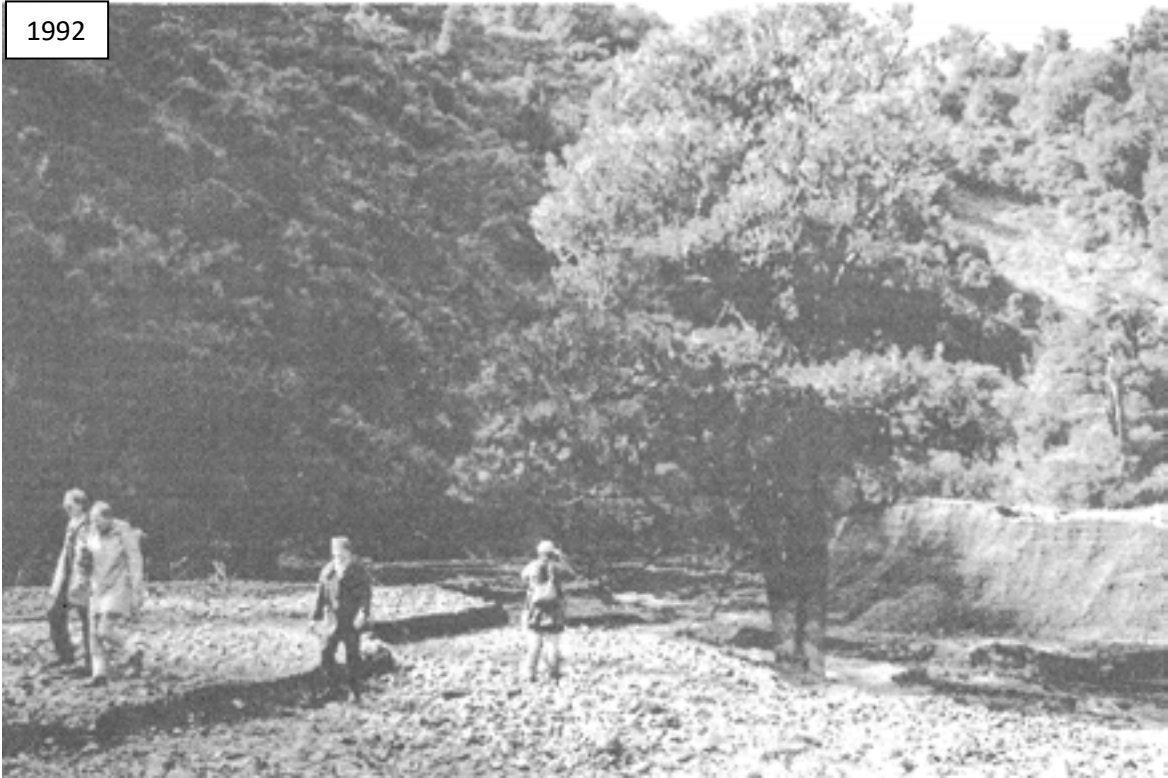
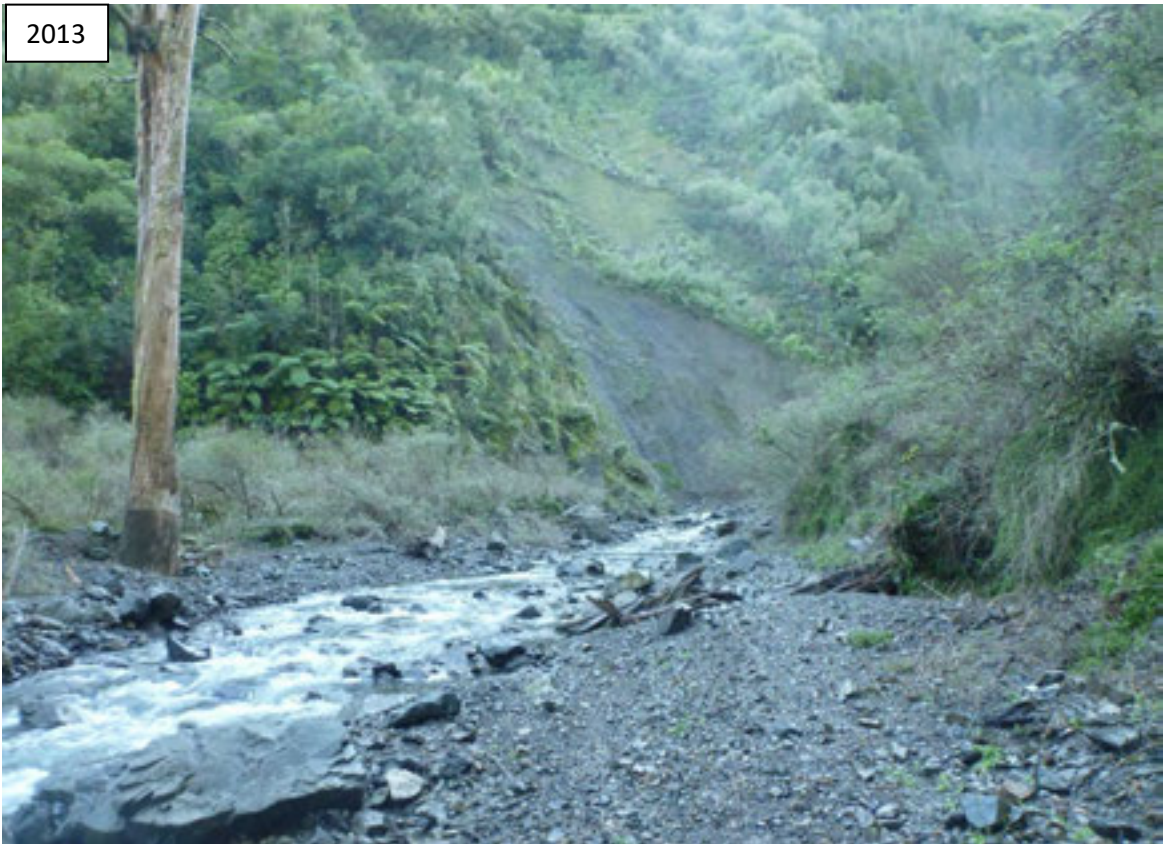
**Figure 4-3: Large kahikatea tree in the Tunawaea Stream, approximately 100 m upstream of the Waipa confluence, in 1992 and in 2013. The 1992 photograph is from Riley et al. (1993). Both photos are taken looking upstream.**

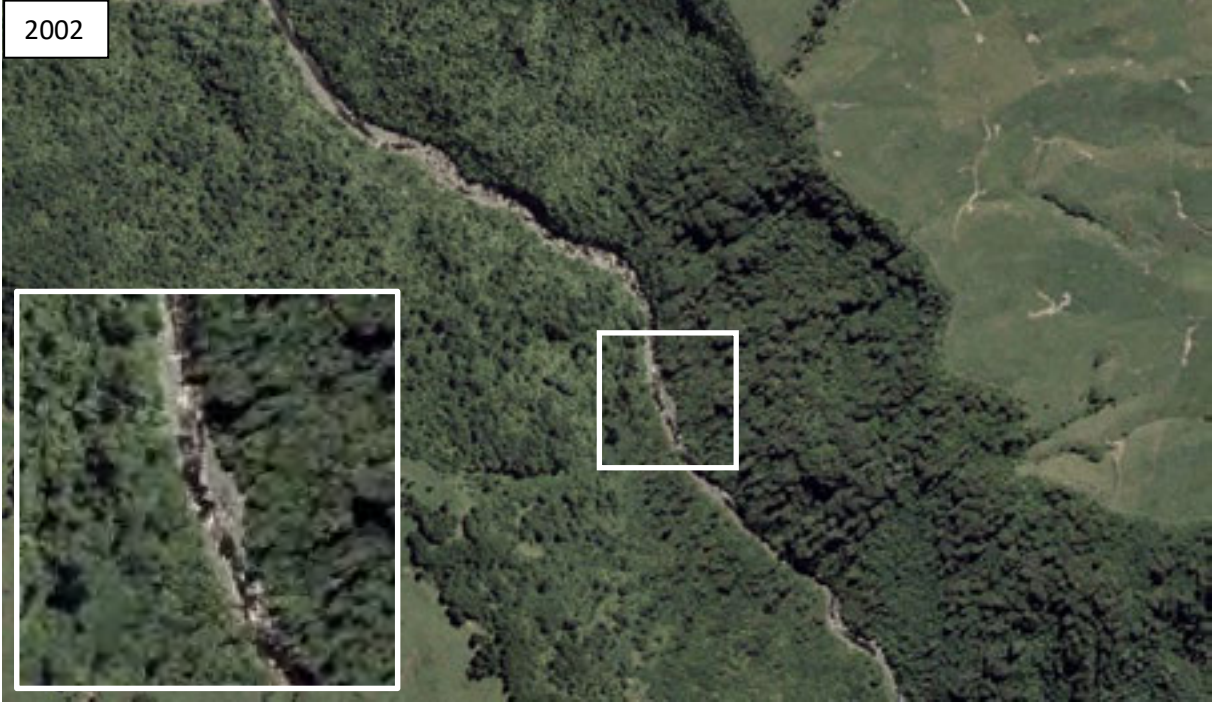
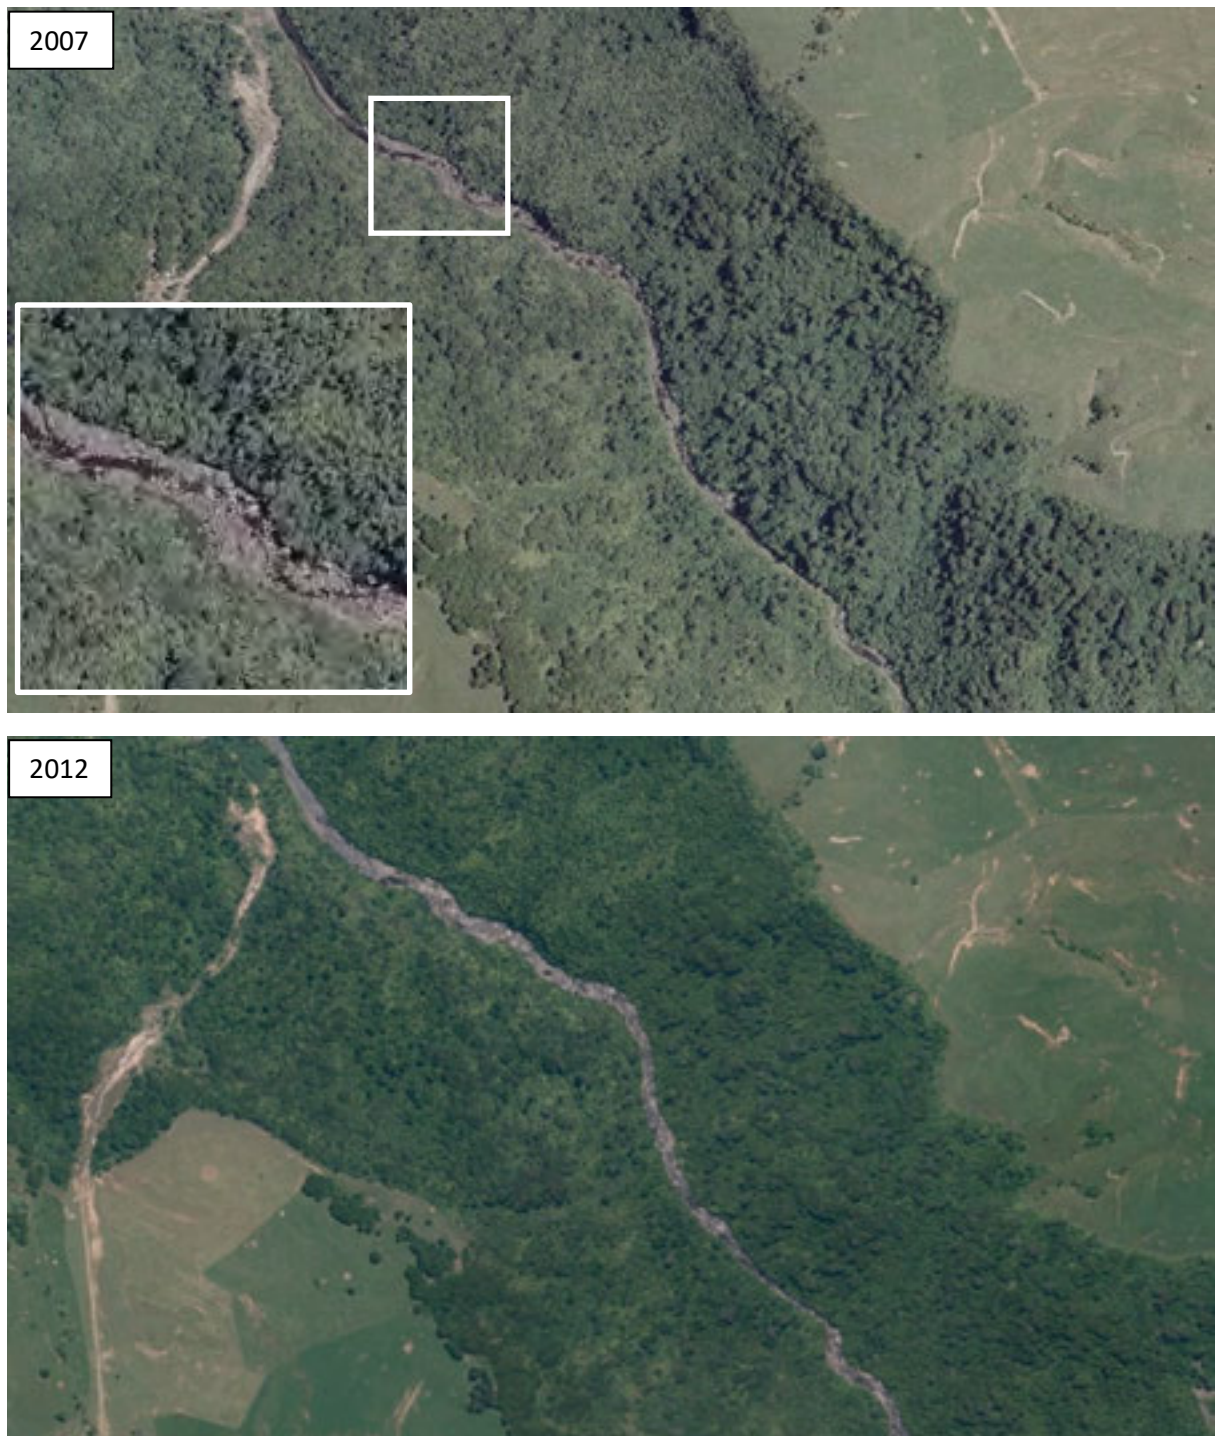
The ignimbrite gorge reach is approximately 1.5km long and starts immediately downstream of the Tunawaea confluence. This reach is steep (2-3%) and narrow (15-25 m wide) and comprises a series of cascades (short drops and pools) where the water spills around large (~1.5 m diameter) ignimbrite boulders. Figure 4-4 presents the aerial photographs of this area. The resolution of the 1983 aerial photograph is fairly poor, however, patches of white-water (from the cascades) are visible. These patches of white-water are no longer apparent on the 1993 aerial photograph, and the reach instead gives the impression of being buried in gravel. By 2002 the boulders and cascades become visible in the reach again, indicating that this reach cleared of gravel in the decade following the landslide dam failure. Narrow lateral bars of gravel are still apparent in the reach indicating that gravel is still passing through this reach. The 2007 and 2012 aerials appear much the same as the 2002 aerial, with perhaps more boulder exposure in 2012.

**Figure 4-4:** Aerial photographs showing changes in the ignimbrite gorge reach. Box inserts provide a zoom in at selected sections of the reach to highlight cascades, gravel burial or bars. Note flow is from bottom right to top left.

- **Ignimbrite gorge reach (1 to 2.5 km):** The aerial photograph analysis suggested there was some gravel build-up in the gorge visible in 1993 that had largely gone by 2002. The model is consistent with this, showing increasing build-up of gravel in the upper and lower parts of the gorge after the Tunawaea Landslide dam failure in 1992, peaking in 1995, and then reducing back to pre-landslide levels by 1998 except for the downstream-most part of the gorge which was affected by sediment backing up from downstream.

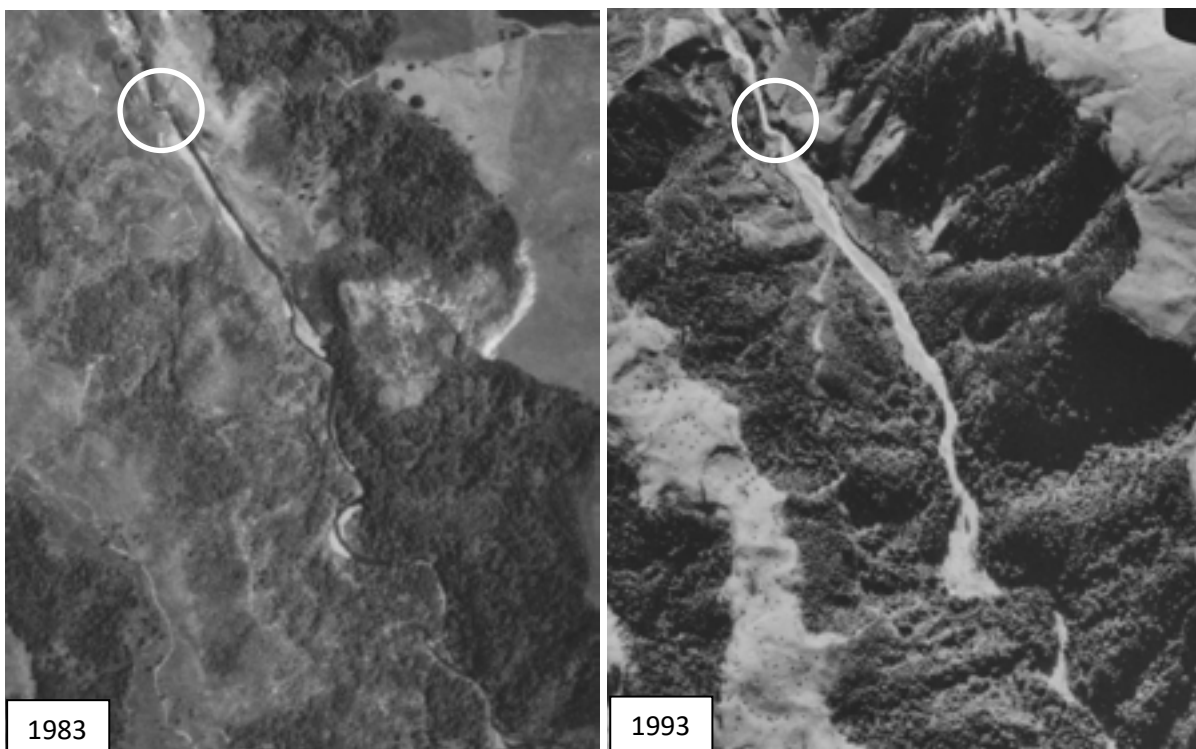
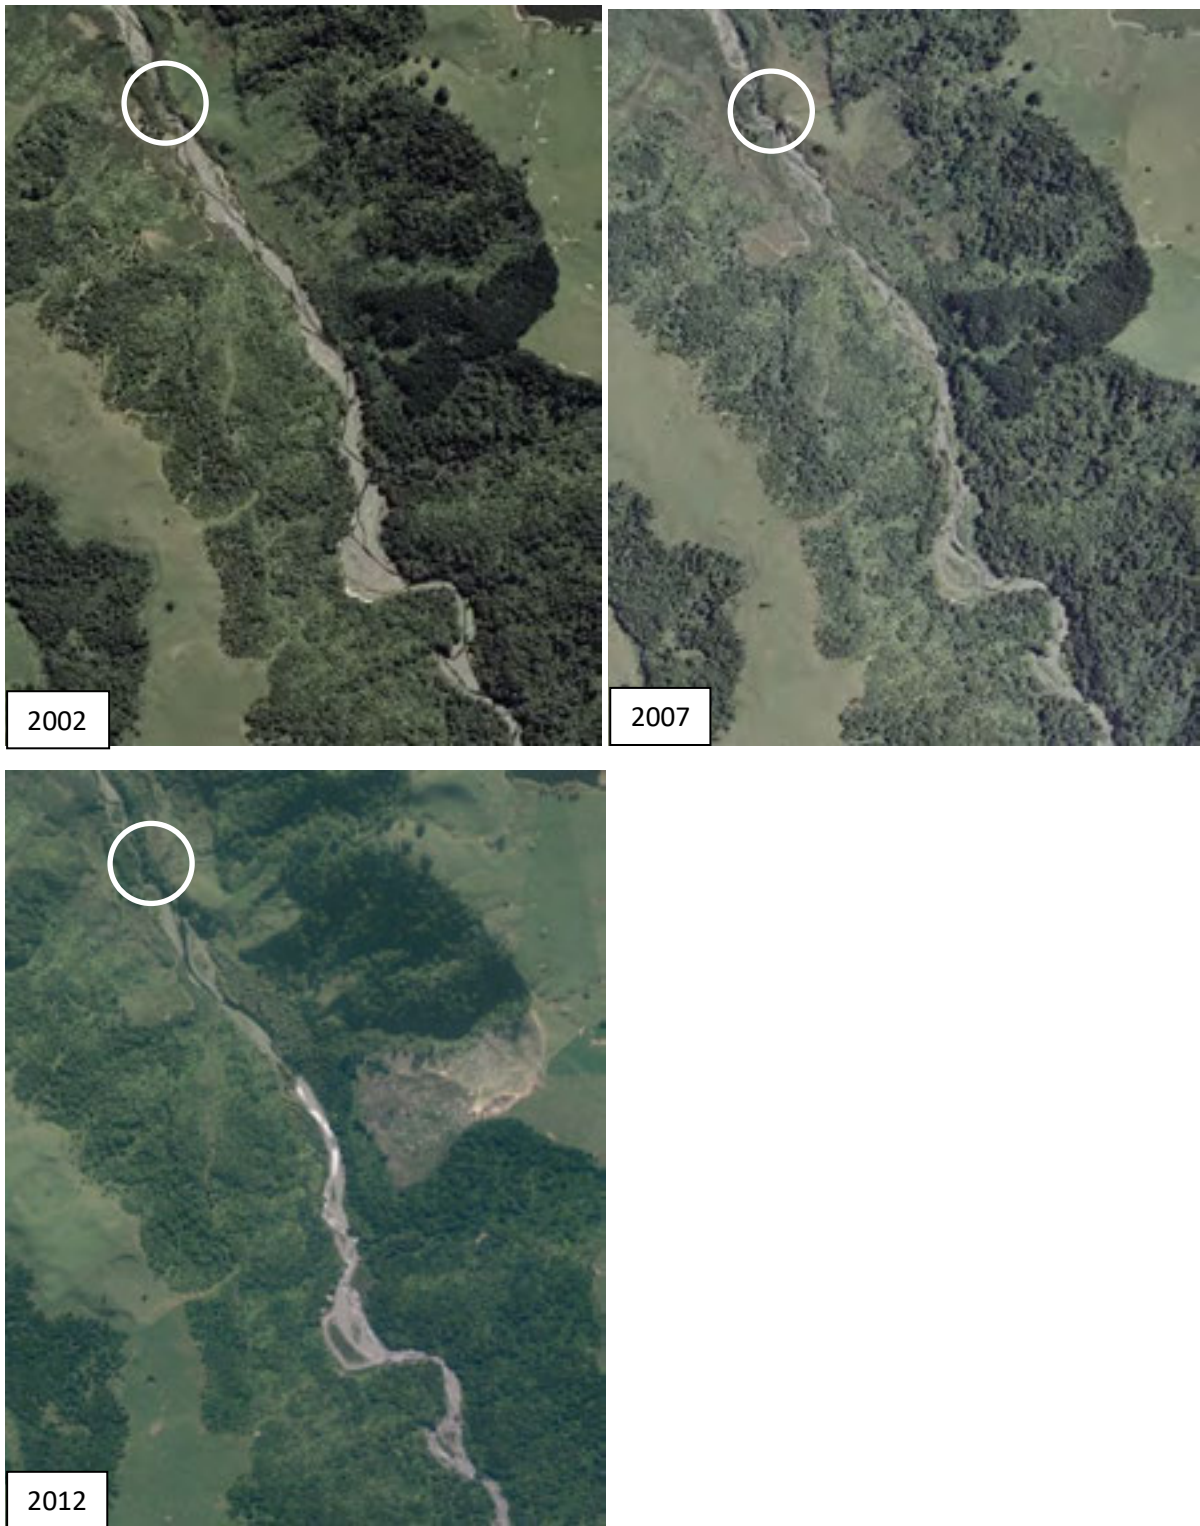
Downstream of the ignimbrite gorge reach the Waipa River remains highly confined but the gradient reduces (0.7-1.1%) and the river widens, with the active channel up to 100 m wide in places. At the downstream end of this reach there is a short (160m long) bedrock pinch in the valley, forming a local constriction. Figure 4-5 presents the aerial photographs of part of this reach including the pinch. In 1983, prior to the Tunawaea Landslide, this reach comprises a single thread low flow channel with occasional point bars where the valley widens. The 1993 photograph indicates that this reach has approximately doubled in width. This is unsurprising as the peak flood wave generated when the Tunawaea dam breached would have been well in excess of a 100 year event in this reach (see Section 1.2; Parkin et al., 1993). It's highly likely that the dam breach flood wave would have removed riparian vegetation and scoured any easily erodible bank material. The 1993 photograph also shows that this reach is filled with gravel, including through the pinch, and the low flow channel is braiding across its surface. Braiding activity is also clear on the 2002 photograph, and while some of the gravel has started to clear from the pinch the low flow is braiding immediately upstream of the pinch and there are large gravel deposits immediately downstream where the channel widens. In 2007 the low flow channel is reverting to a single thread, forming long alternate bars. Some of these appear to have been planted with rows of trees, but many of the gravel bar surfaces also look like they are naturally revegetating. In 2012 the low flow has completely reverted to a single thread channel but many bars appear clearer of vegetation than in 2007, perhaps as a result of a floods in the intervening period, and there is still clearly more gravel stored in this reach than prior to the landslide.

**Figure 4-5: Aerial photographs showing changes in the reach downstream of the ignimbrite gorge. Note flow is from bottom to top. The circled area indicates the location of the bedrock pinch.**

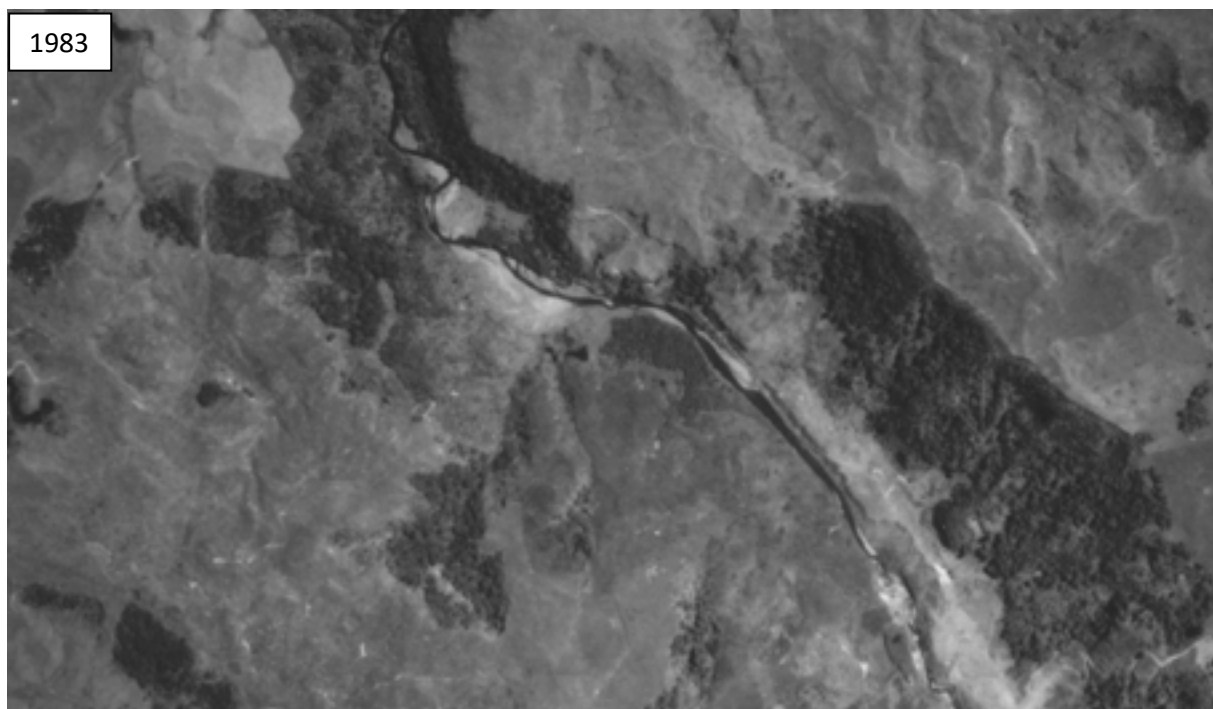
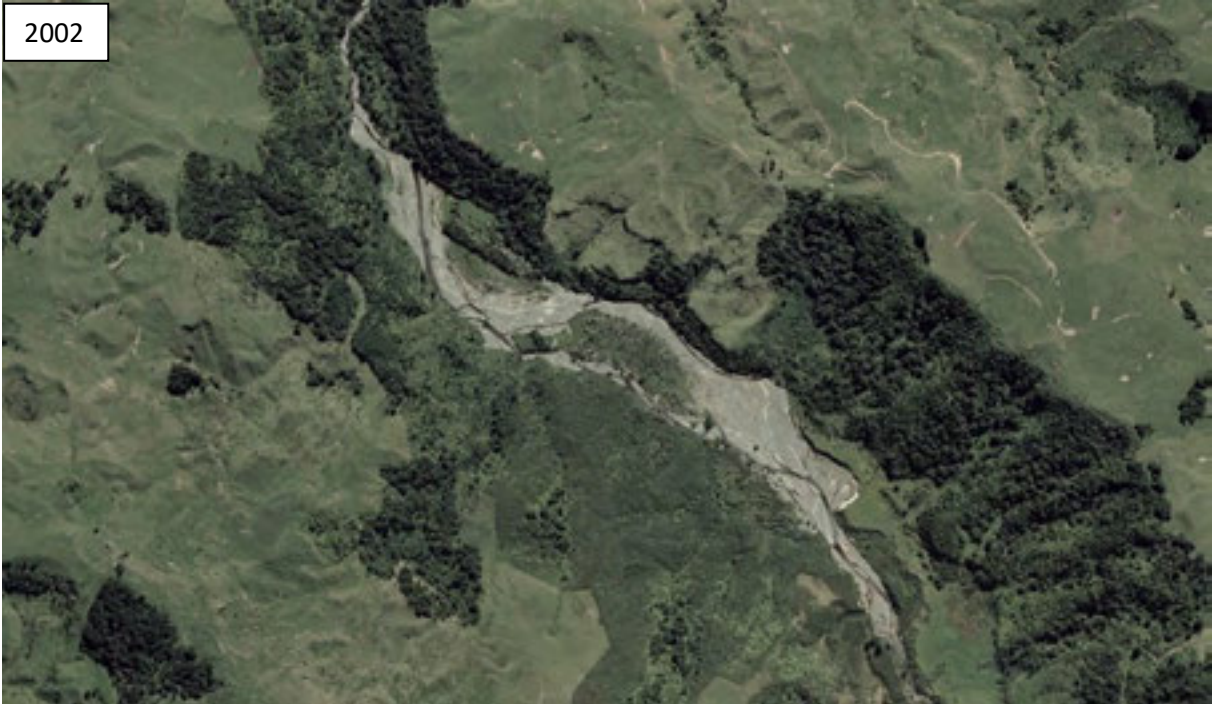
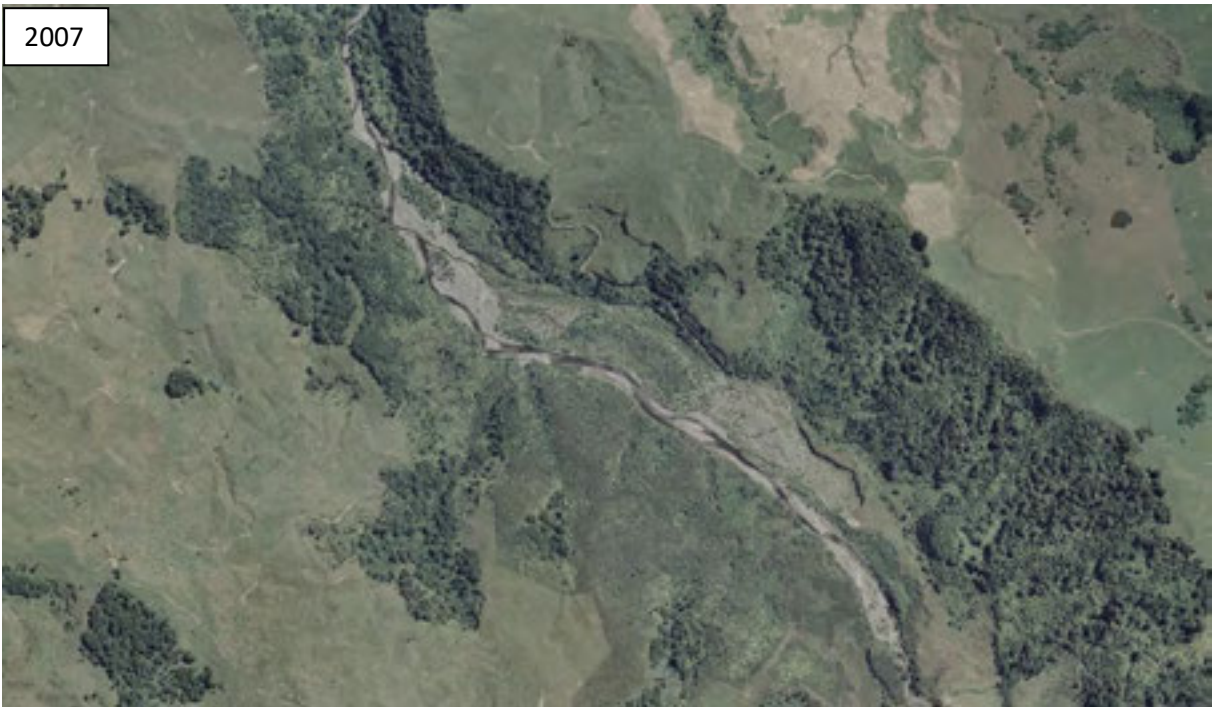
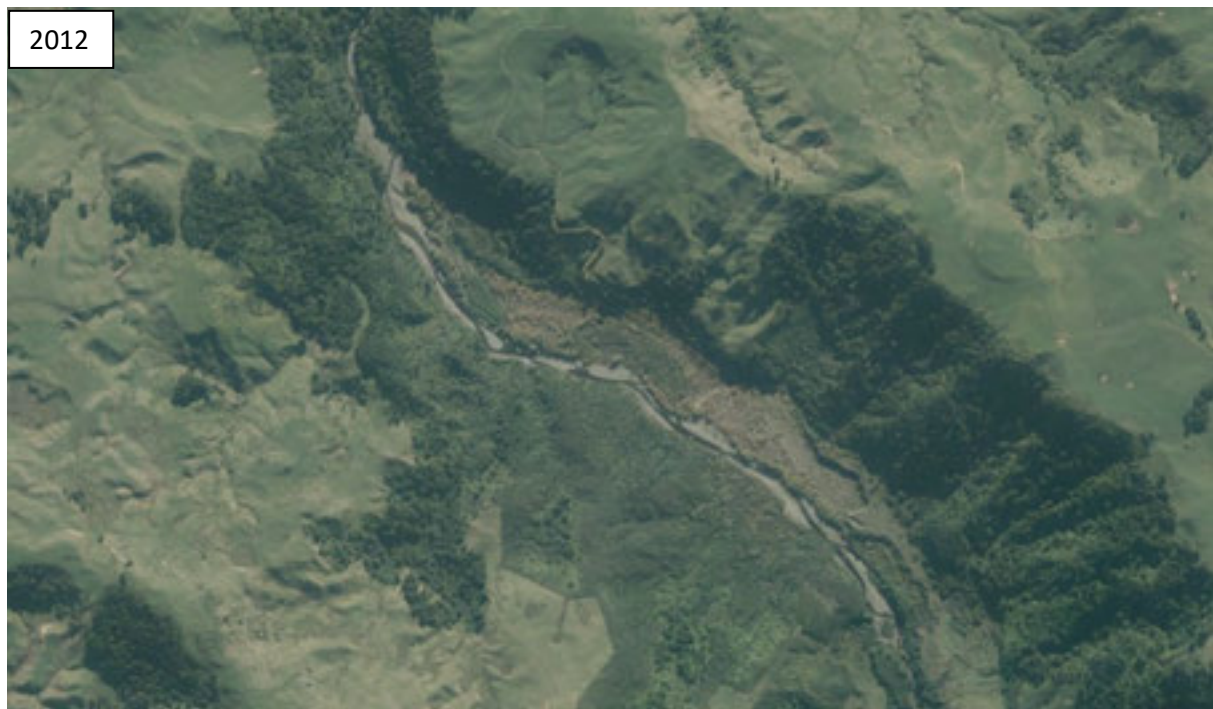
The pumice terrace reach has undergone substantial change following the Tunawaea Landslide. The pumice terraces are approximately 16m high and comprise very fine (Figure 3-3) pumice and ash deposited during the Taupo eruption that occurred in 186 AD. Figure 4-6 presents the aerial photographs of this area. In 1983 most of this reach is 40-50 m wide. The channel is straight through the main pumice terrace section and then becomes sinuous downstream. There are occasional lateral or point bars. It is possible that the biggest change in this reach occurred soon after the Tunawaea Landslide, but unfortunately the 1993 aerial photograph is missing for this reach so we are uncertain of the timing of change in this area. The changes are very well captured on the 2002 photograph which shows the active channel has widened to around 125-175 m between valley or terrace margins. A huge volume of pumice terrace material has eroded away and the low flow channel is braiding across extensive gravel deposits. One low flow channel runs hard against the right bank and another has broken left leaving a large vegetated island. In 2007 extensive planting is apparent (rows of trees), keeping the low flow channel pushed to the left bank. However, the low flow channel is still braiding a little around mid-channel and alternate bars. By 2012 the planted trees have become more established and the low flow channel has further reverted to a single thread and looks to have incised. There are still active lateral and mid channel bars of gravel throughout this reach.

**Figure 4-6: Aerial photographs showing changes in the pumice terrace reach.** Note the 1993 aerial photographs unfortunately miss this section of the Waipa River. Flow is from bottom to top.

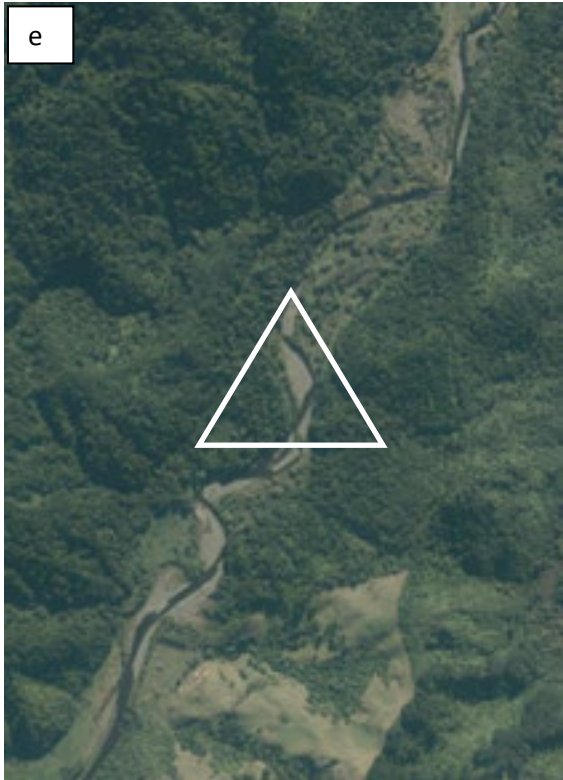
Downstream of the pumice terraces the Waipa River enters a partly confined reach. While not as narrow as the gorge, the valley margins are relatively narrow, more so than through the pumice terrace reach, and the valley gradually widens through this reach from approximately 50 m to 200 m wide. This partly-confined setting limits the ability of the river to adjust laterally, but there are small pockets of floodplain within the valley margins. Figure 4-7 presents the aerial photographs of one of the wider sections of this reach where there has been some loss of floodplain over the period since the Tunawaea Landslide. The 1983 aerial photograph shows the low flow channel meandering within the valley margins, alternating from one valley wall to the next. There are several large point bars present and in one location the low flow channel splits around an island. In 1993, the low flow channel has widened and there are areas of floodplain erosion apparent, for example in the circled area. In 2002 changes are apparent further upstream, for example in the boxed area where there appears to have been loss of vegetation and sediment deposition across the floodplain on both sides of the river. The 2007 and 2012 photographs show revegetation, including some planting within the area marked with a triangle. Between 2007 and 2012 there is also some bank erosion on the right bank within the area marked with the triangle. In 2012 there was still active movement of gravel through this reach, however the size of gravel bars reduces downstream. Based on the aerial photograph evidence it appears that the bottom end of this reach, at a river distance of 16 km (as defined in Figure 2-2), is the approximate extent to which the Tunawaea gravel slug has progressed.

**Figure 4-7: Aerial photographs showing changes in the semi-confined reach.** Note flow is from bottom to top. Areas noted with a circle, box or triangle indicate locations of notable change.
