# Waipa morphological modelling study Phase 3: Analysis and modelling

Phase 3: Analysis and Modelling

NIWA CLIENT REPORT No: CHC2015-073  
Report date: June 2015  
NIWA Project: EVW14502

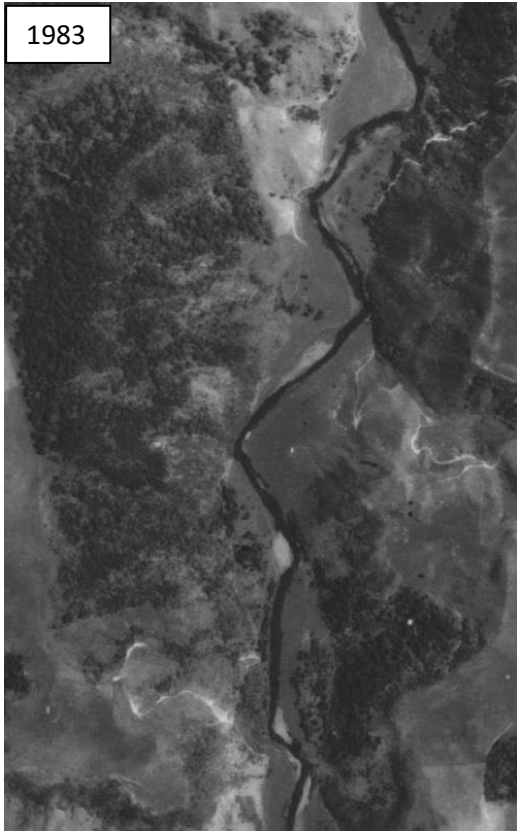
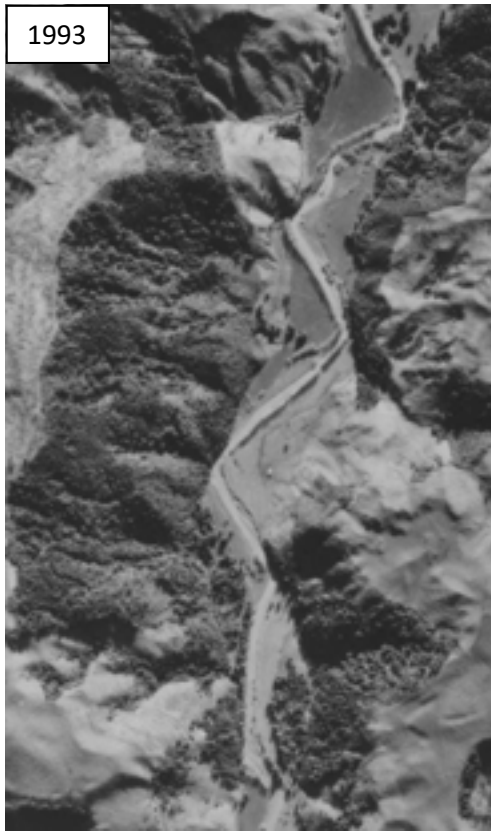
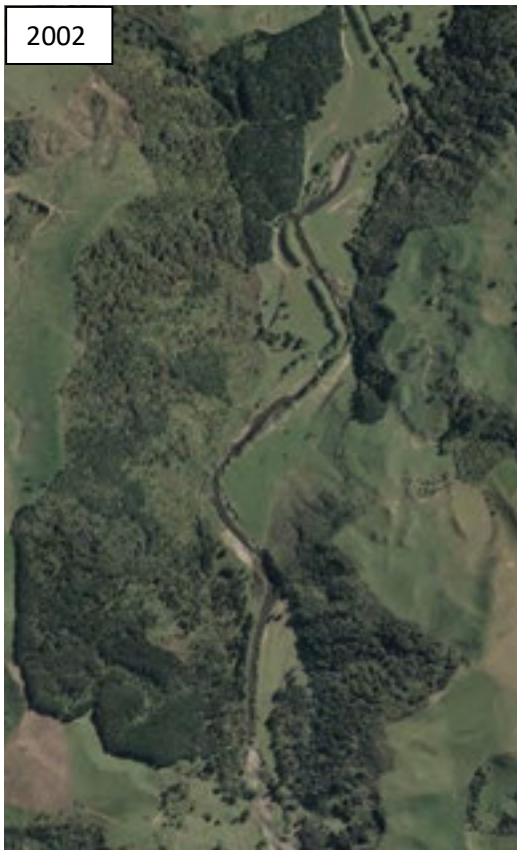
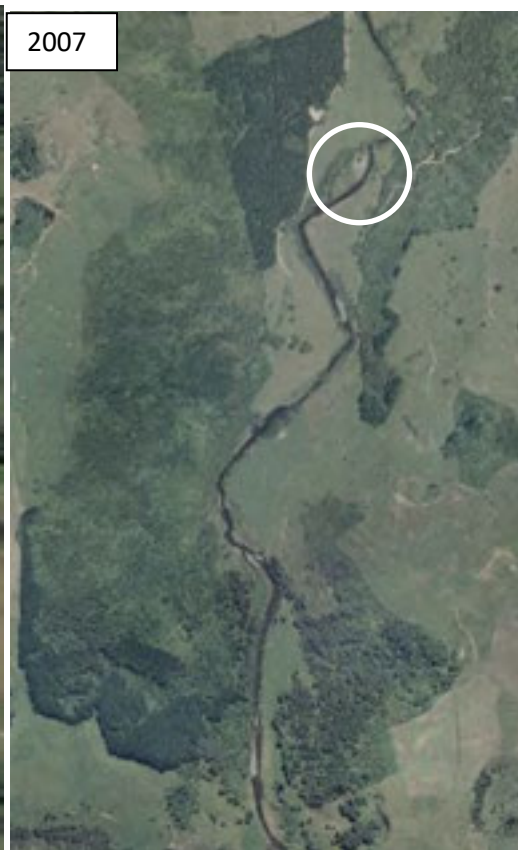
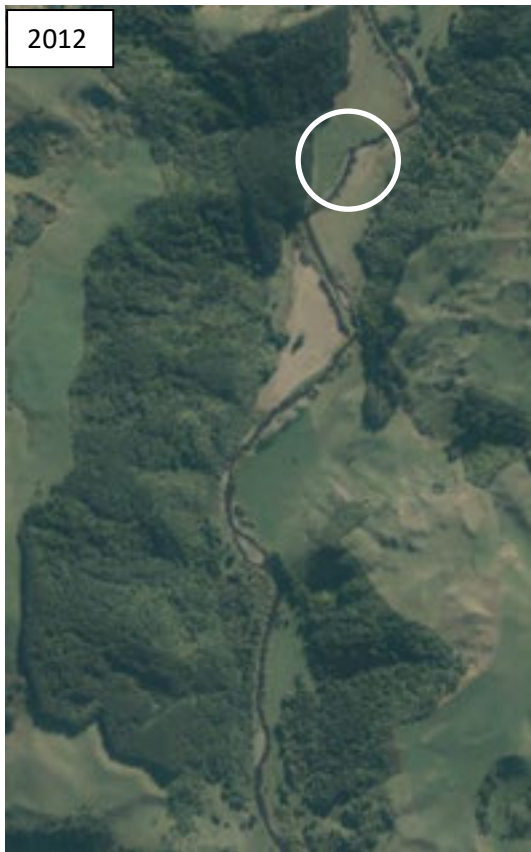
Further downstream the valley continues to open out. The river is still partly confined by the valley margins but the valley ranges from approximately 150 m to 350 m wide, allowing the formation of larger floodplain pockets. Geomorphically, this reach is fairly similar to the adjacent (partly confined) reach upstream, however, bars within this reach are few and far between, and this appears to have been the case since before the Tunawaea Landslide. Figure 4-8 presents the aerial photographs of the lower part of this reach, just upstream of Toa Bridge. These photographs all show a narrow low flow channel with an occasional small gravel bar. There are a few areas of bank erosion noted, for example in the area circled where the channel cuts into the left bank by approximately 40 m.

**Figure 4-8: Aerial photographs showing changes in the floodplain pocket reach.** Note flow is from bottom to top. The circled area indicates a location of bank erosion.

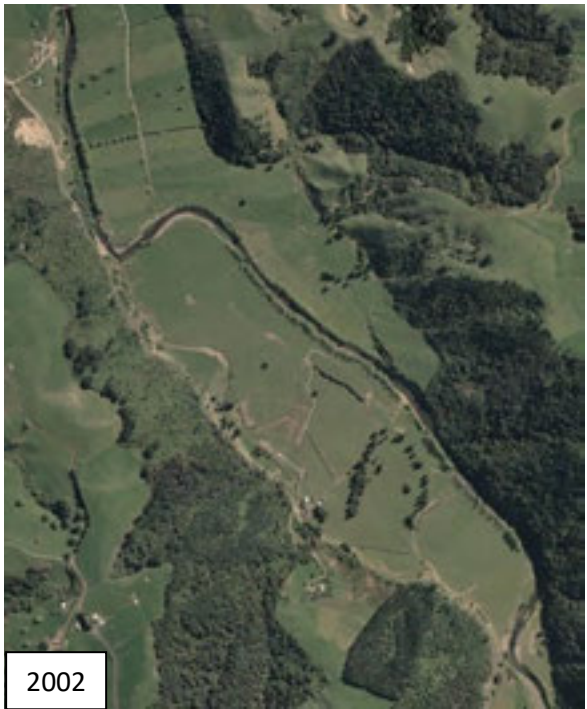
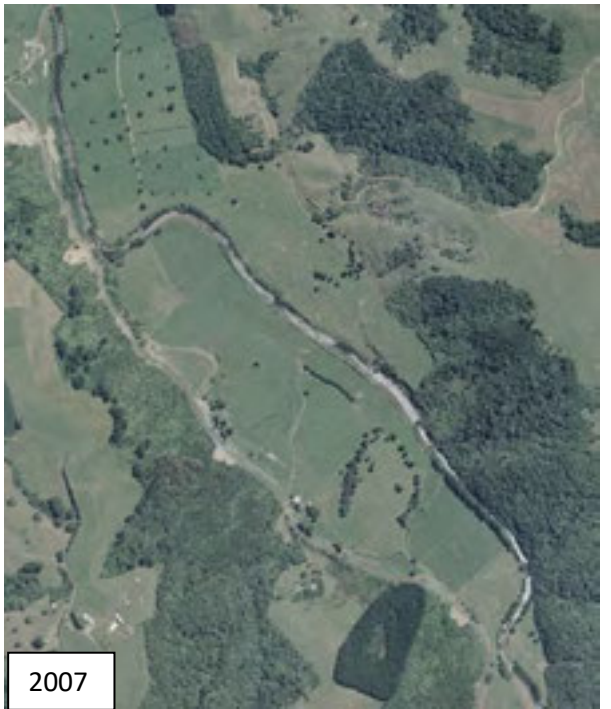
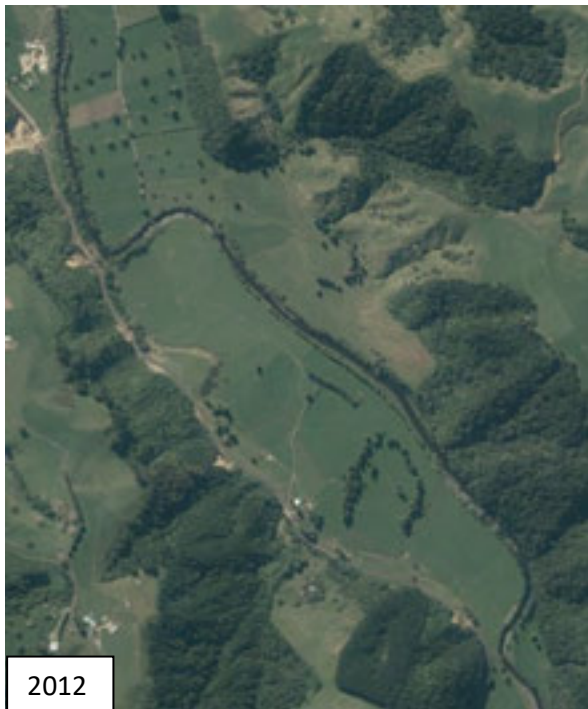
Downstream of Toa Bridge the Waipa River is mostly laterally unconfined by its valley margins. It does pass through one area where the valley closes in to 150 m wide, and this section of the reach is presented at the upstream end (bottom) of each of the aerial photographs in Figure 4-9. This reach, like the floodplain pocket reach upstream, appears very stable in the photographs over the period from 1983 to present. Gravel bars are very small and infrequent along this reach, and the channel alignment has been consistent and controlled by riparian vegetation (willows).

**Figure 4-9: Aerial photographs showing changes in the upper floodplain reach.** Note flow is from bottom to top.

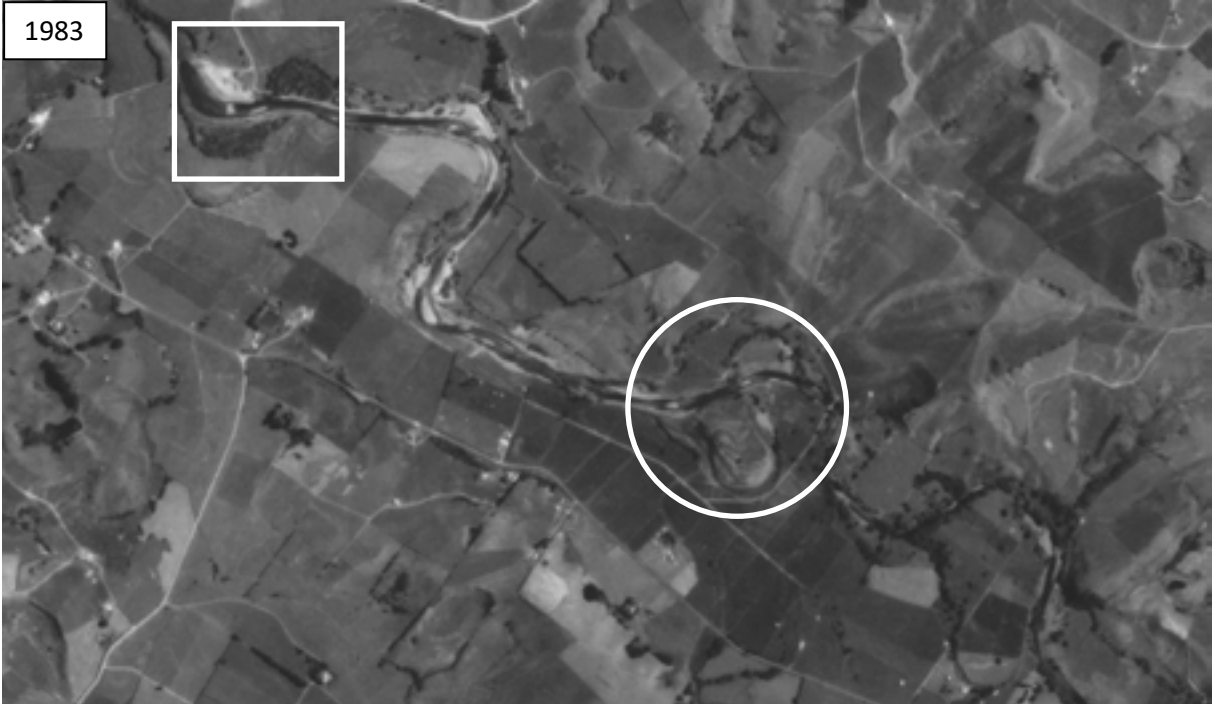
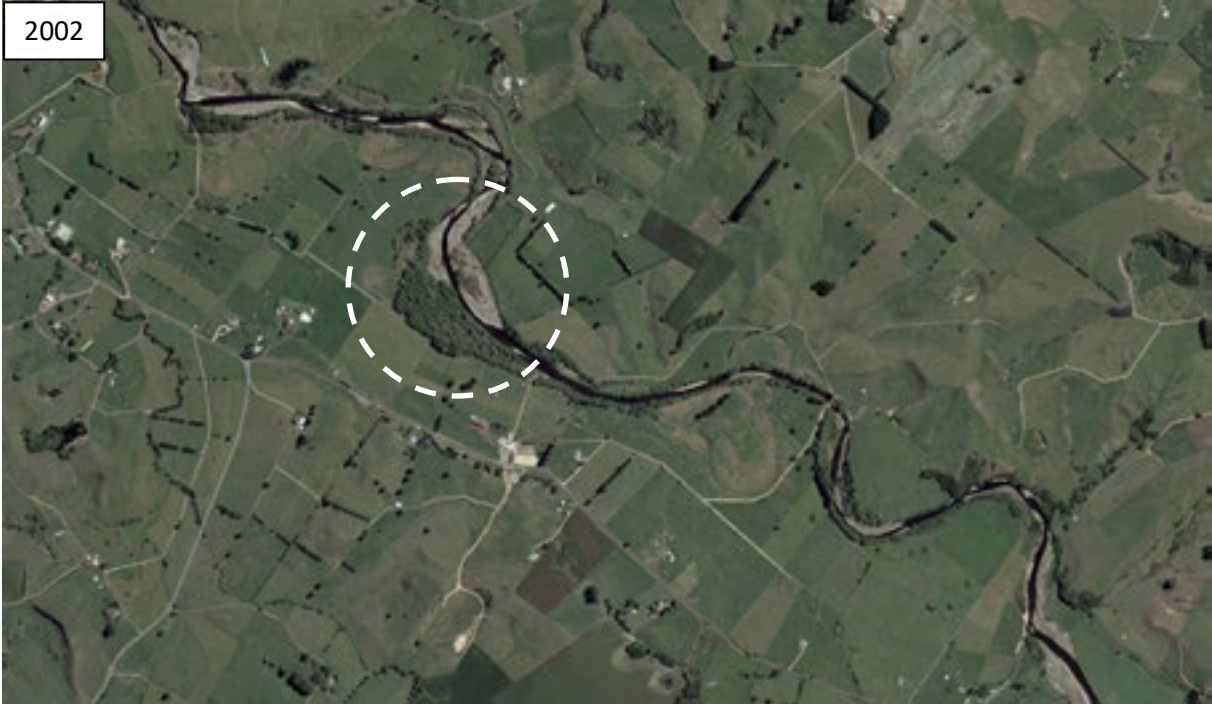
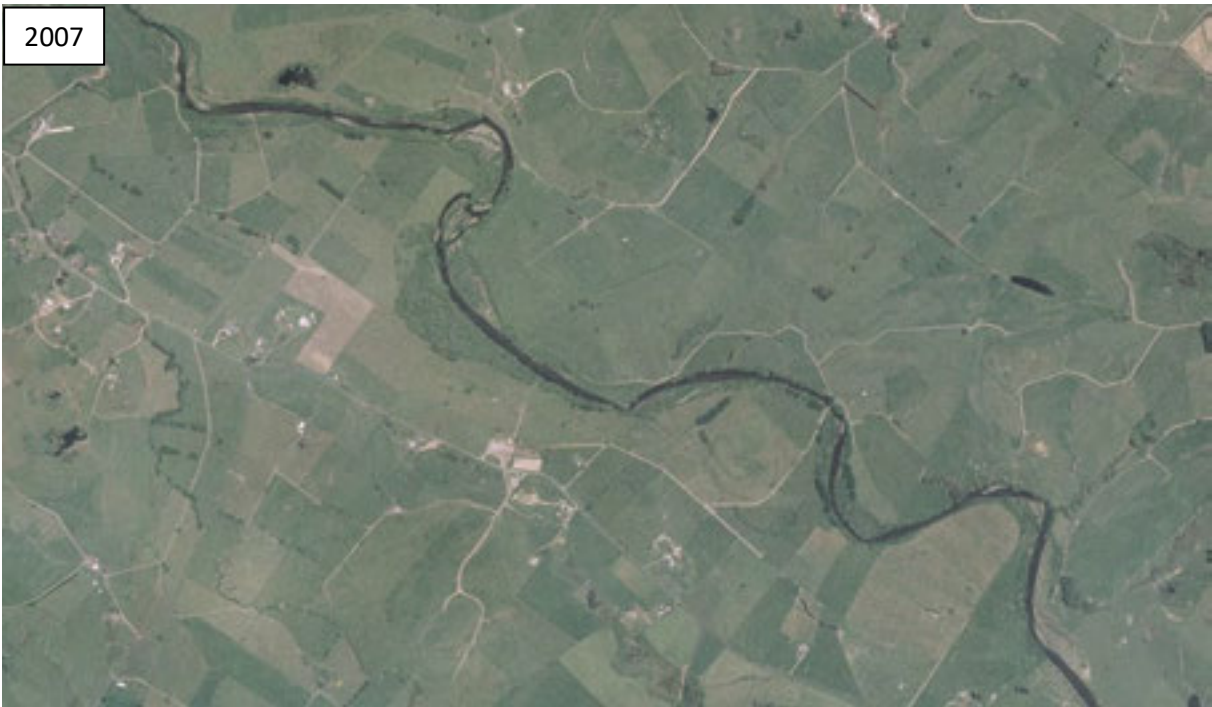
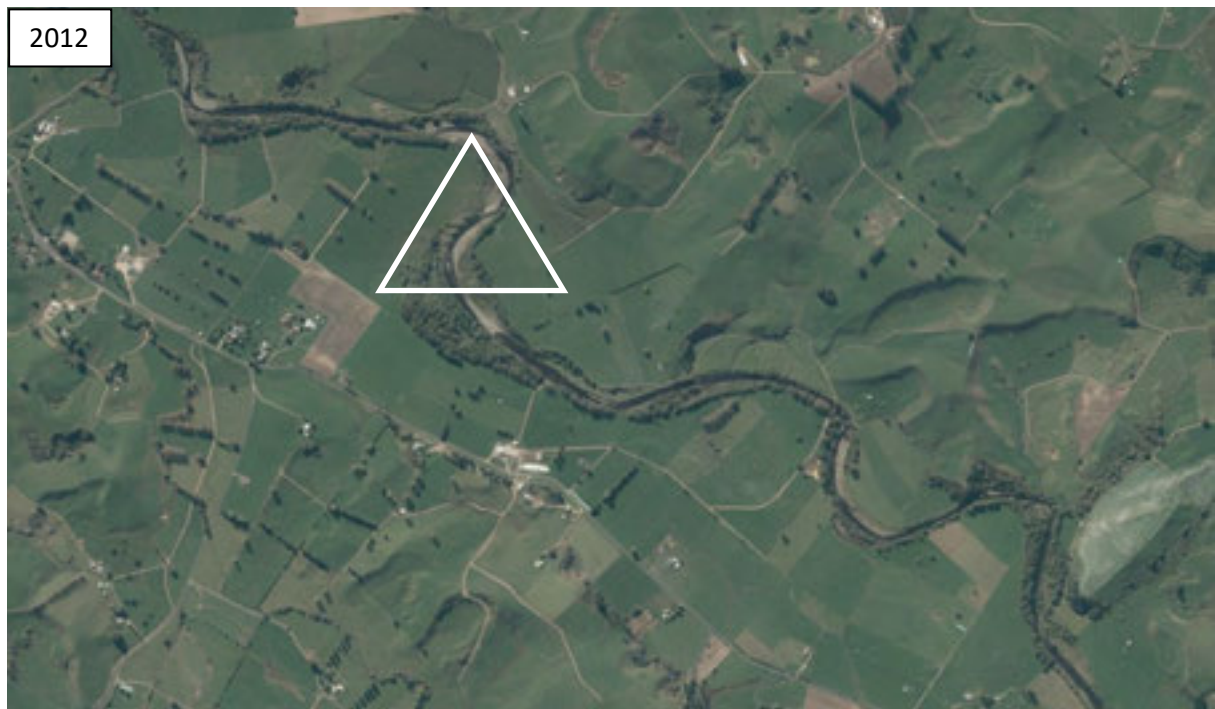
indicated with a triangle to push the river back to the right and reclaim some of the previously eroded left bank.

**Figure 4-10: Aerial photographs showing changes in the cut offs and gravel extraction reach.** Note flow is from bottom right to top left. Areas noted with a circle, box or triangle indicate locations of notable change.

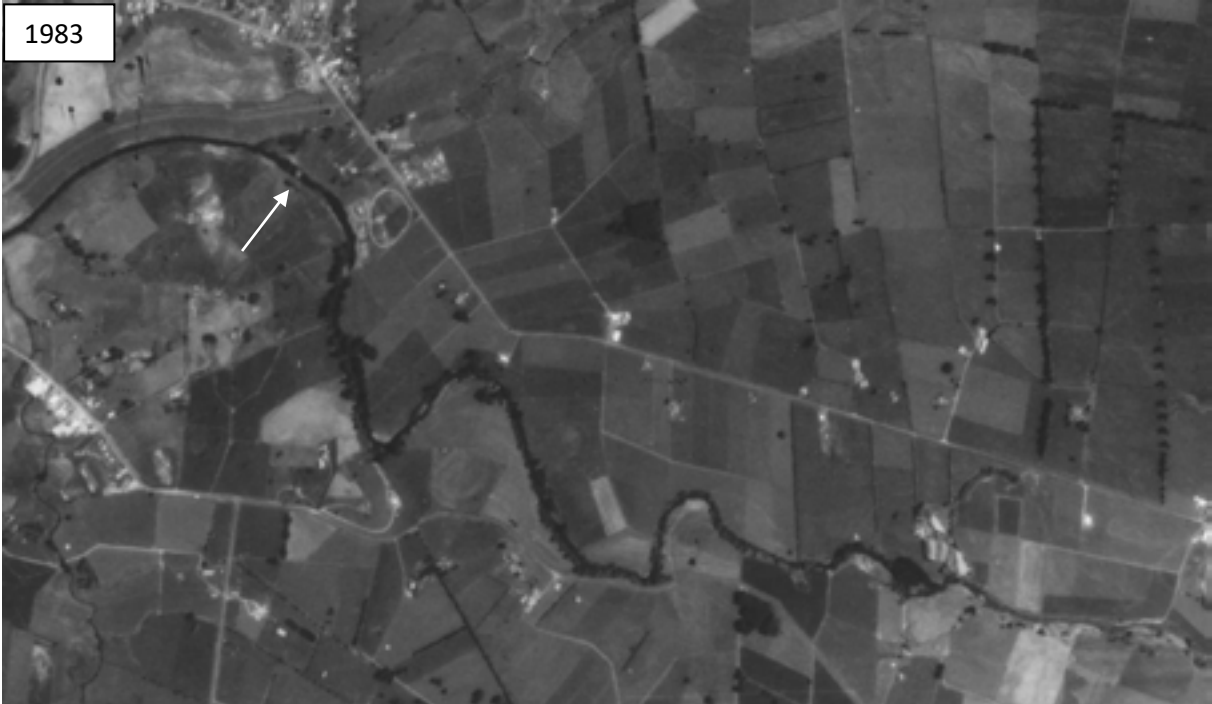
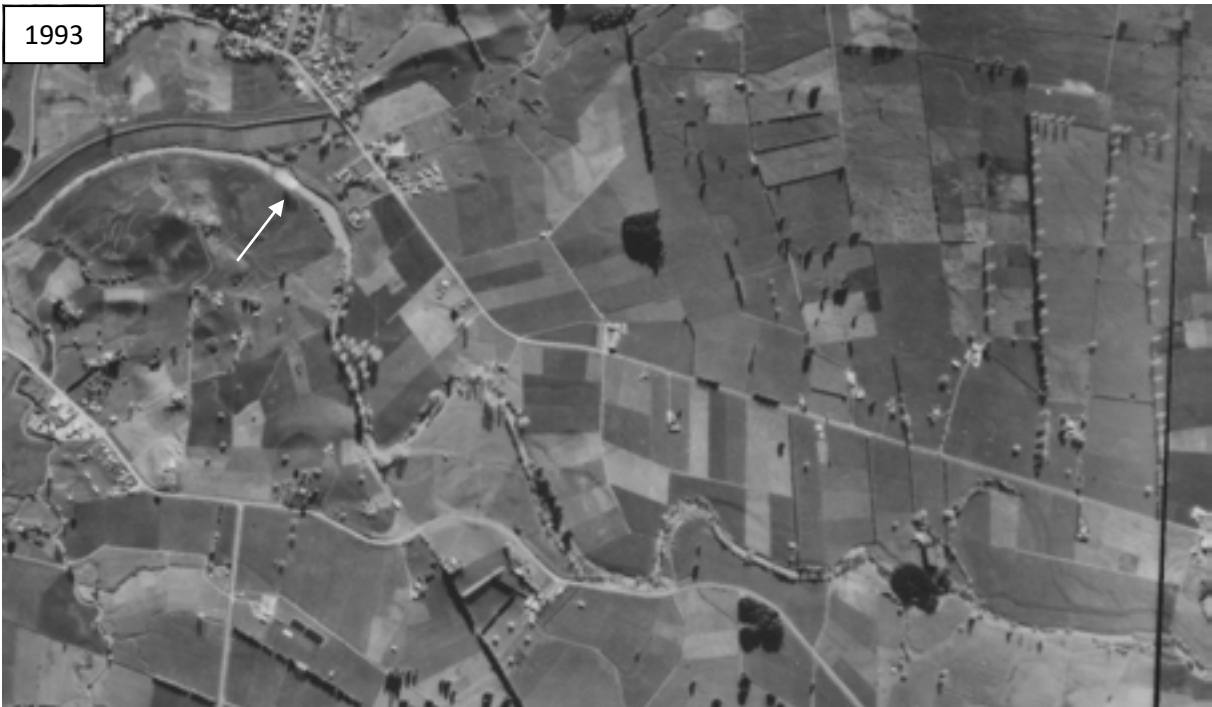
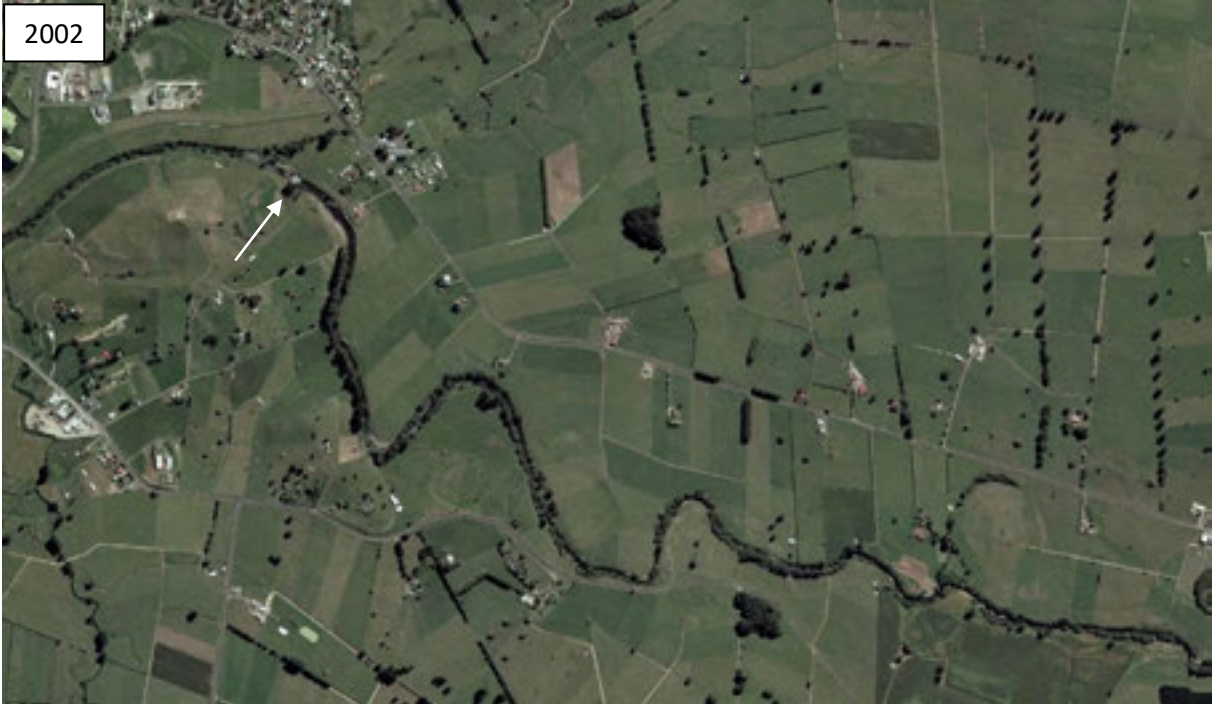
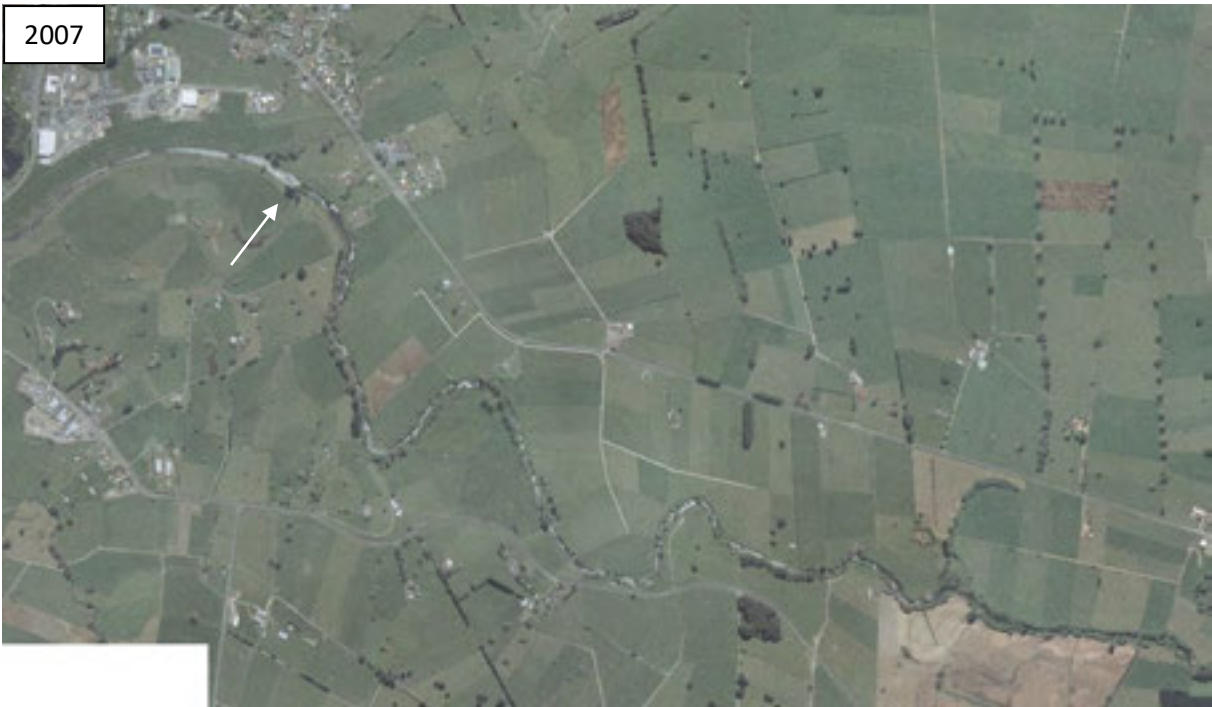
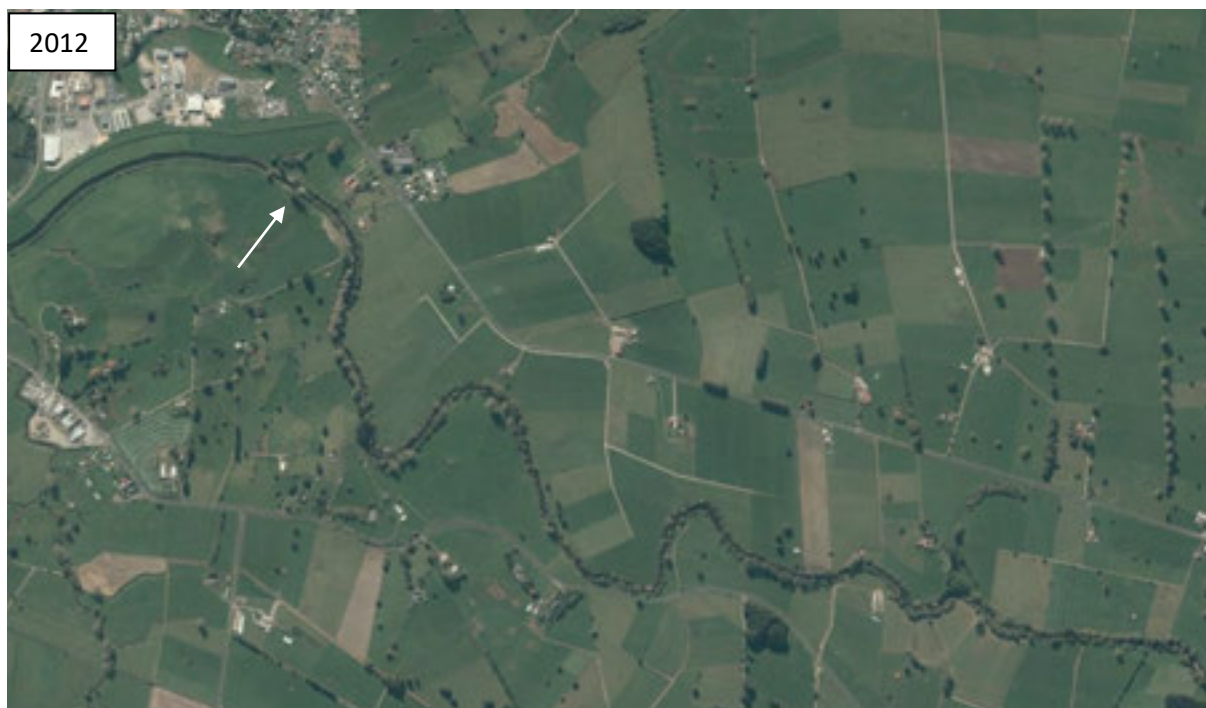
The Waipa River continues to be laterally unconfined, bordered by extensive floodplain, all the way down to Otorohanga Bridge (and beyond). This reach includes the weir adjacent to the Otorohanga water treatment plant. As evident on the aerial photographs (Figure 4-11), this reach has remained laterally stable through the study period. The only clear changes on these photographs are a small amount of erosion in the vicinity of the weir between 1983 and 1993 and perhaps tree removal and replanting in the sweeping curve between the weir and the Otorohanga Bridge. Overall, this reach has been remarkably stable.

**Figure 4-11: Aerial photographs showing changes in the bottom reach.** Note flow is from right to left. The weir is marked with a white arrow on each photograph.

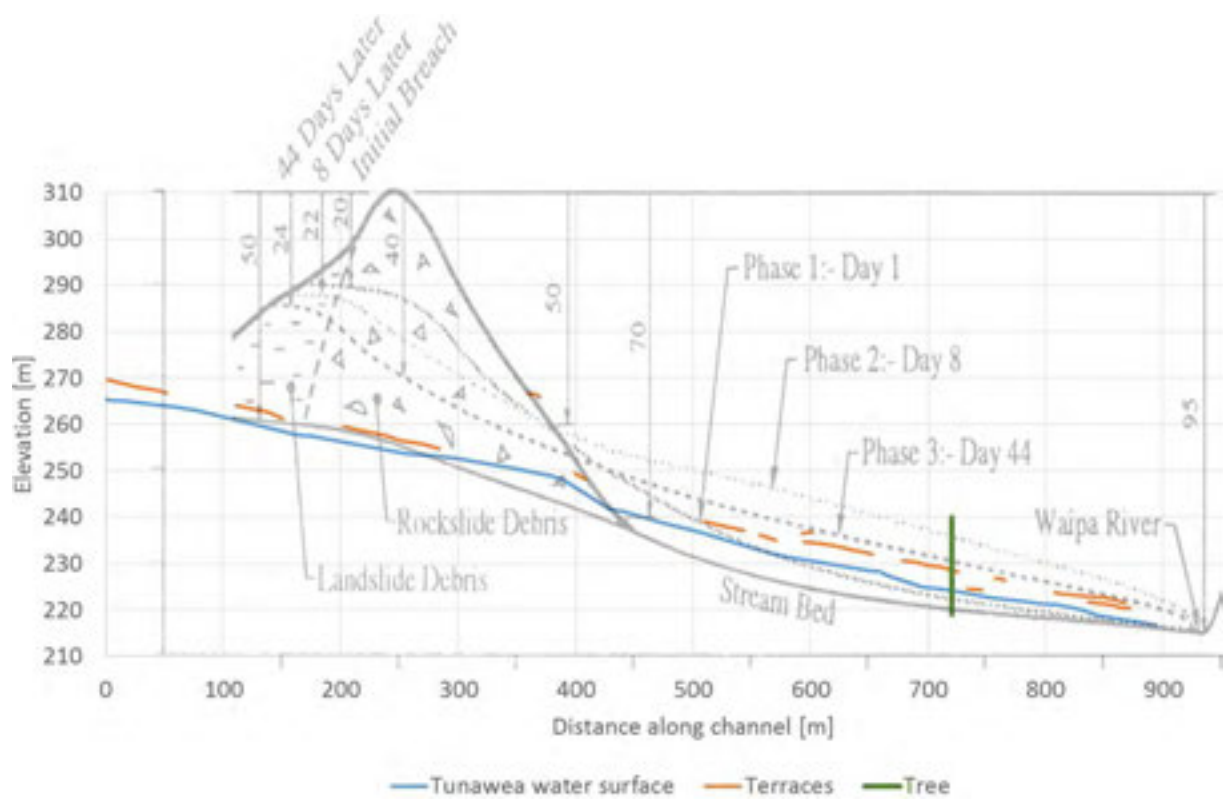
Following the 1991 landslide and subsequent dam break a number of long section profiles were surveyed of Tunawaea Stream downstream of the landslide (Riley et al. 1993). The water surface profile and the elevation of distinct river terraces were resurveyed in July 2014 and are overlaid on the original survey data in Figure 4-12. Since the final historic survey, which was done 44 days after the landslide dam failed, the channel bed has lowered approximately 8 m over much of the lower Tunawaea but is still approximately 5 m higher on average than the original pre-landslide bed elevation. River terraces surveyed in July 2014 are representative of bed levels at different stages of post dam-break river bed incision.

**Figure 4-12: Long-profile of the Tunawaea (Riley et al. 1993), overlaid with water and terrace surface profiles surveyed by NIWA.** The location and approximate size of the Kahikatea Tree described in Section 4.1.1 and shown in Figure 4-3 is also marked.

<sup>1</sup> The average re-working thickness from peak gravel build up (day 2) to surveyed 2014 water level in Figure 4-12 is approximately 15 m. However, raised terraces remain to either side of the channel and the original valley sides have been re-exposed at the edges of the gravel flats so the average thickness of the re-working is likely much less than 15 m.

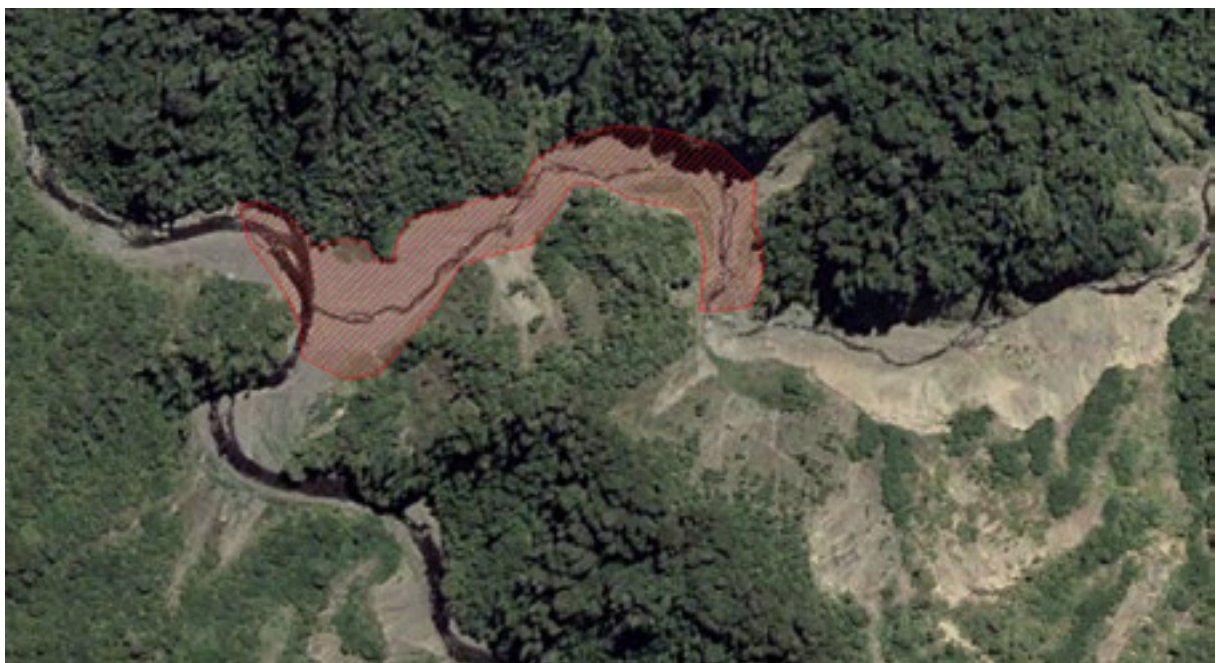
**Figure 4-13: Approximate maximum extent of gravel build up in the lower Tunawaea.** Maximum gravel extent shown hatched in red overlaid on 2002 aerial photography. Landslide site visible further upstream (right) and Waipa visible downstream (left, flowing from bottom to top).

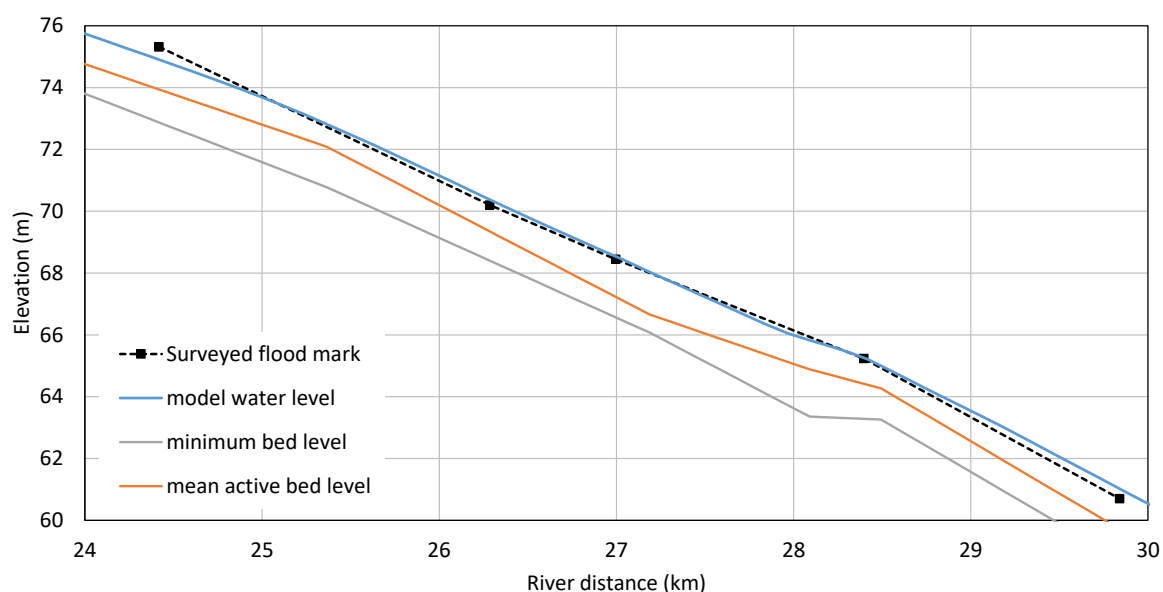
**Figure 4-15: Comparison of modelled and surveyed flood peak level 12 June 2014.**

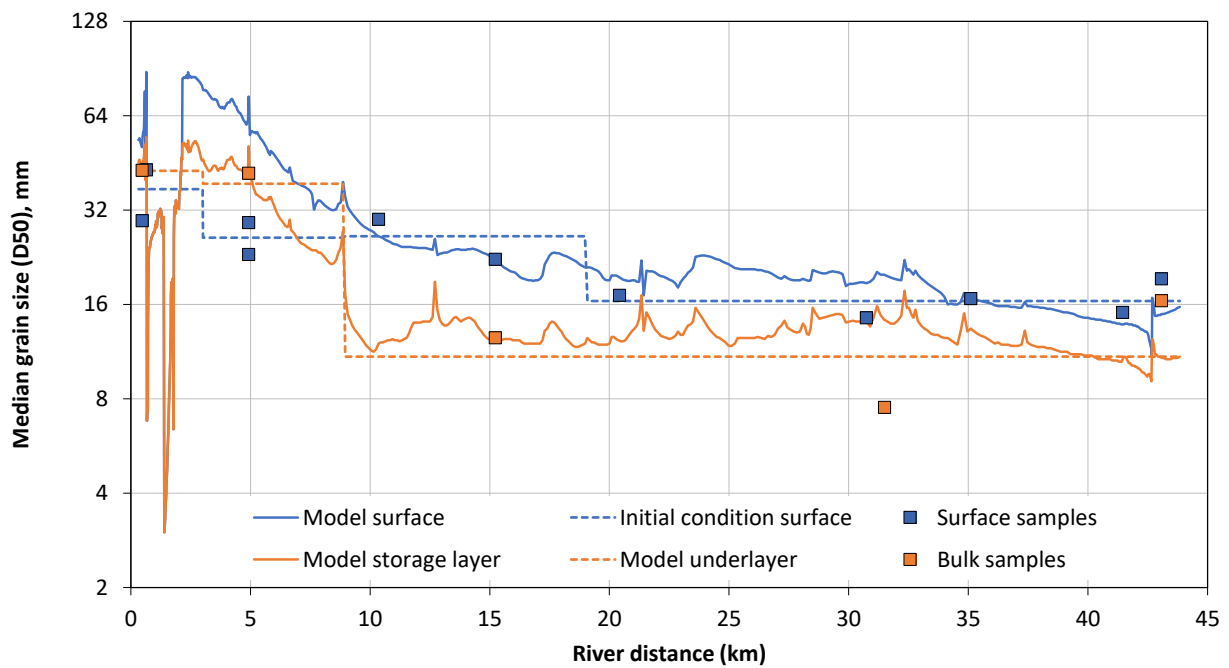
**Figure 4-17: Comparison of model and sampled surface and sub-surface sediment composition.** Model results from July 2014, coinciding with most of the sediment data collection (some surface sediment data were collected in July 2013 but model results are very consistent between 2013 and 2014).

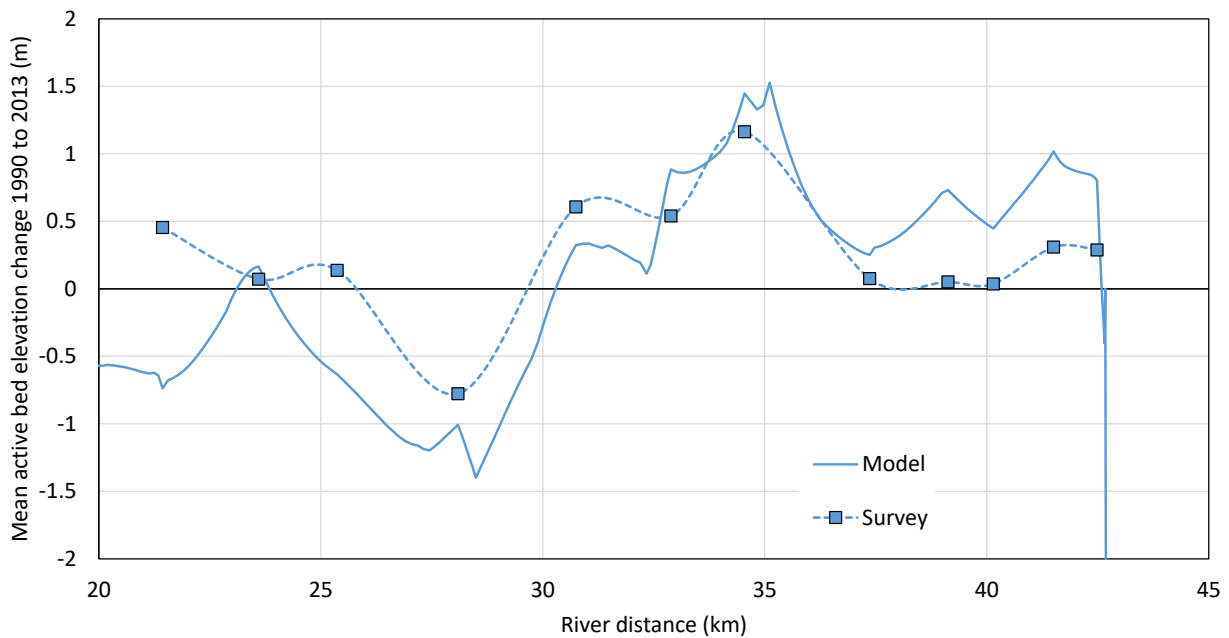
The bed level change in the model matches the patterns of surveyed change well in the lower 20 km of the model where historic data are available. The model shows slightly too much erosion in the upstream part of the reach (20 to 32 km) and slightly too much deposition in the downstream part of the reach (37 to 43 km).

**Figure 4-18: Comparison of modelled and surveyed mean active bed level change from 1990 to 2013.** Comparison is only shown for the reach from 20 km downstream as no 1990 survey data are available upstream of this point.

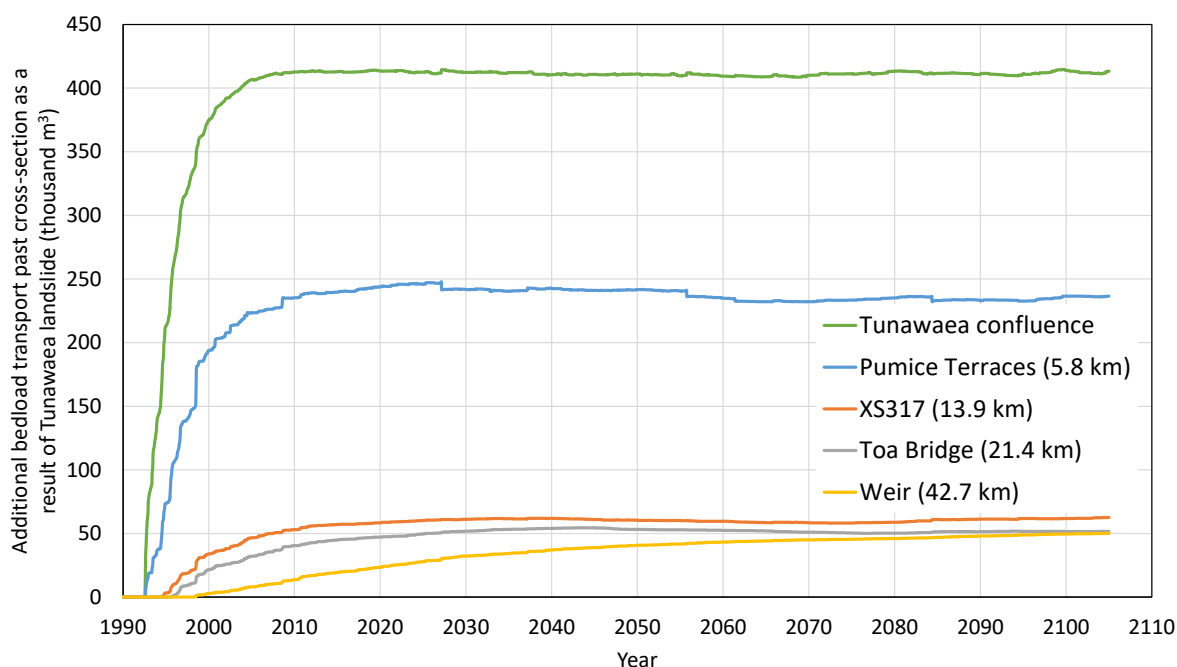
**Figure 4-19: Cumulative time-series of additional bedload transported past different locations along the Waipa as a result of the Tunawaea Landslide.** The lines show the additional volume of bed material which has been moved past each location. The slope of each line indicates the increase in bedload transport rate at a location as a result of the landslide, i.e. a steep gradient indicates where and when there is a high additional bedload and a flat gradient indicates no change in the transport rate due to the landslide.

Based on both photographic observations and modelled results, the study reach has been subject to two key morphological driving ‘events’, with the landslide effect dominating the upper 15-16 km and channel operations (straightening and extraction) dominating the lower reaches. To isolate the landslide effects we therefore looked at the increases in bedload and changes in bed levels for scenarios with and without the landslide sediment feed. By comparing simulations of the Waipa from 1993 (i.e. the year of the landslide) to 2105 with and without the effect of landslide sediment from the Tunawaea it is possible to separate out past and future change resulting from the landslide. Figure 4-19 shows the additional accumulated bedload transport in the Waipa resulting from the Tunawaea Landslide, and Figure 4-20 shows the effect on bed levels.

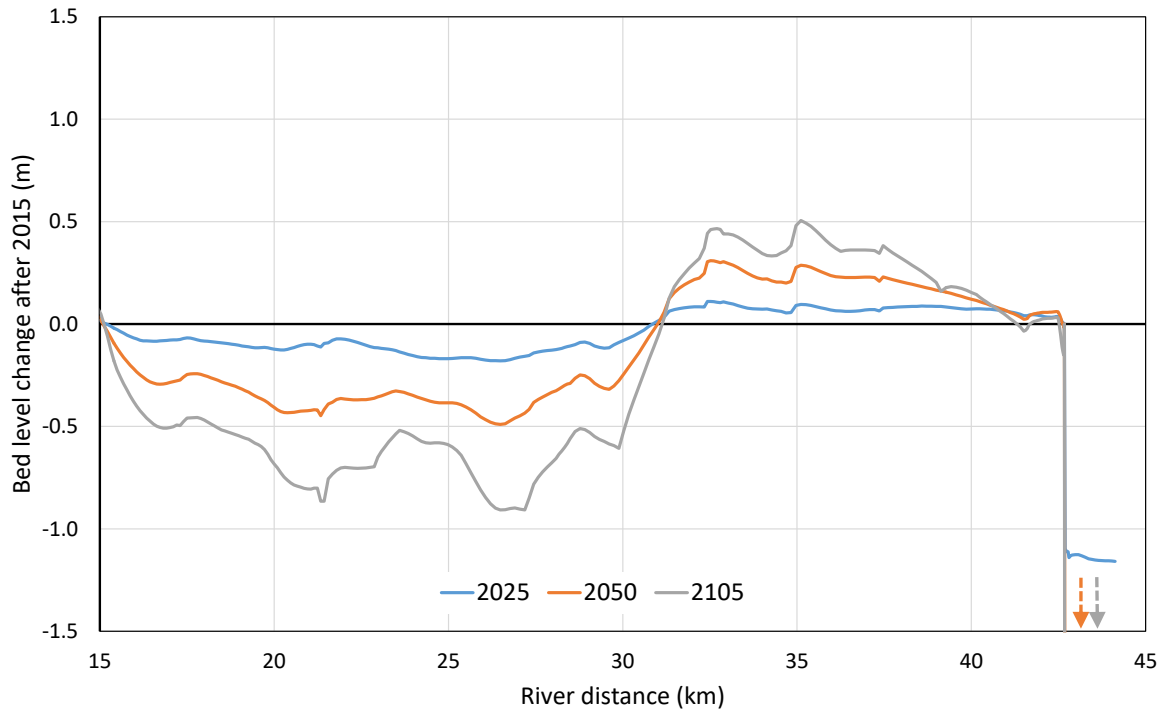
**Figure 4-21: Model predictions of future bed level change downstream of the landslide influenced reach of the Waipa.** Plot shows predicted bed level change after January 2015.

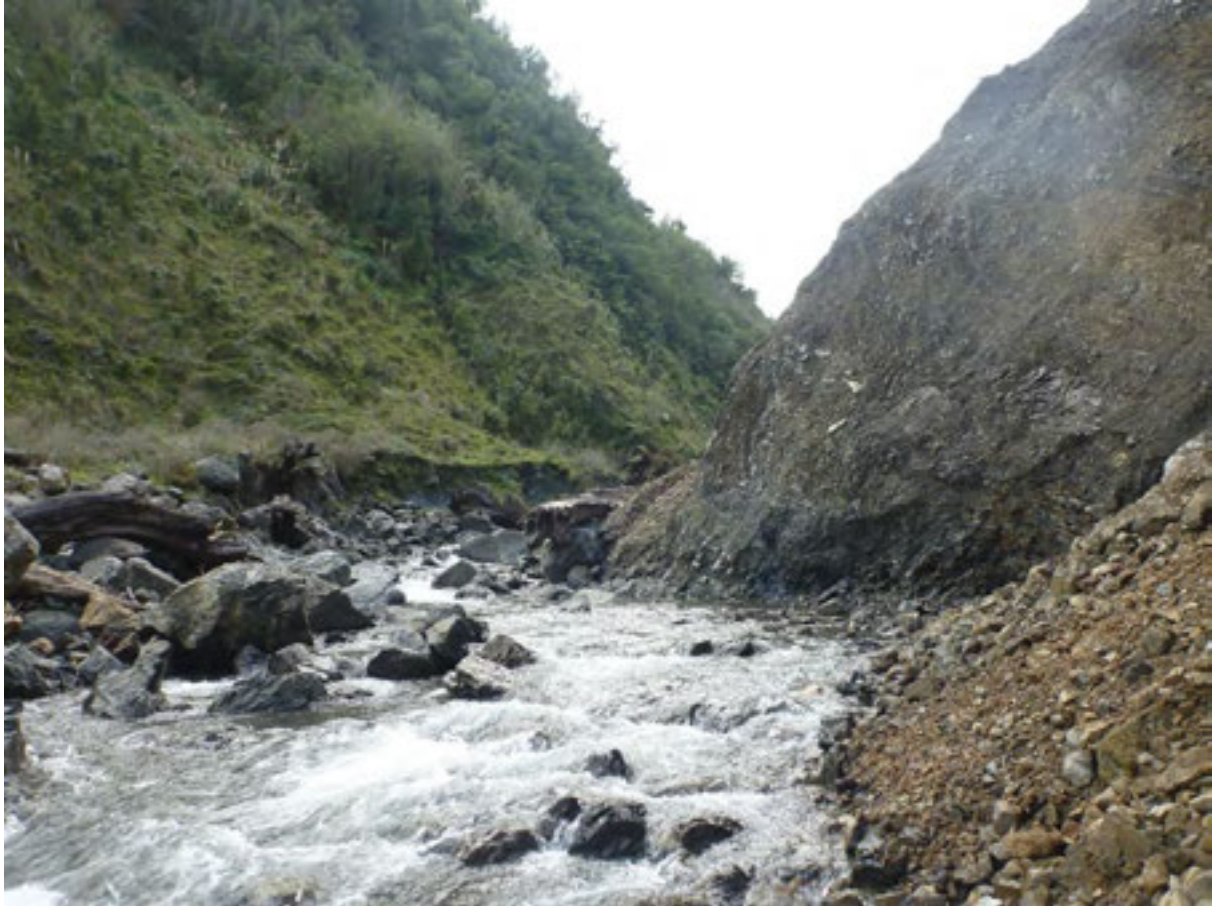
landslide deposit, steepening the slope face and increasing the likelihood of further failure. At one location the landslide toe had eroded 18 m between when an aerial photograph was taken in April 2012 (Google Earth) and our survey in July 2014. Figure 5-1 shows a photograph of active bank erosion steepening the toe of the landslide deposit.

**Figure 5-1: Active bank erosion at the toe of Tunawaea Landslide, July 2014.** Photograph looking upstream on the Tunawaea Stream approximately 750m from the Waipa confluence.
