# SECTION I

# INTRODUCTION

This report summarises the Environment Waikato technical report *Coromandel Beaches: Coastal Hazards and Development Setback Recommendations*. The key objectives and content of the full report include:

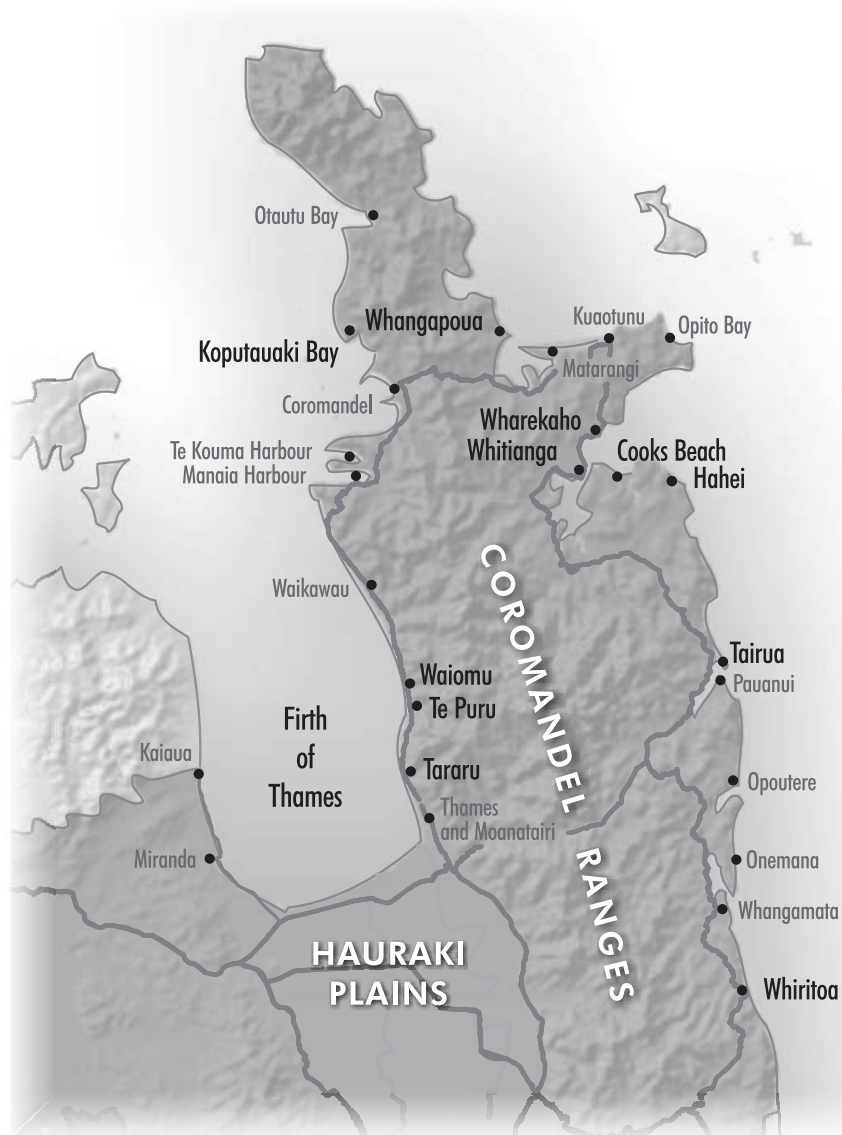
**Figure 2:** Coromandel Peninsula coastline and the location of main settlements. The settlement names are marked in larger text where an existing threat from coastal erosion has been identified to development or important cultural sites

A recent review of coastal erosion and flooding in the Waikato Region identified a large number of settlements on the Coromandel where buildings or private properties are vulnerable to coastal erosion or flooding (see *Figure 2*). These problems could get worse over the next 50 to 100 years because of:

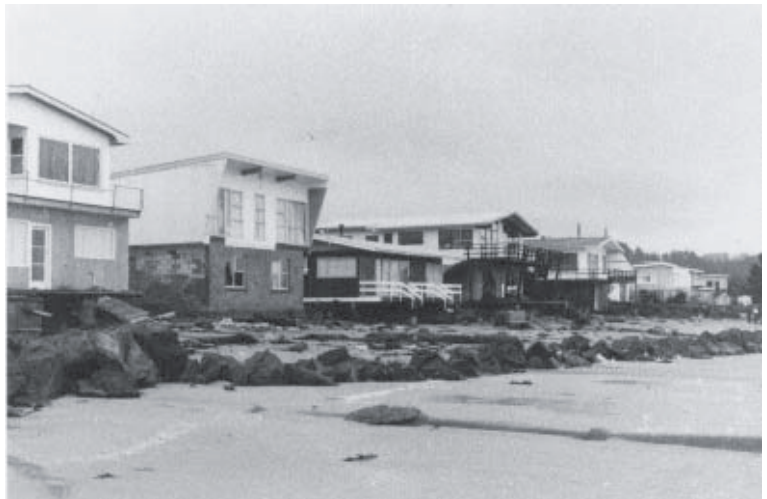
**Figure 3:** Cooks Beach after a major storm in 1978.

The crucial role of natural dunes in protecting properties from coastal hazards was not well recognised, and many dunes were bulldozed to improve sea views, leaving very little land between the sea and beachfront development (see Figure 1). Native sand binding plants that help the dunes to rebuild after a storm were replaced with lawns and exotic ornamental plants. Soon after coastal development began it became clear that in a number of new subdivisions there was not enough dune reserve remaining in the front of properties. For example, in 1978, storms threatened many properties along the Coromandel Peninsula (Figures 3 and 4).

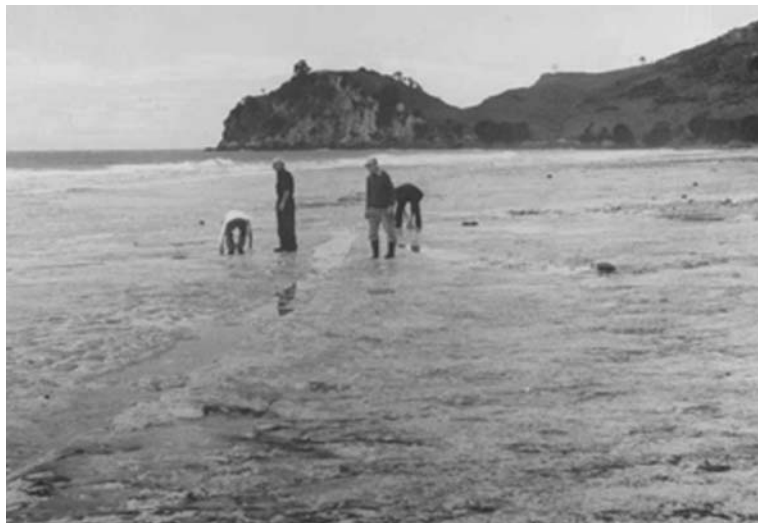
**Figure 4:** Hahei Beach has only small sand reserves, just a layer of sand over harder surfaces. In 1978, all this sand was washed from the beach, exposing the hard layers underneath. During calmer periods, waves and currents work the sand back to create the sandy beach.

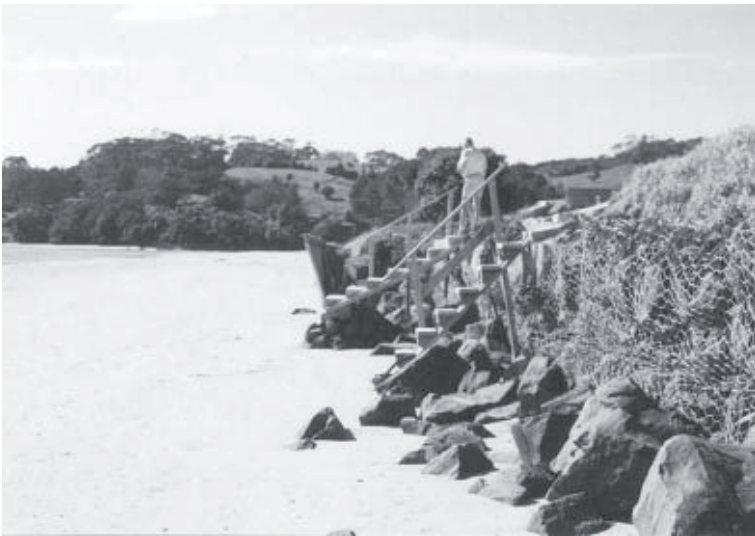
**Figure 5:** Coastal structures at Cooks Beach, 2001. The structures degrade the appearance of the beach, and the beach level has dropped in front of the structure, restricting public access to and along the beach.

When houses and roads are threatened by coastal erosion, coastal armouring structures (e.g. seawalls) are often built in an attempt to halt erosion. Many of these structures affect the appearance of the beach, affect public safety and restrict public access to and along the beach (Figure 5). During times of erosion, the level of the beach drops in front of a seawall, so that there is no dry beach left at high tide.
