Geothermal features annual monitoring report – June 2021

August 2021

Document #: 21036557

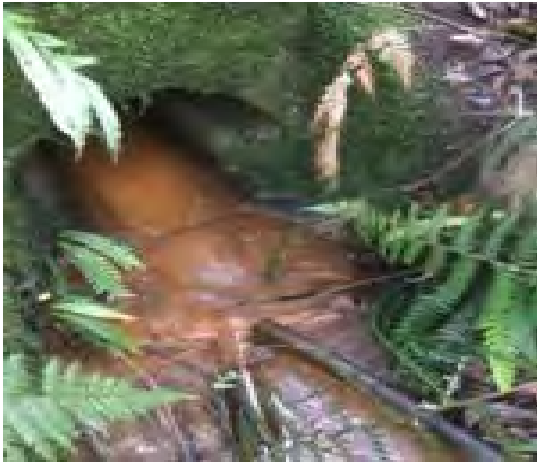
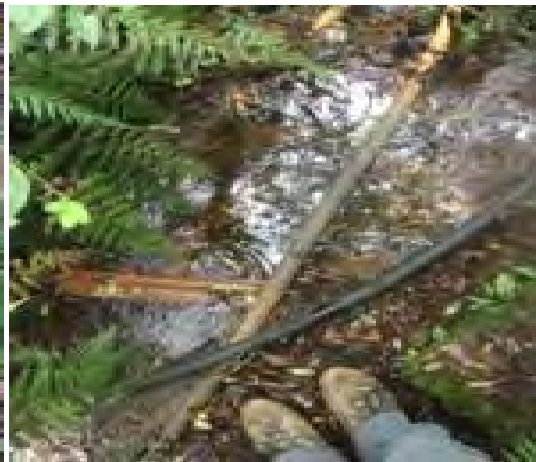
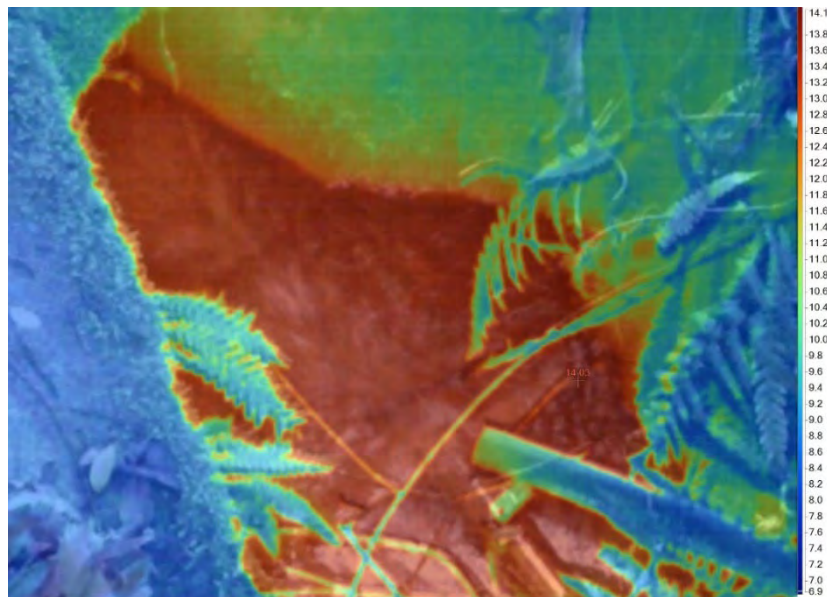
- A small feature appearing more similar to a culvert than a natural spring due to anthropogenic modifications to the feature. The feature is distinguishable from nearby water bodies by orange staining in the flow area.
- This feature has insufficient data continuity for long-term trend comparisons.

Date	pH	Temp °C	Level (m)	Flow (l/s)	Clarity	Colour	Ebullition
2018/02/08	7.6	22.1		<2.0	Clear	Colourless	nd
Comments	<i>Water temperature:</i> Transferred from Fulcrum <i>Water level:</i> Overflowing

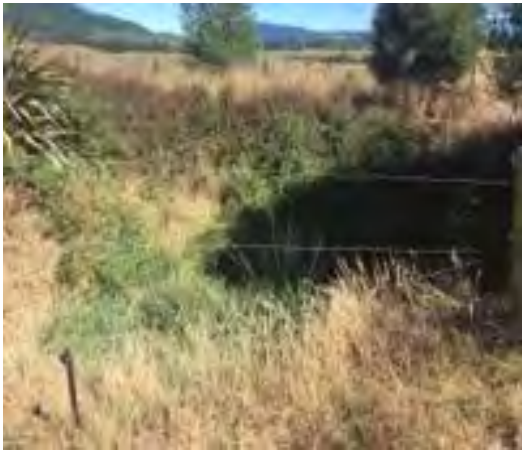
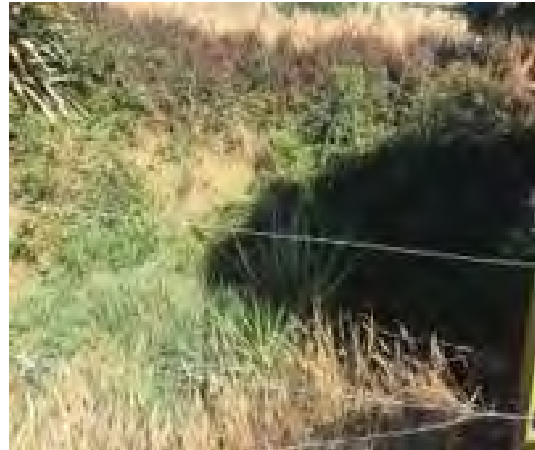
Date	pH	Temp °C	Level (m)	Flow (l/s)	Clarity	Colour	Ebullition
2019/01/14		14.0					
2020/02/25		25.0					
Comments	No activity, ground collapsing at southeast side.

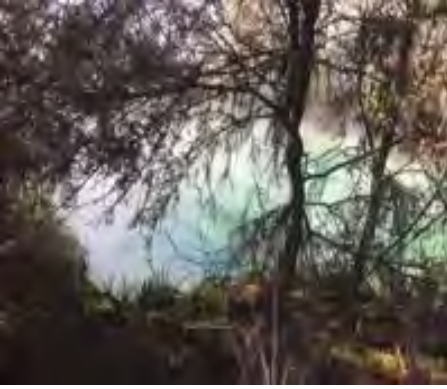
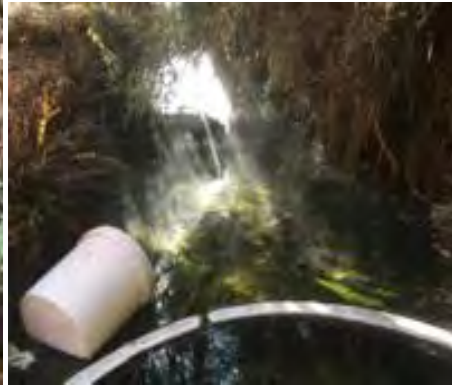
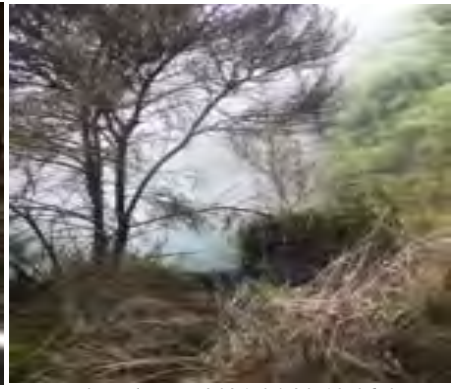
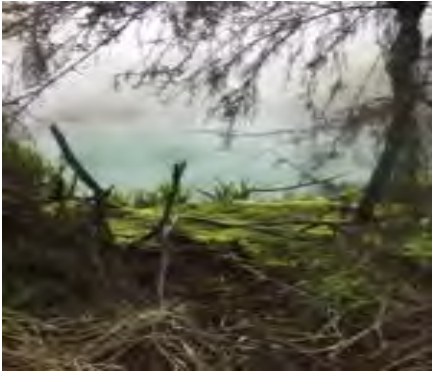
Date	pH	Temp °C	Level (m)	Flow (l/s)	Clarity	Colour	Ebullition
2015/05/08	8.0	65.8		<0.5	Cloudy	Blue/green	Upwelling at outlet
Comments	Surging Water level: Overflowing						
2016/01/18	7.5	64.2		<0.5	Cloudy	Green/blue	Constant upwelling at outlet
Comments	Water level: Overflowing						
2017/01/20	7.5	50.5		<0.5	Clear	Blue	Audible bubbling
Comments	Ebullition: Too steamy to see the pool						
2018/02/08	7.0	60.4		<0.5	Cloudy	Green - Light	Upwelling at outlet
Comments	pH: Temp 49.4 Water level: Overflowing						
2019/01/14	7.0	52.0		<0.5	Cloudy	Blue - Green	Audible bubbles
Comments	Water level: Overflowing Ebullition: Raining difficult to see						
2020/02/25	7.9	60.4		<0.5	Clear	Green	Steaming, cannot see pool to see ebullition.
2021/04/29	7.0	50.8	0	<5.0	Clear	Colourless	Only audible
Comments	Sampled from outflow due to barbed wires, where algal communities are observed. Ebullition cannot be visually observed due lack of access and steam discharge blocking line of view.

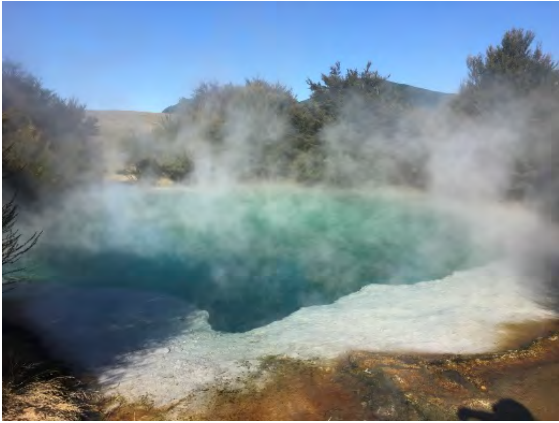
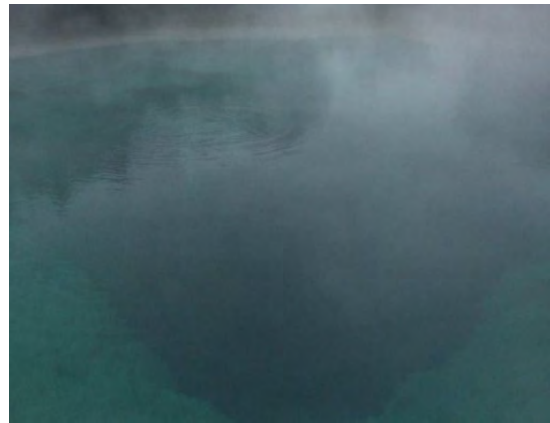
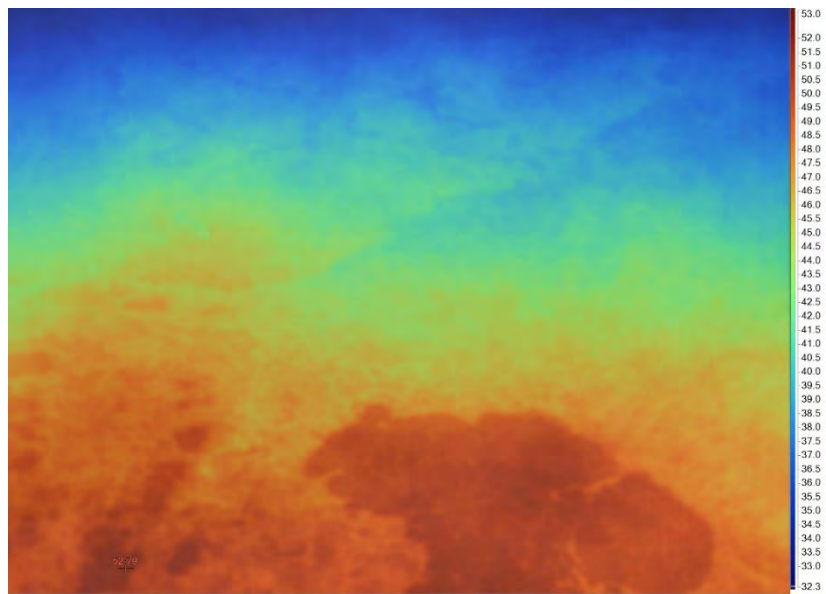
- Large circular pool ~15 m in diameter, also known as the Scalding Pool.
- This pool previously had a shallow discharge channel dug when it was on private forestry land. In the mid 1990s the land surrounding the two Whangapoa Pools was given to the NZ Government and designated Scientific Reserve under the management of the Department of Conservation. DOC restored the natural water level, removed pipes and pine trunks from the pool and sinter outflow terrace, and planted native vegetation on the surrounding land.
- Temperature and pH conditions remain stable between 2005 to 2021.

Date	pH	Temp °C	Level (m)	Flow (l/s)	Clarity	Colour	Ebullition
2015/05/08	8.0	61.3		<0.5	Clear	Blue	Upwelling in centre
Comments	<i>Water level: Overflowing</i>						
2016/01/18	8.0	65.3		<0.5	Clear	Blue/Aqua	Upwelling
Comments	<i>Water level: Overflowing</i>						
2017/01/20	7.0	64.8		<0.5	Clear	Turquoise	Upwelling in centre
2018/02/08	6.5	59.3		<0.5	Clear	Turquoise	Upwelling in centre
Comments	<i>Water level: Overflowing</i>						
2019/01/14	7.5	64.3		<0.5	Clear	Blue	Constant upwelling in centre
Comments	<i>Water level: Overflowing</i>						
2020/02/25	8.0	66.7		<0.5	Clear	Green - Blue	Constant upwelling
2021/04/29	7.0	57.0	0	<5.0	Clear	Colourless	Constant ebullition from a single point
Comments	Noodles of sinter near outflow. Suspended silica fragments in water, sinter layers are very weak. Some fresh silica deposited on pool rim, but very thin layers only.

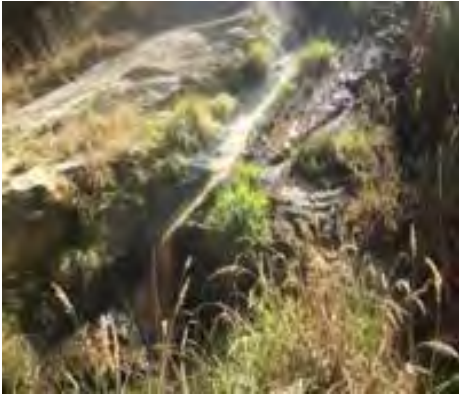
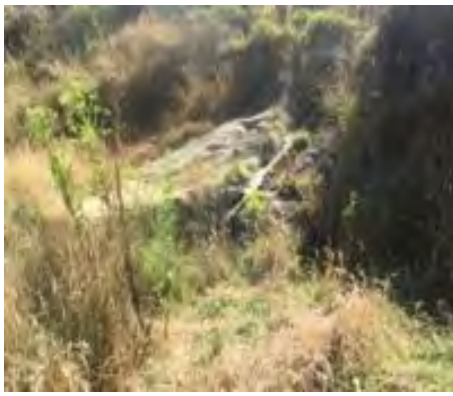
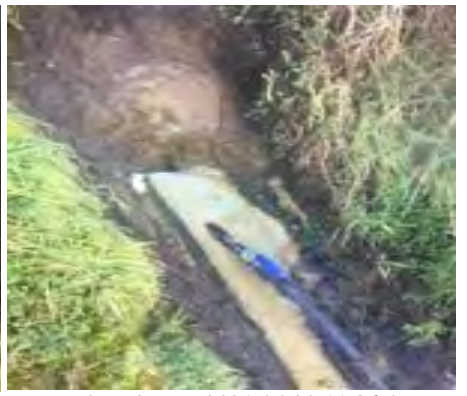
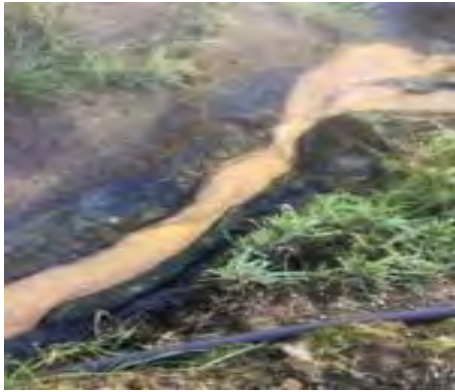
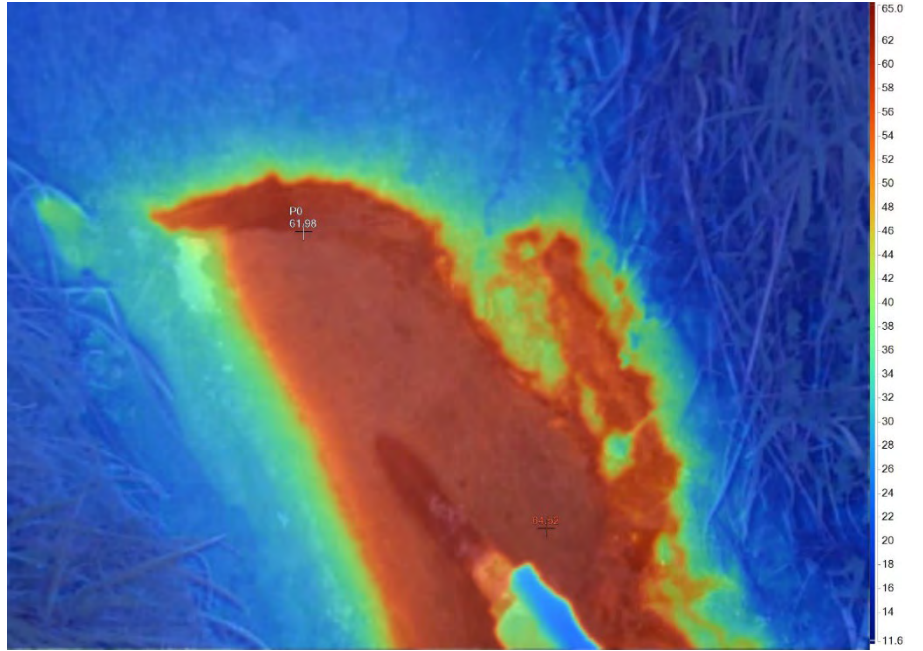
- A feature springing from a fracture in an ignimbrite block, cascading down as a small waterfall.
- Temperature decreased significantly between 2007 to 2016, accompanied with a minor pH decrease. By 2020, both properties recovered to 2005 levels.
- In recent years a landslide on the ignimbrite face substantially altered the spring and outflow characteristics.
- The landowner channels some of the flow to a private spa pool.

Date	pH	Temp °C	Level (m)	Flow (l/s)	Clarity	Colour	Ebullition
2015/05/08	6.5	52.4		<2.0	Clear	Clear	nd
Comments	<i>Water level: Overflowing</i>						
2016/01/18	7.0	58.0		<0.5	Clear	Clear	nd
Comments	<i>Water level: Overflowing</i>						
2017/01/20	6.0	40.0		<0.5	Clear	Clear	nd
2018/02/08	5.5	42.5		<0.5	Clear	Colourless	nd
Comments	Looks like there has been a flood or a slip, area has changed. <i>Water level: Overflowing</i>						
2019/01/14	6.5	60.1		<0.5	Clear	Colourless	nd
Comments	<i>Water level: Overflowing</i>						
2020/02/25	7.9	67.6		<0.5	Clear	Colourless	nd
2021/04/29	7.0	66.8	0	<5	Clear	Colourless	Nd, flowing like a stream
Comments	Algal growth observed.

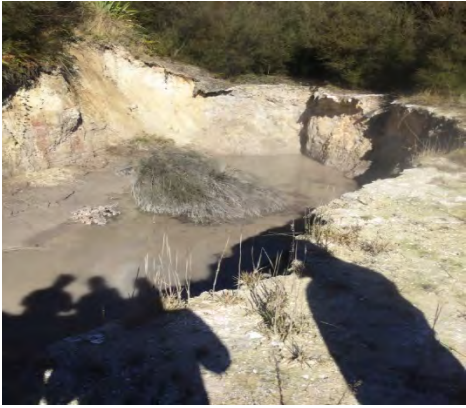
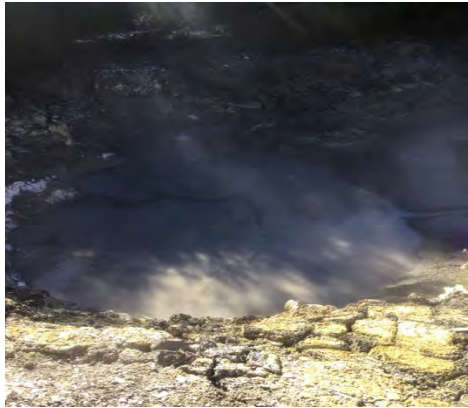
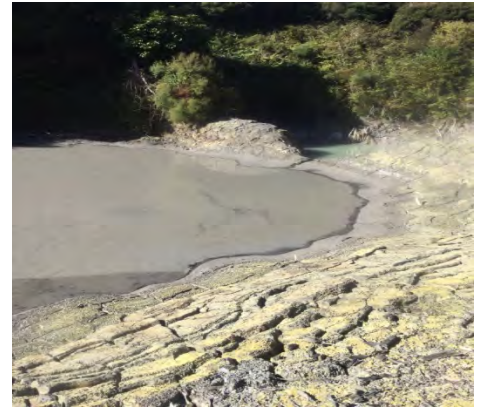
Date	pH	Temp °C	Level (m)	Flow (l/s)	Clarity	Colour	Ebullition
2007/04/01				None	nd	nd	nd
Comments	Two mud pools located at site. E2763448 N6295832. <i>Water level: nd</i>						
2008/01/01		64.4	2.0	None	Muddy	Grey	nd
Comments	Surrounding weeds flattened and covered in mud. <i>Water level: Below surface</i>						
2009/02/01		47.5		None	nd	Grey	nd
Comments	Pool is overflowing. Area of steaming ground and burnt vegetation beside the pool. <i>Water level: nd</i>						
2010/06/14		7.0	66.0	None	Murky	Brown	Calm
Comments	Water level covering ground between the pools in a 0.6 m wide channel. <i>Water level: Overflowing</i>						
2010/06/14		6.1	41.0	<2.0	Murky	Brown	Calm
Comments	Water level covering ground between the pools in a 0.6 m wide channel. <i>Water level: Overflowing</i>						
2011/07/24		63.0	1.5	>0.5	Murky	Brown	Calm
Comments	<i>Water level: Below rim</i>						
2021/04/29		62.3	0.3	Nd	Muddy	Brown – Light	Constant on multiple spots.

Comments	Floating black raft structures similar to bacterial mats or sulphur globules observed. Small pool flows into the larger pool and has stronger ebullition. <i>Water Level: Has been decreasing, lowest ever observed by Richard Setters (Steam field coordinator, Mercury)</i>

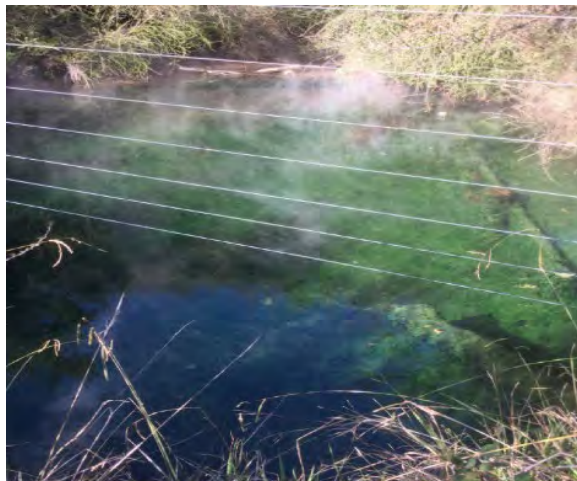
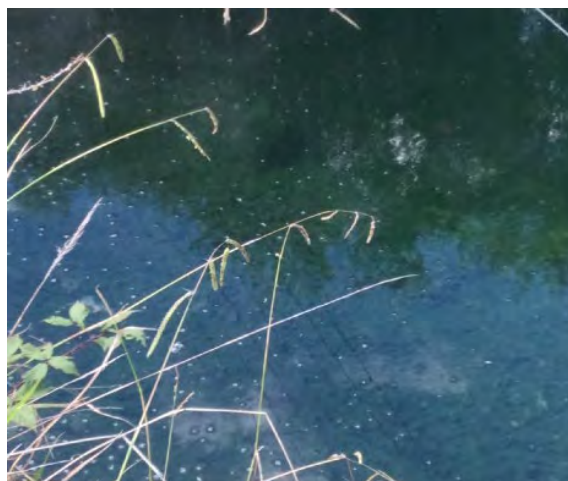
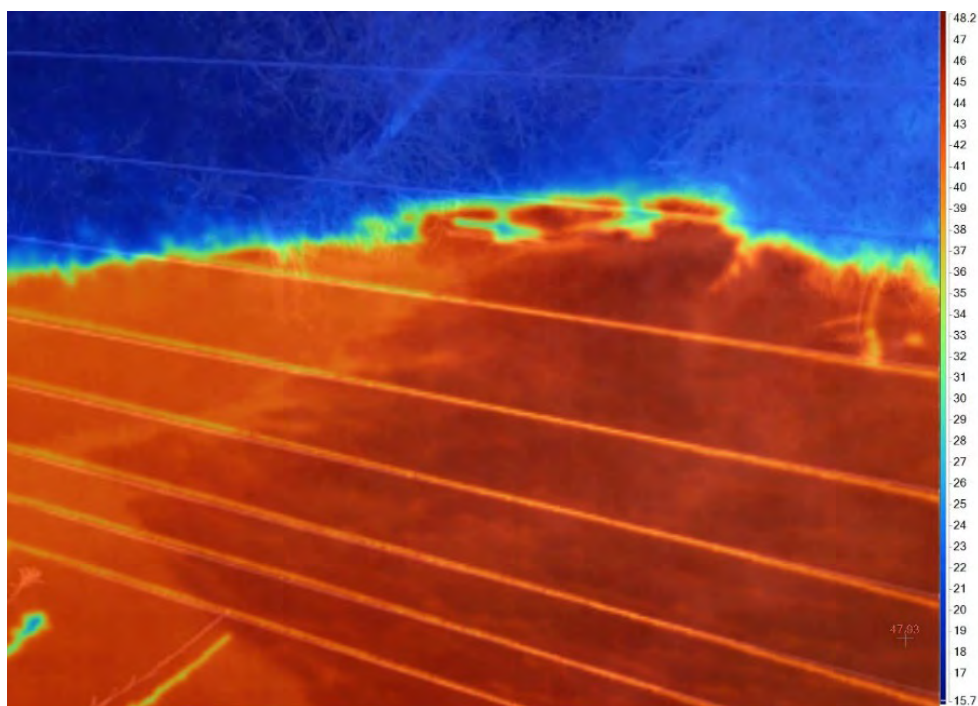
Date	pH	Temp °C	Level (m)	Flow (l/s)	Clarity	Colour	Ebullition
2018/02/08	3.1	51.6		<1.0	Clear	Colourless	nd
Comments	Bath house torn down. Now just a pool. Water level: Overflowing						
2021/04/29	6.0	47.9			Clear	Colourless	Nd, bubbly surface
Comments	Water surface is covered by numerous gas bubbles.

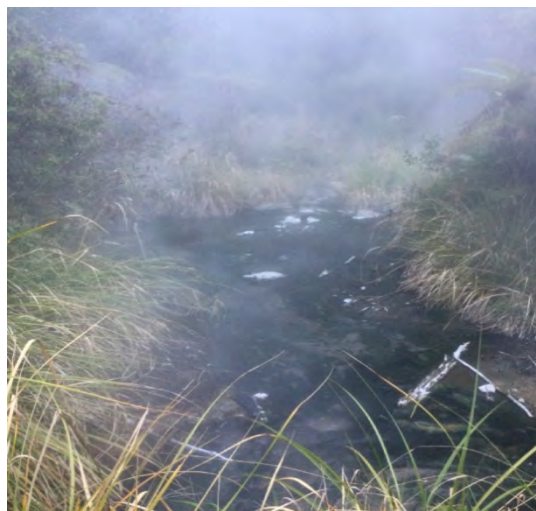
Fig.1- taken on 2021-04-29

Date	pH	Temp °C	Level (m)	Flow (l/s)	Clarity	Colour	Ebullition
2018/02/08	5.5	56.2		None	Clear	Colourless	nd
Comments	Thick blackberry all the way to site. Cannot see wooden fence from road. <i>Water level: nd</i>						
2021/04/29	7.3	60.8		<10.0	Clear	Colourless	
Comments	Minor sinter deposition on stream margins

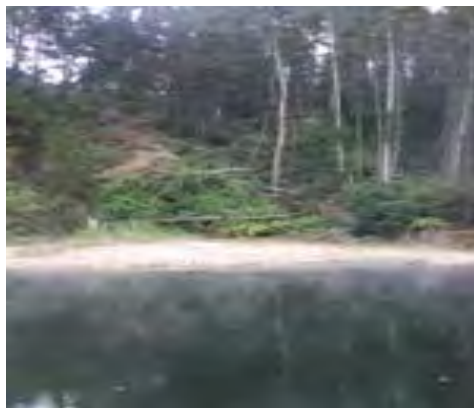
Fig.7 - taken on 2021-04-30 12:43:42"

6.0	51.0	0.3	>10.0	Cloudy	Green – Murky	Constant low ebullition
Comments	The sediment apron has become permanent. Increased pH since last monitoring trip.

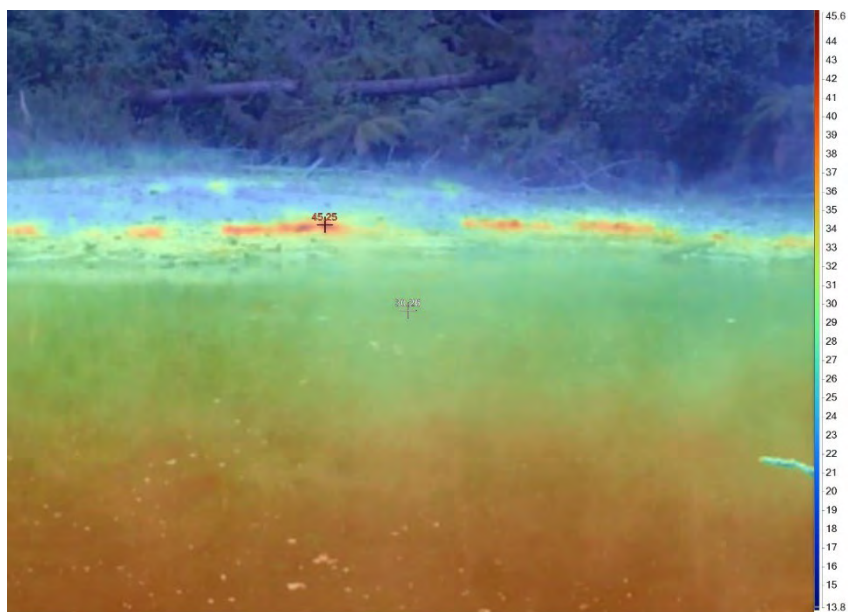
Fig. 8 Infrared image of the distal part of the hydrothermal eruption crater. Taken on 2021-04-30.

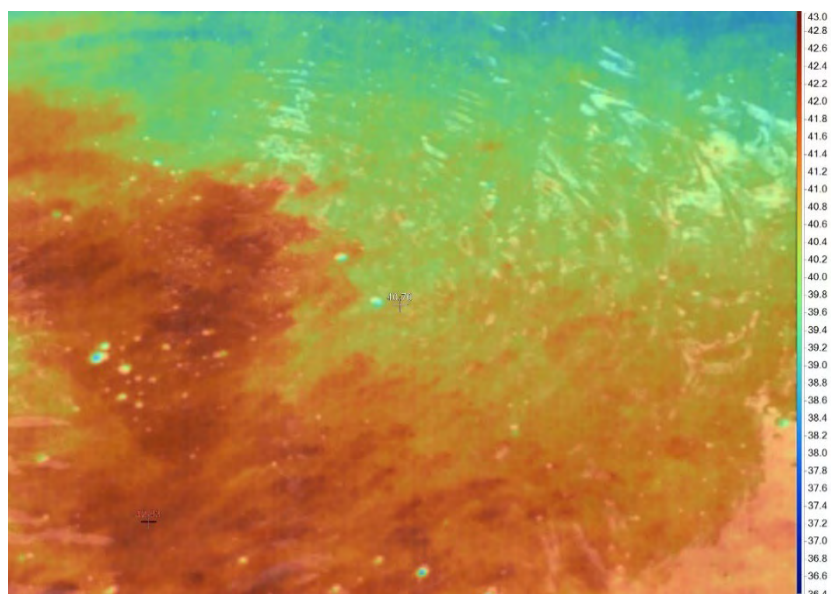
Fig. 9 Infrared image of the proximal part of the hydrothermal eruption crater. Taken on 2021-04-30.

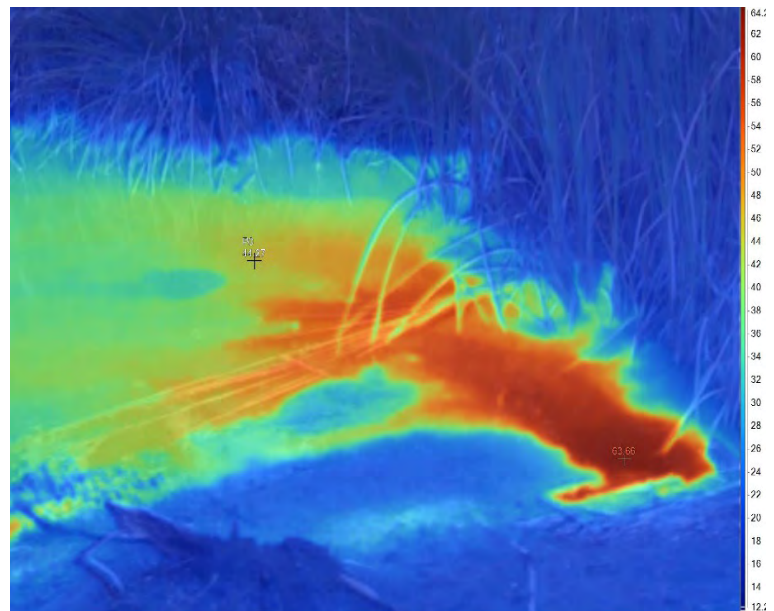
Fig. 8 Infrared image of the Biodiversity Pool. Taken on 2021-04-30.

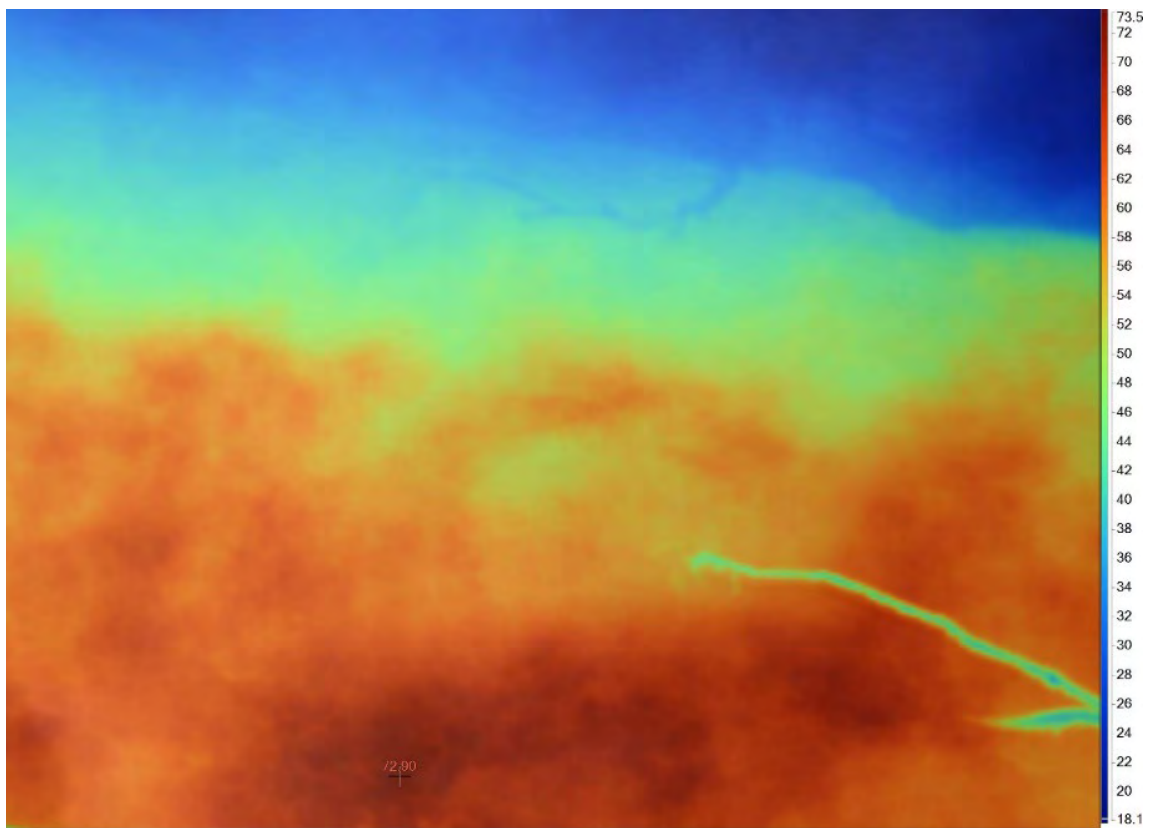
2021/04/30	7.0	77.8	0		Clear	Colourless	Constant weak ebullition from single part of the pool.
Comments	Pool no longer overflowing as observed on Dec 2020. Recent sinter deposits are damaged and algal communities are gone. Areas of increased temperatures around pool now cool.

Fig. 1 Infrared image of Map of Australia. Taken on 2021-03-26.

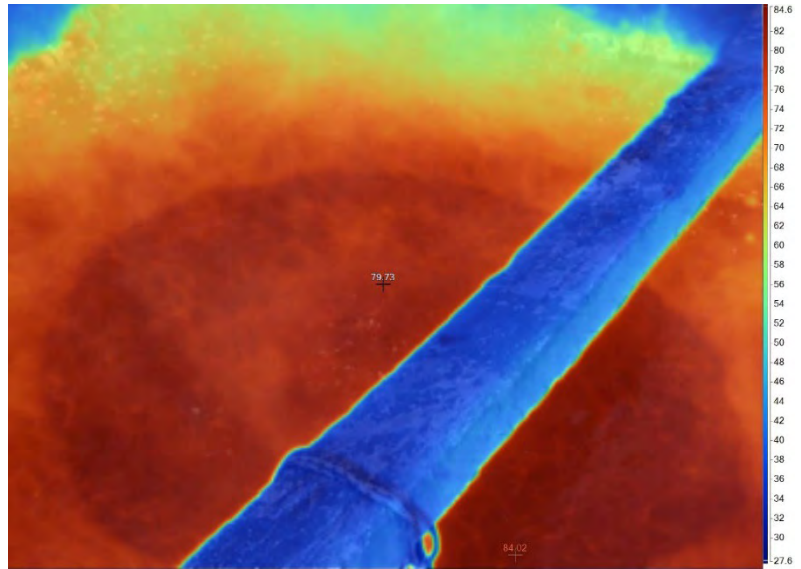
Fig 5. Infrared image of OKF26. Taken on 04-12-2020.

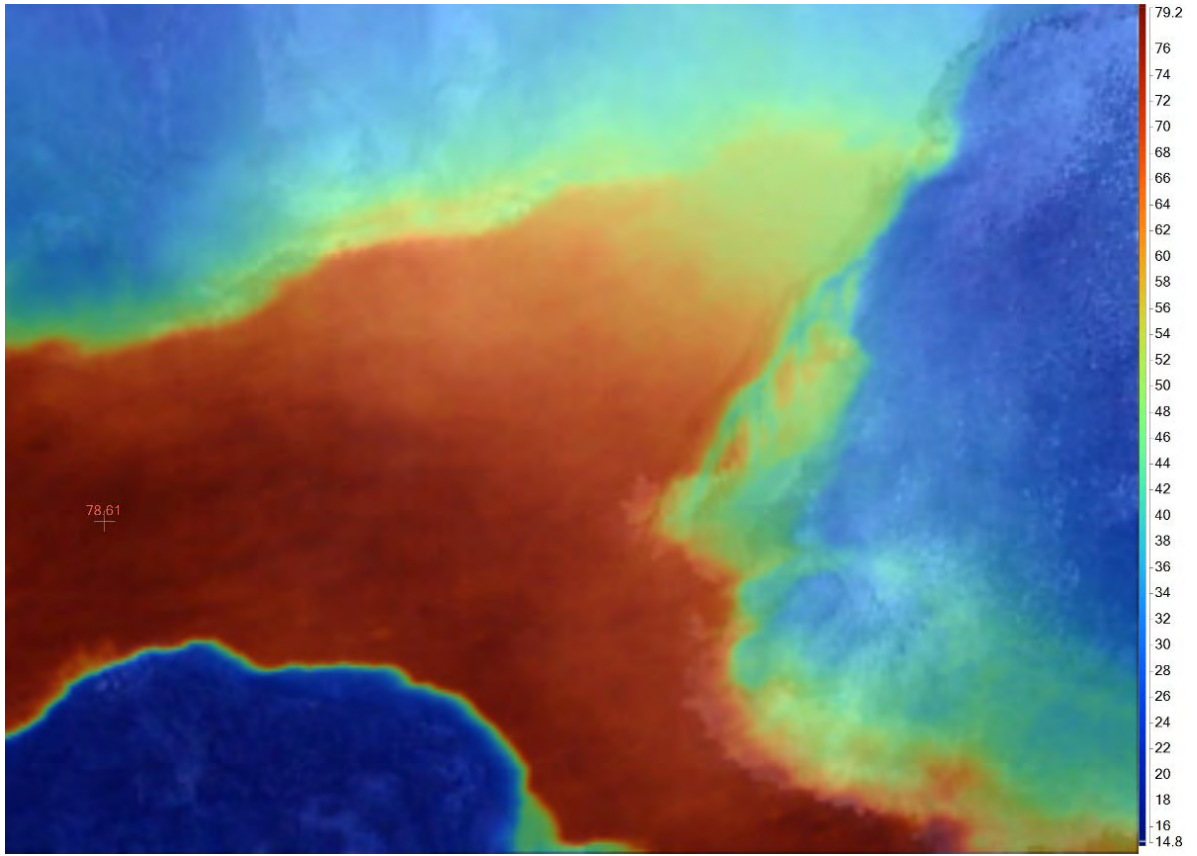
Fig. 9 Infrared image of Diamond Geyser. Taken on 2021-03-26.

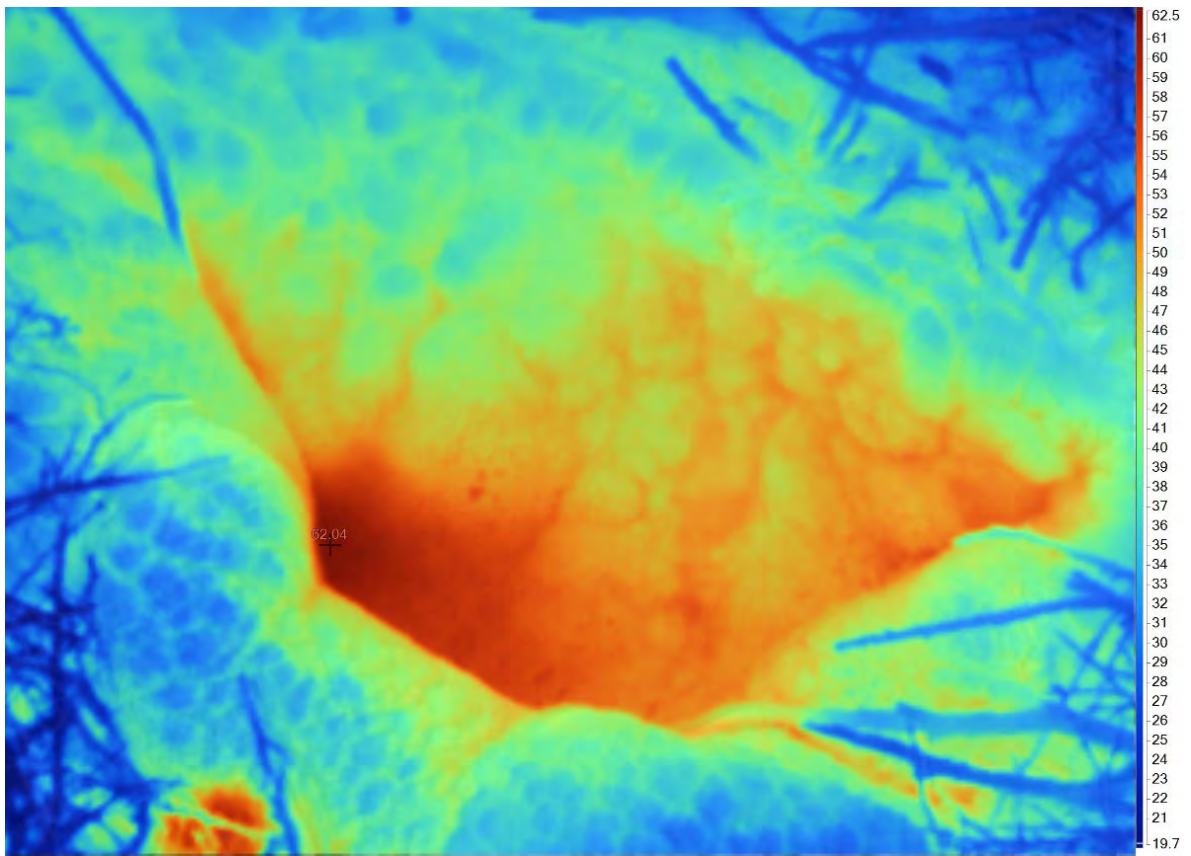
Fig. 9 Infrared image of Bush Geyser. Taken on 2021-03-26

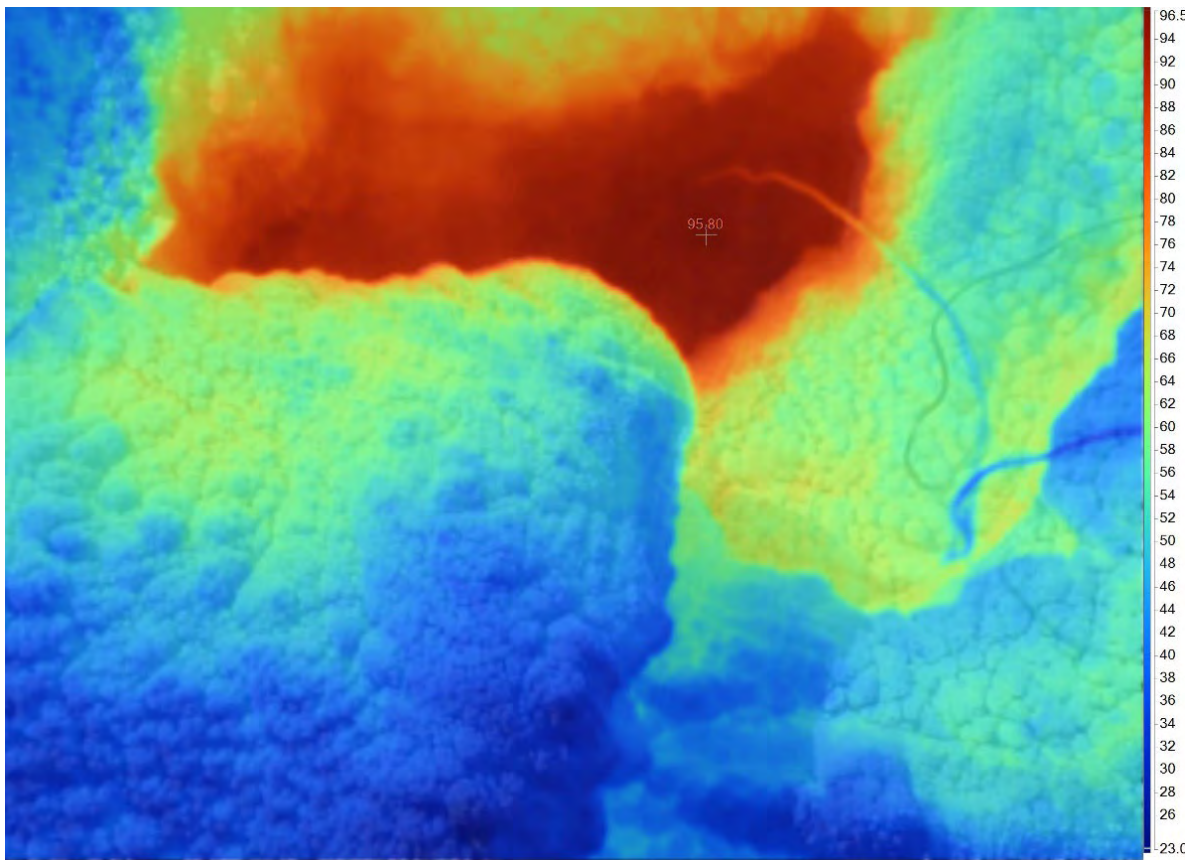
Fig.6 Infrared image of Sapphire Geysers. Taken on 2021-03-26.

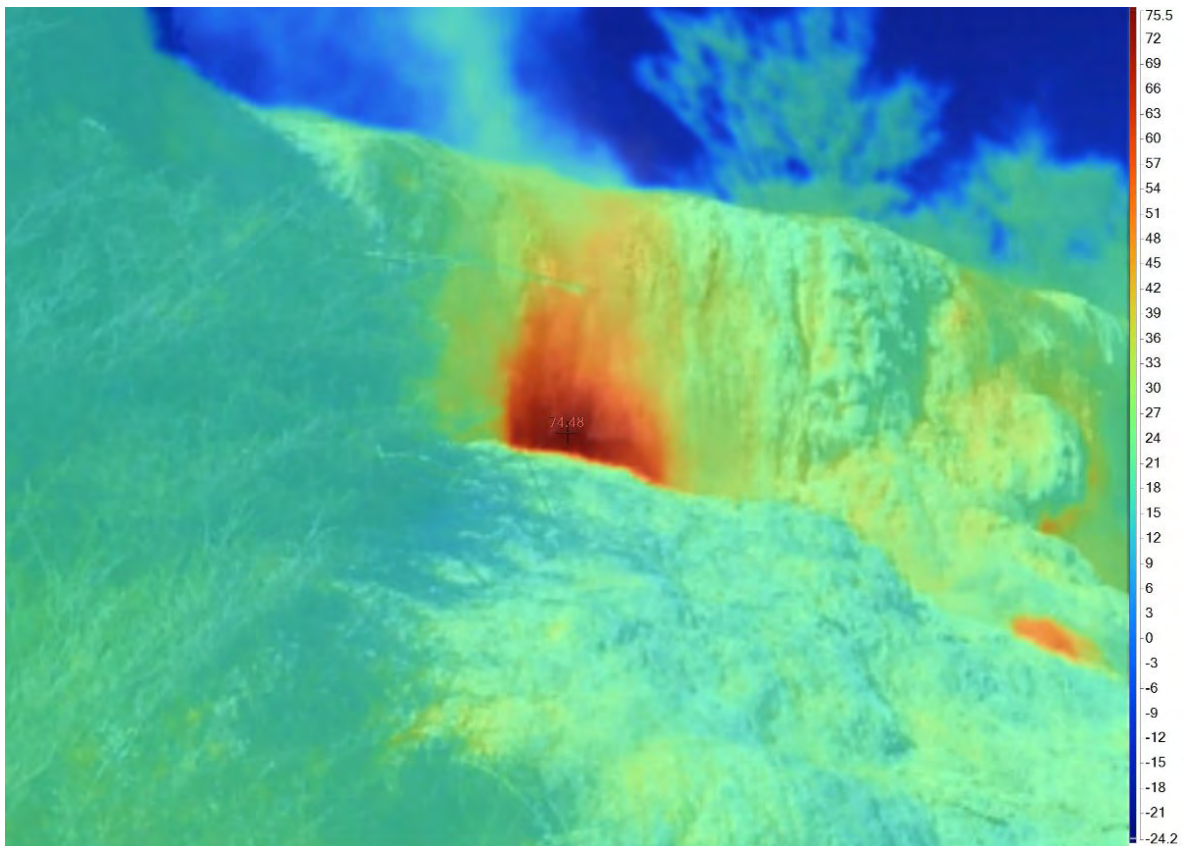
Fig. 10 Infrared image of Cascade Geyser. Taken on 2021-03-26.

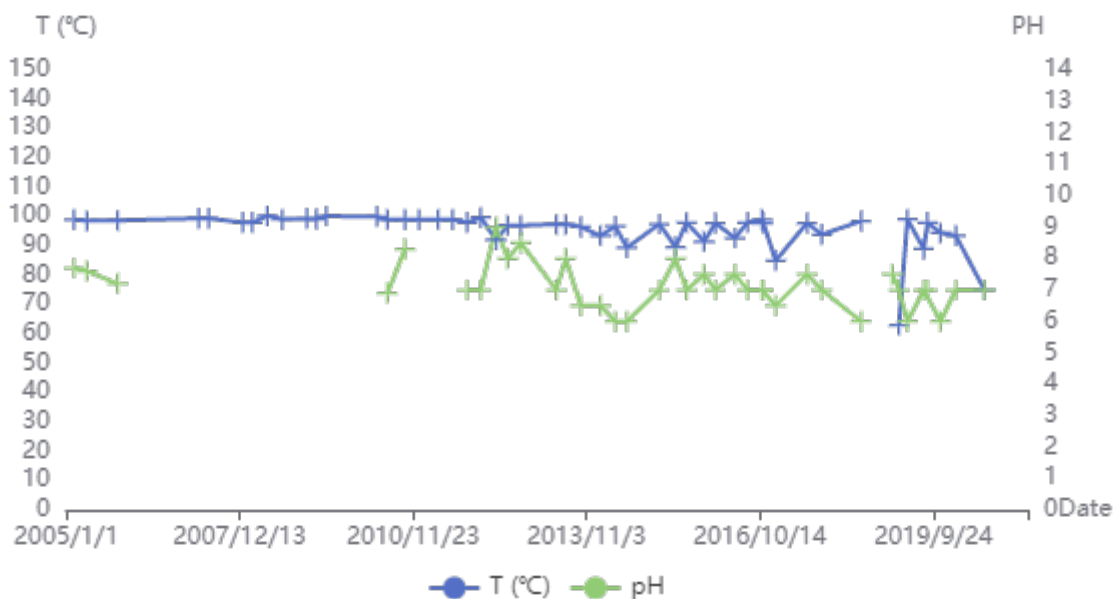
Devil's Throat: Temperature and pH for 2005/1/1 - 2021/5/1

- The temperature of this feature has remained in constant near-boiling conditions, except in February 2019 when measurements dropped to 63 °C and again to 75 in August 2020 (75 °C).

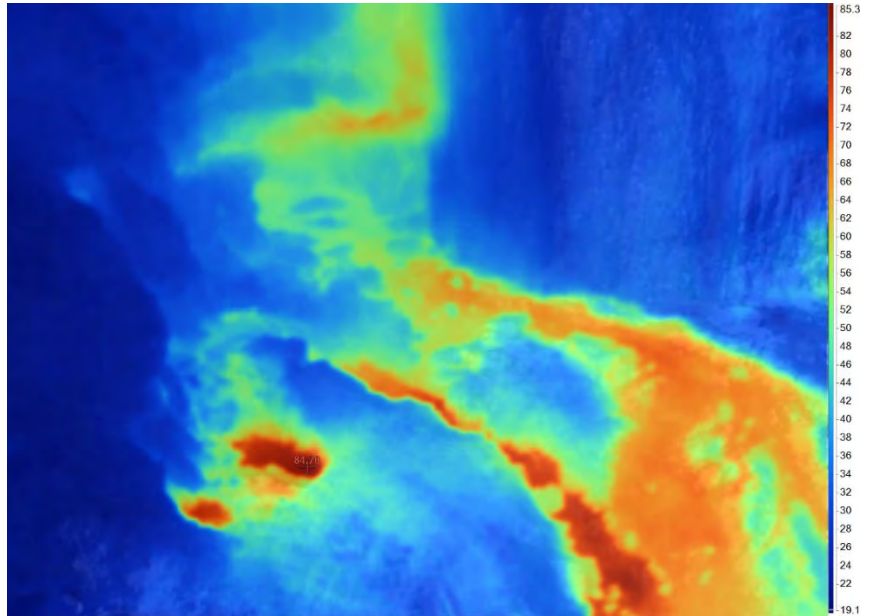
Fig. 8 Infrared image of Devil's Throat. Taken on 2021-03-26.

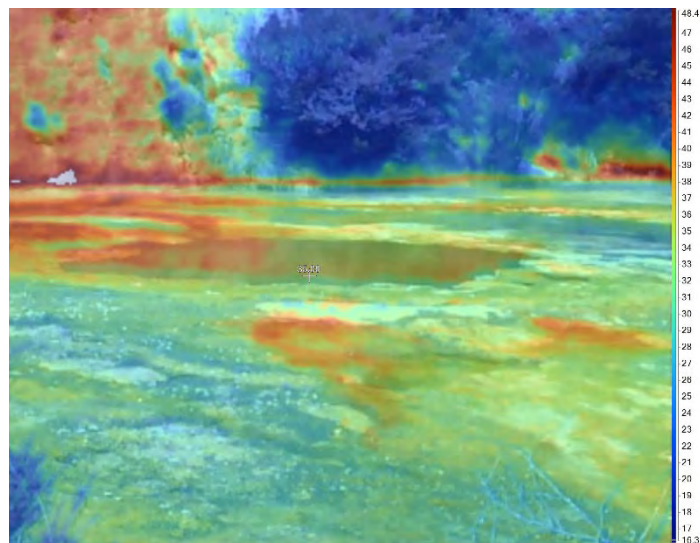
Fig.9 Infrared image of Map of Africa. Taken on 2020-12-04.

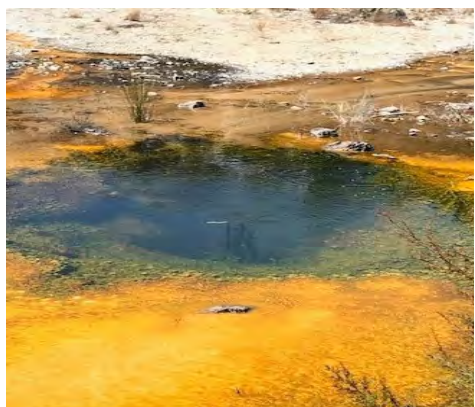
Fig.4 - taken on 2020-02-11 13:02:02"

- Prominent conophyton structures were observed in the middle of the pool in February 2020 (Fig.4). Previous visit of the author to the pool in March 2019 did not record observations of the conophyton structures. By December 2020, the pool is almost 50% populated by silicified conophyton structures (Fig.5 and Fig.6). It is important to note that this period when the conophyton structures were observed coincides with a period with no overflow from higher elevation features. By March 2021 (Fig.7), Wairiri Geyser was erupting and overflowing over Manganese Pool, and no conophyton structures were present any longer.

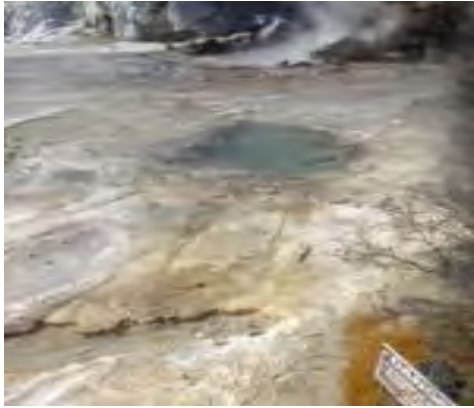
Fig.7 - taken on 2021-03-26 11:58:03"

2021/03/26		57.0	0		Cloudy	Colourless	Nd
Comments	Spring reduced in size by ~1/3. All conophyton structures now silicified and inactive. Overflow from Wairiri Geyser enters this feature, diluting the waters.

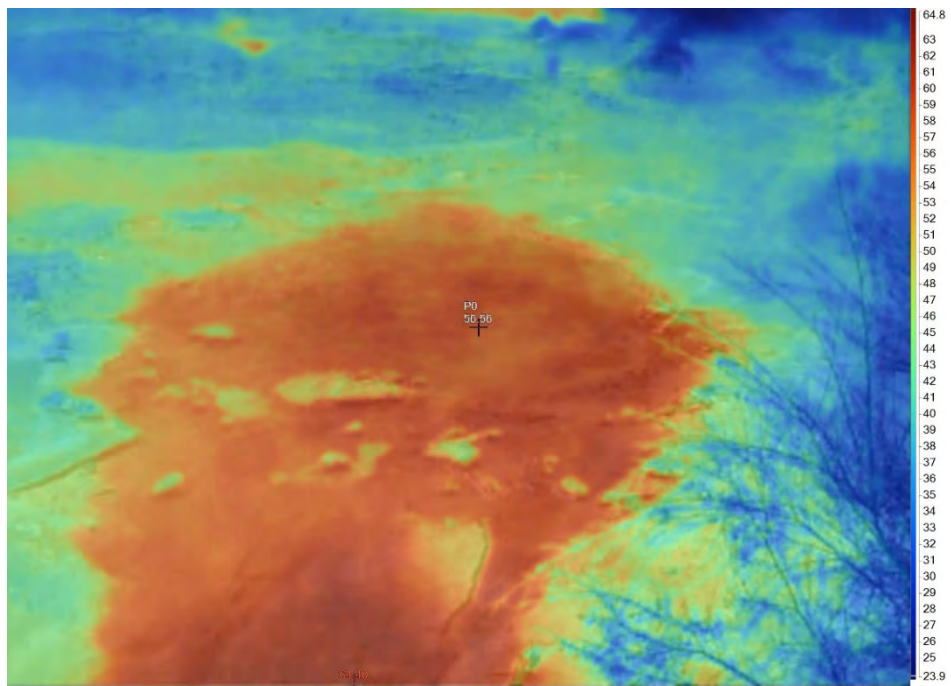
Fig. 8 Infrared image of Soda Fountain. Taken on 2021-03-26.

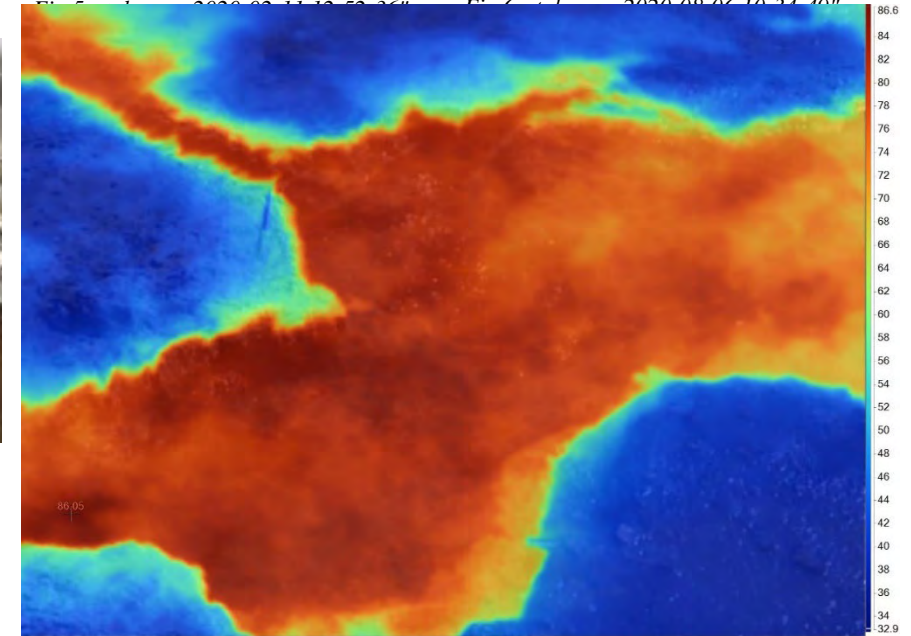
Fig. 8 Infrared image of Fred and Maggie Pool. Taken on 2021-03-26.

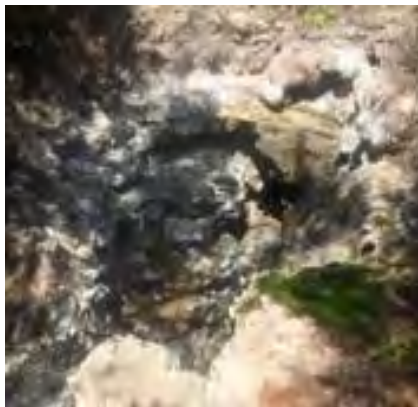
Fig.5 - taken on 2020-02-11 13:51:27"

- The temperature measured at Soda Fountain regularly fluctuates from near-boiling conditions (95 – 100 °C) to 70 °C. In 2014, the temperature was at its coldest, declining to ~50 °C before returning to the regular trend.
- This feature typically has an outflow, but may irregularly become fully dry (Fig.5).

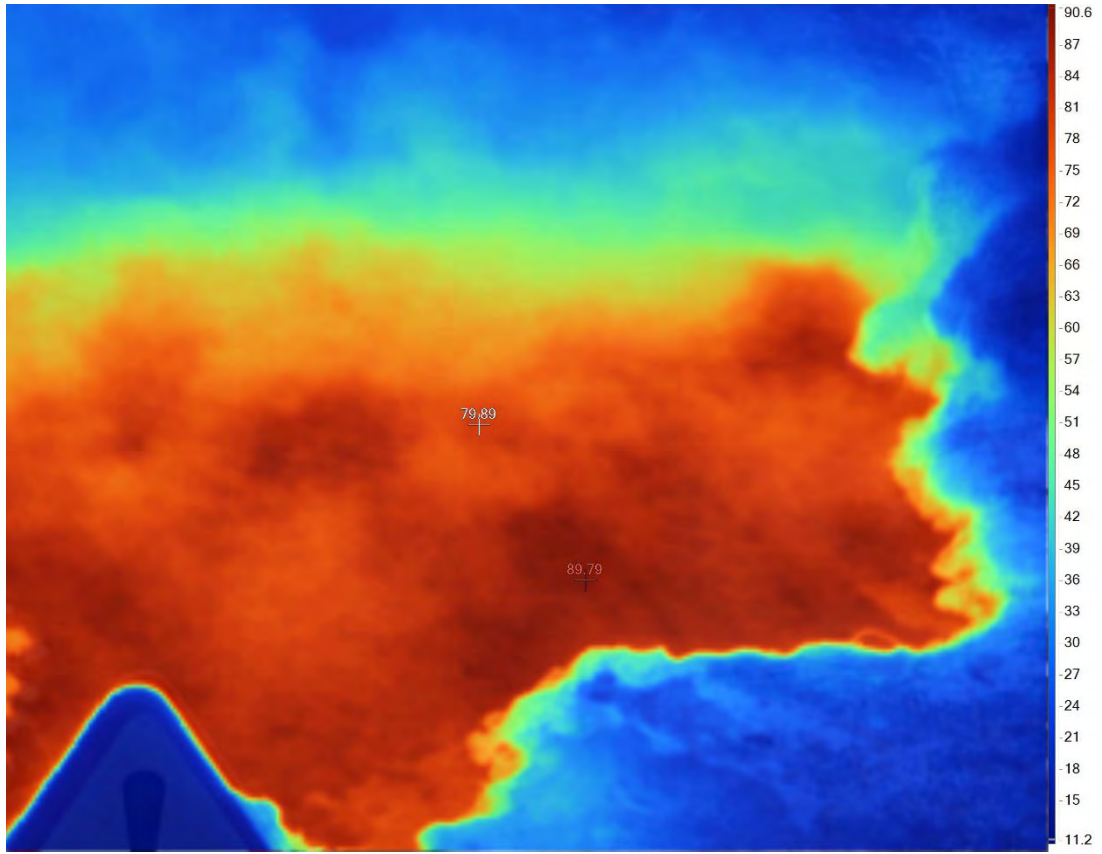
Fig. 10 Infrared image of Soda Fountain. Taken on 2021-03-26.

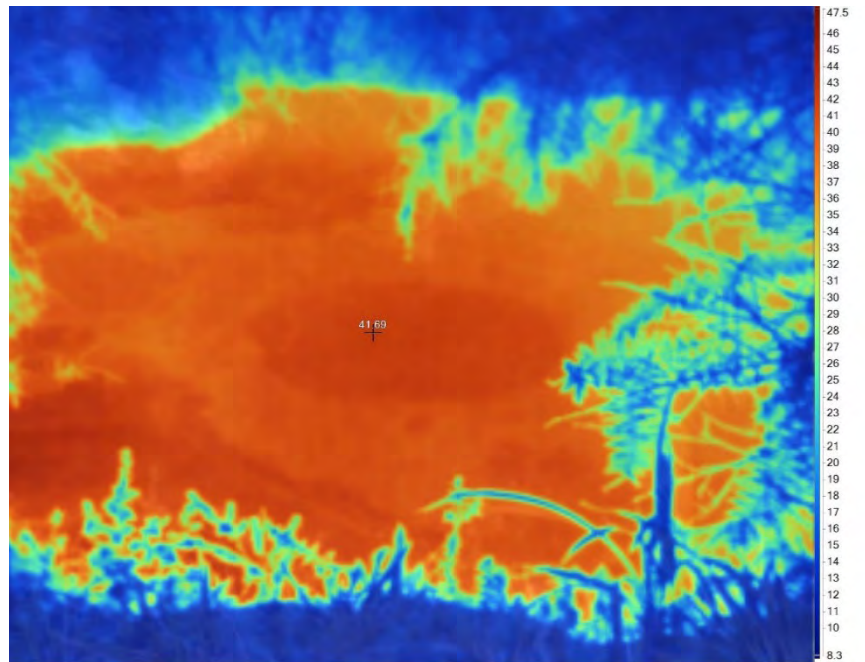
Fig.8 Infrared image of South Pool by Boardwalk. Taken on 2020-12-14.

- From 2006 to 2017, water temperature has always fluctuated between 50 and 80 °C. In 2017, a decreasing temperature trend was observed, and until 2021, the temperature has remained below 50 °C.
- pH conditions are regularly between pH 5 and 8, except in 2013 (pH 2, possibly anomalous) and 2019 (pH 3).
- Water colour may vary between murky grey and cloudy brown.

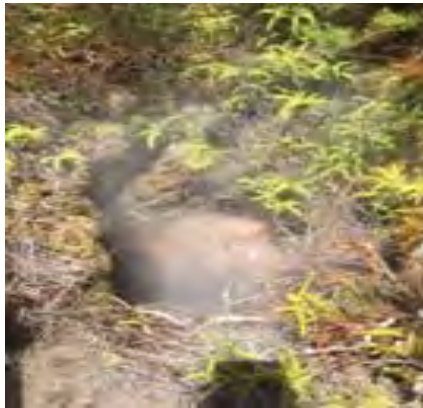
Fig.5 - taken on 2020-12-04 14:19:27"

Date	pH	Temp °C	Level (m)	Flow (l/s)	Clarity	Colour	Ebullition
2019/01/14		35.6					nd
Comments	Water level: Dry						
2019/04/16		31.7		0.0	---	---	Steaming on front
Comments	Water level: Nd						
2019/07/26		27.0		None	---	---	Steaming
Comments	Ebullition: At front						
2019/08/19				None	---	---	Steaming
Comments	Ebullition: At front						
2020/12/04		62.0					
Comments	Deposition of red minerals around vent possibly As-rich.

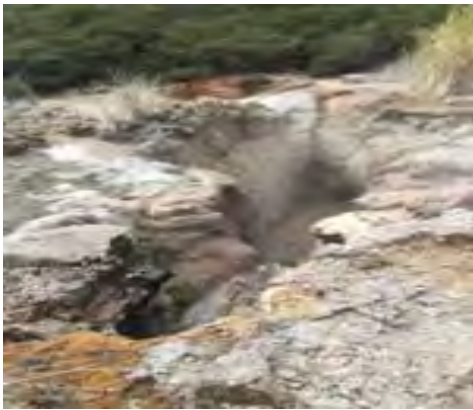
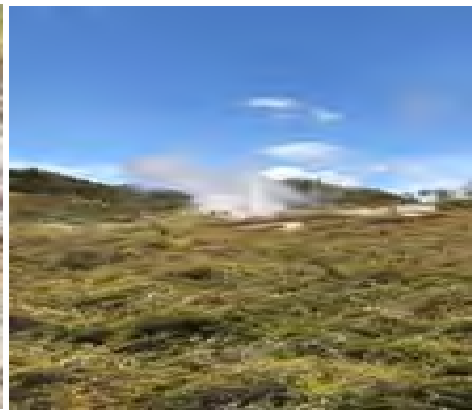
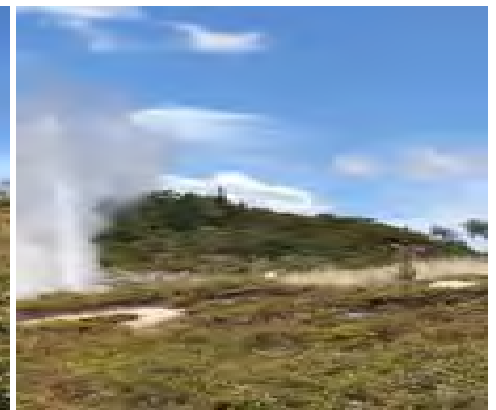
- From the tourist centre, the tourism site operators see frequent eruptions of this geyser.
- The geothermal ground surrounding the geyser (above the sinter terrace) is still active.

Date	pH	Temp °C	Level (m)	Flow (l/s)	Clarity	Colour	Ebullition
2019/07/26				None	---	---	Deep audible bubbling
Comments	Looks like it has erupted recently- water around the edge. Got confirmation that it has erupted 3 times recently <i>Ebullition: Steaming</i>						
2019/08/19	43.5			None	---	---	Deep audible bubbling
Comments	Looks like it has erupted recently- water around the edge. Got confirmation that it has erupted 3 times recently <i>Ebullition: Steaming</i>						
2020/12/04						White	Erupting
Comments	<i>Eruption: Erupting for 90 seconds, playing up between 7 and 10 m high. Microbial mats observed inside the wall of the geyser vent. Geyser vent is ca 3 m long, 1.5 m deep, and 3 m deep, with a flat gravel floor. Rising about 50 cm from the floor is a pipe encrusted with sinter. The pipe was once much longer but has been broken, with the longer part lying fallen on the gravel bed. The geyser vent is quite dry after an eruption due to rapid evaporation of the hot water. The site manager Greg Gibson says it fills very quickly, in less than a minute once the water starts rising following the previous eruption and erupts up to 8-13 times a day.</i>
