Geothermal features annual monitoring report – June 2021

August 2021

Document #: 21036557

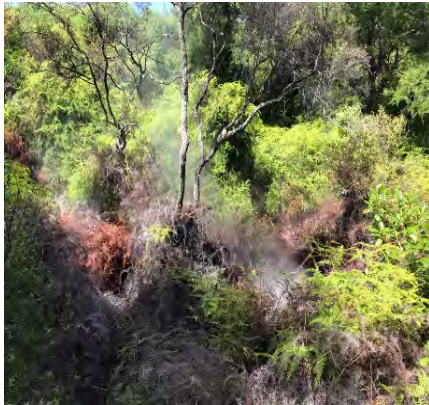
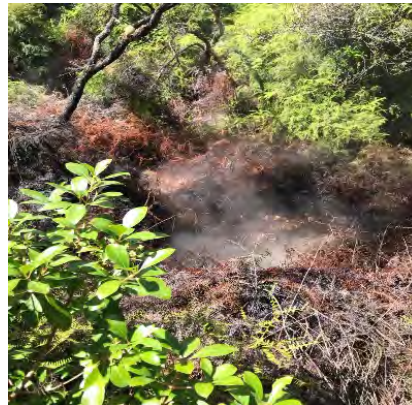
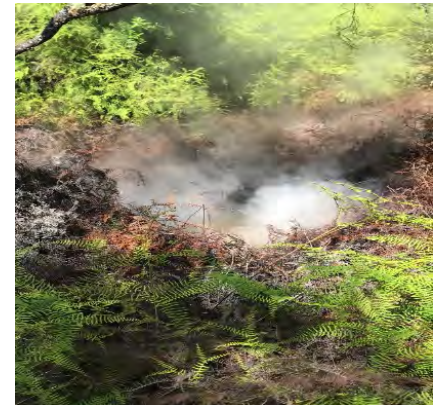
- A set of 3 new non-flowing neutral chloride springs discovered due to audible eruption and visible steam column >5 m high. Vegetation surrounding the features is still green while dead vegetation is observed proximal to margins of features, indicating new and localised thermal features. The three pools are the west pool, middle pool, and east pool. Age of features unknown but appears very recent because the vegetation is freshly dead.
- Infrequent periods of increased ebullition for about 1-2 minutes, with water column rising to ~1 m and splash zone extending 2 m away from middle pool.
- Location near old overgrown path, approximately 25 m NE of old sinter terrace leading up to Kurapai (3065_183).
- Measurements are from the middle pool.

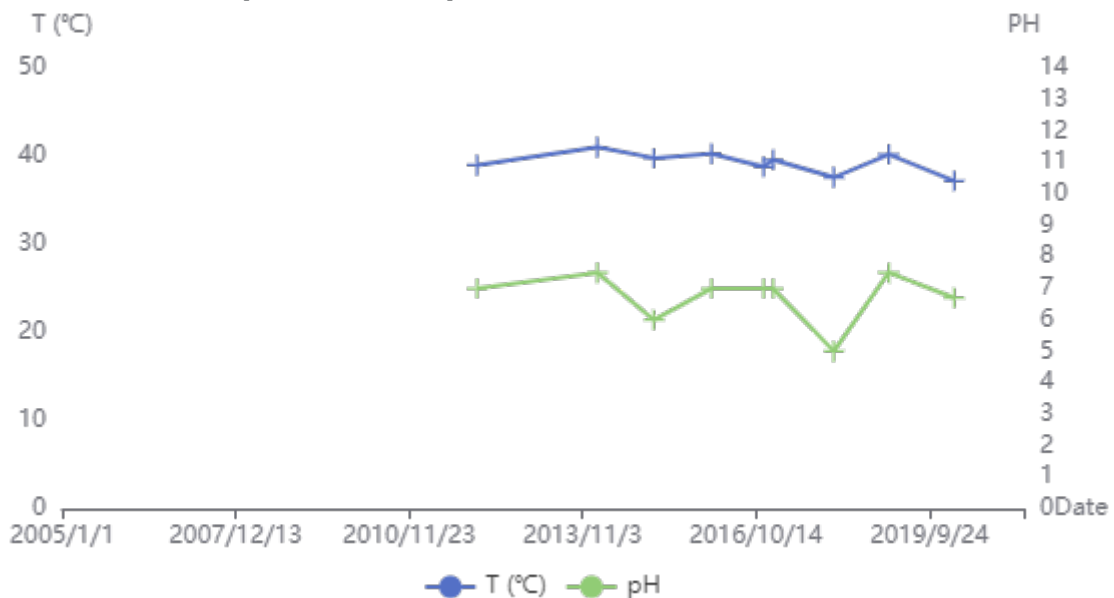
Butcher's Pool: Temperature and pH for 2005/1/1 - 2021/5/1

- Butcher's Pool is a natural hot pool that Rotorua District Council has built wooden swimming pool infrastructure around. Both the temperature and pH conditions at Butcher's Pool have been relatively stable since 2010. Based on infrared imagery (Fig.3), the hottest water seem to accumulate around the margins of the pool, and not in the centre.

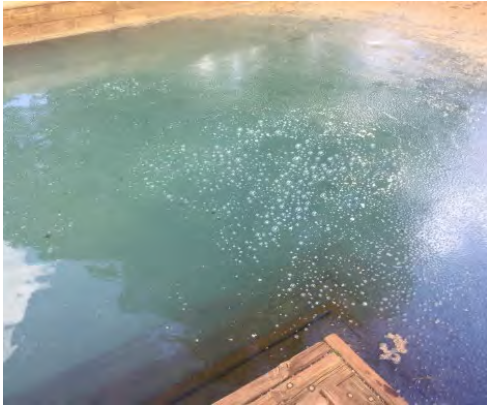
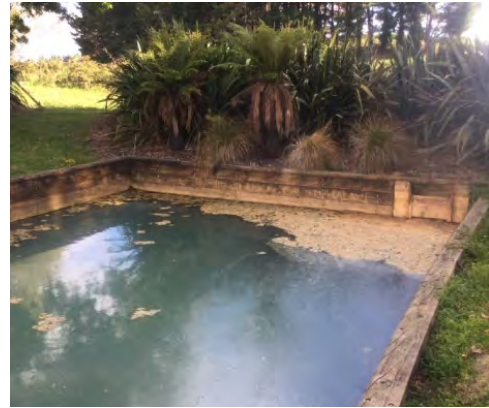
Comments	Water surface has scum and an oily sheen.

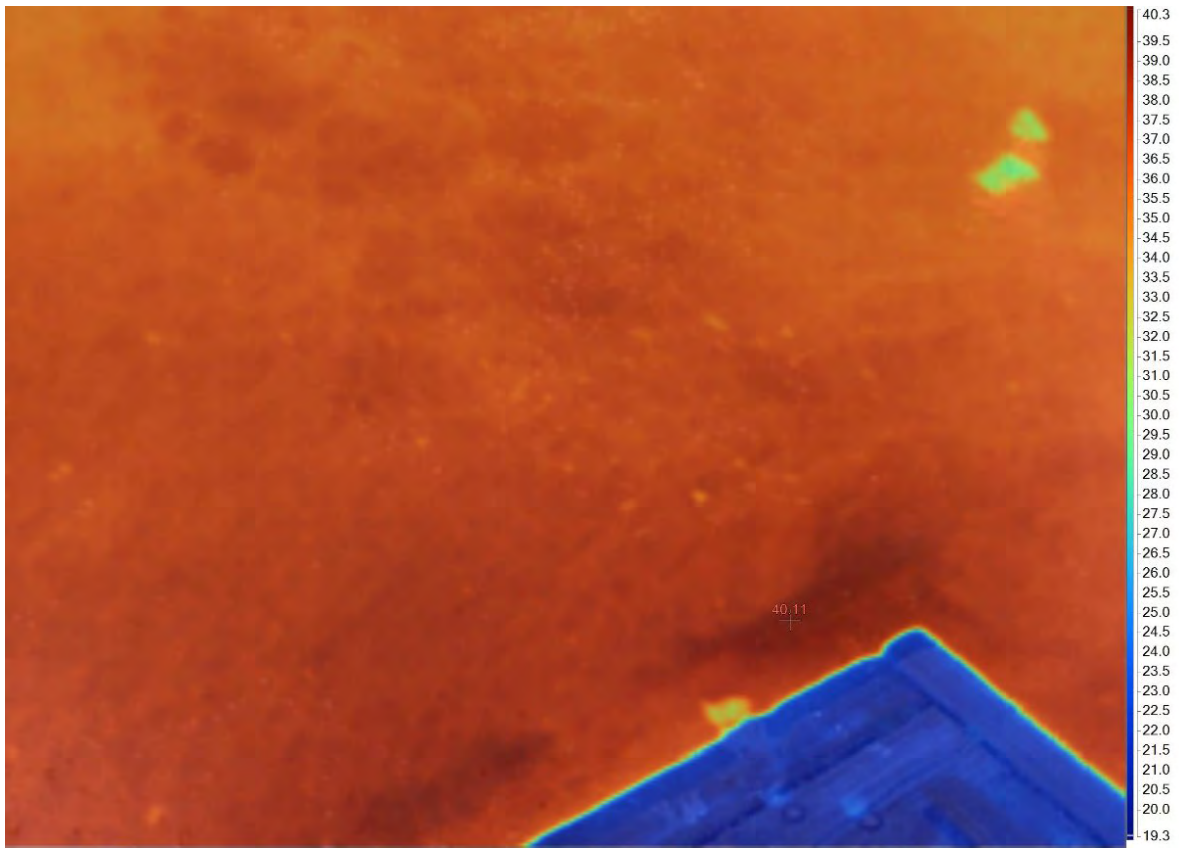
Fig. 3 Infrared image of Butcher's Pool. Taken on 2021-03-25.

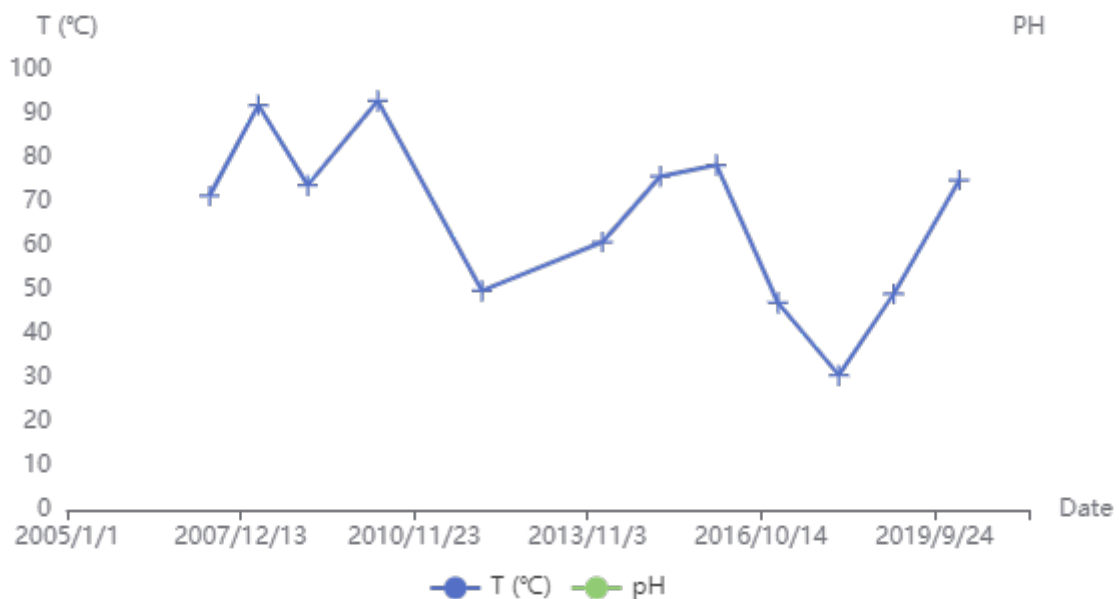
Wharepapa Rd: Fumaroles: Temperature and pH for 2005/1/1 - 2021/5/1

- The fumaroles are in a flat paddock on a dairy farm, adjacent to a very hot chloride spring. The fumarole area heat output fluctuates greatly over the course of years, expanding and contracting the area and number of fumaroles and mud pools. The fumaroles experienced cooling periods from 2008 to 2011 and from 2016 to 2017.
- During a visit in March 2021, the fumaroles have been buried by soil, and no thermal signature was observed through an infrared camera.

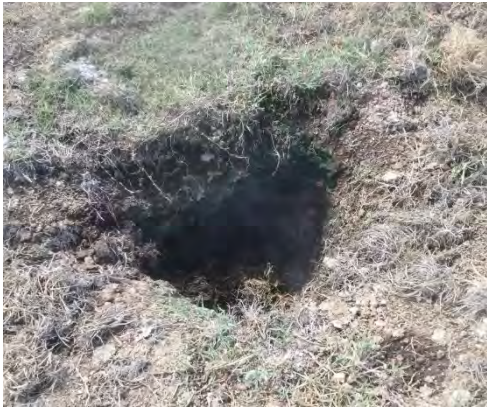
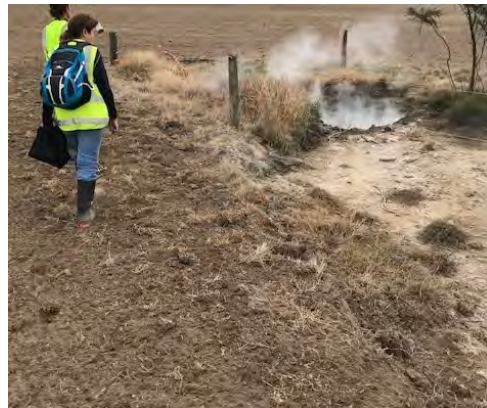
Date	pH	Temp °C	Level (m)	Flow (l/s)	Clarity	Colour	Ebullition
2015/01/28		75.8	0.9				Audible bubbling
Comments	Ground collapsing <i>Water level:</i> Below ground level <i>Area of feature:</i> 0.5x0.7						
2016/01/12		78.4					Audible bubbling
Comments	Small collapse on side						
2017/01/27		47.1	0.4	None	nd	nd	Audible bubbling
Comments	Collapsing, covered in grass <i>pH:</i> nd <i>Water level:</i> depth <i>Area of feature:</i> 0.24 x 0.27						
2018/02/09		30.6		None	Muddy	nd	nd
Comments	Ground collapsed into vent, depth 0.1 m below ground level <i>Water level:</i> nd						
2019/01/15		49.1	0.9	None	Muddy	Brown - Dark	Constant bubbling
Comments	Fumarole 1 & 2 now one larger fumarole <i>Water level:</i> Below ground level - angled						
2020/02/26		75.0					Steaming
Comments	Ground collapsing in vent.

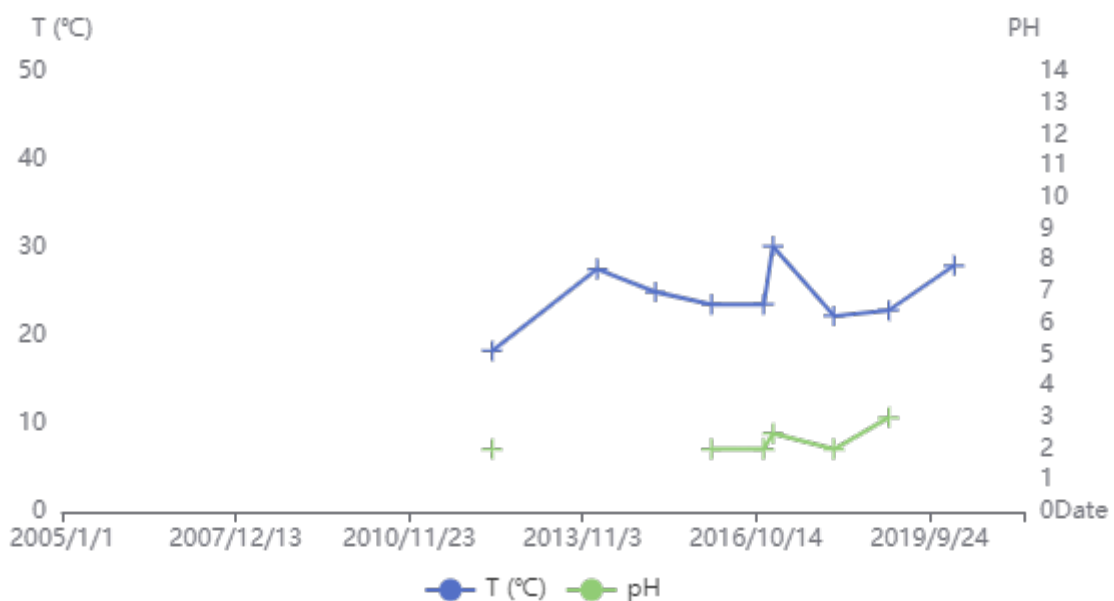
Longview Road Mud Pools: Temperature and pH for 2005/1/1 - 2021/5/1

- The average temperature of the mud pools appears to be approximately 23 – 25°C. Two temperature increases were observed in 2011 and 2017. In 2011, the temperature increased from <20 °C to the average levels. In 2017, the measurement shortly increased to 30.2°C, before again returning to the mean level, and then increasing again in 2019.

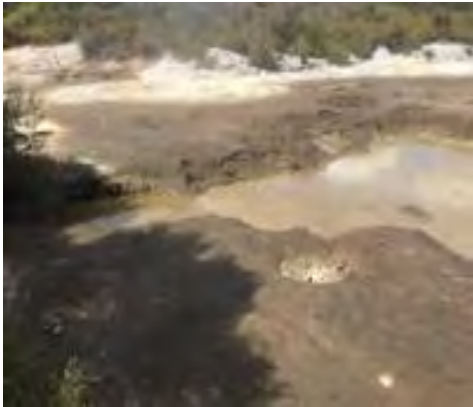
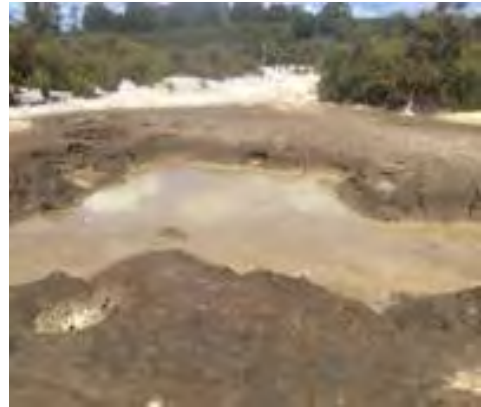
Comments	Lots of new holes opened up, sulphur deposits around some vents. Ground too soft to walk around to get to pool. Could not get close to take pH measurement.

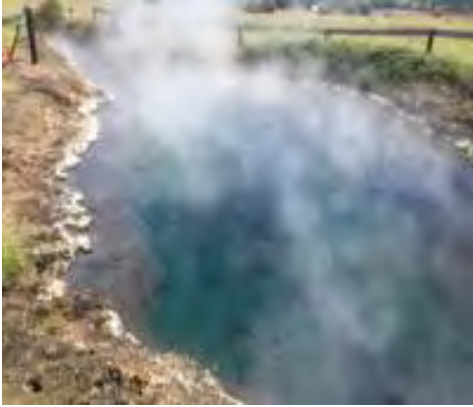
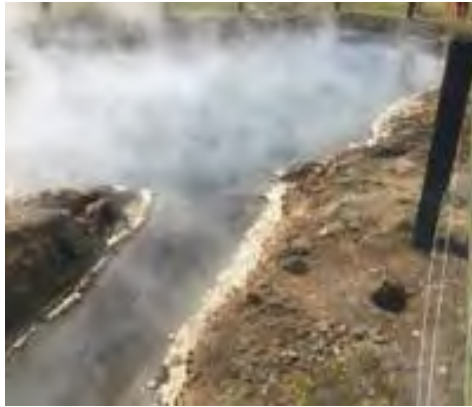
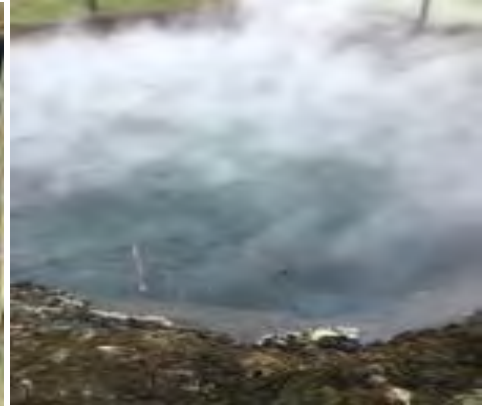
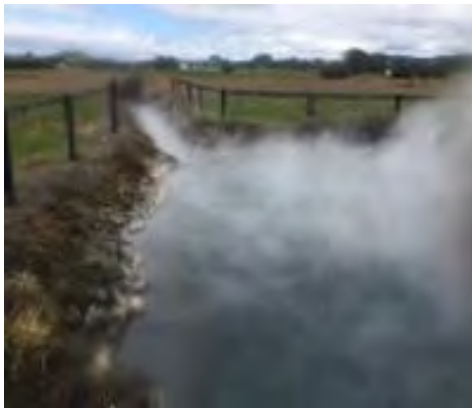
Comments	Oily sheen observed on water surface around pool margins, provenance unknown.

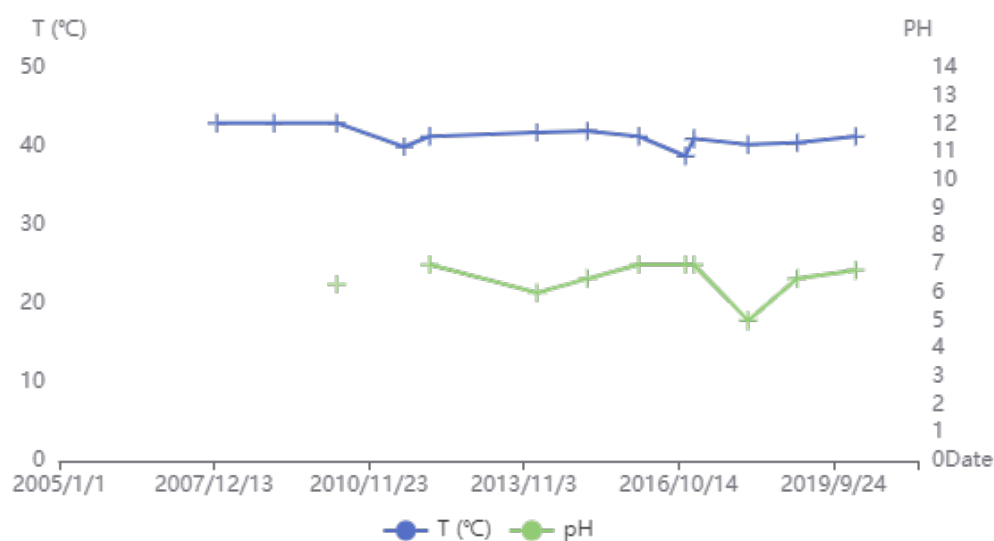
No 3 across Golden Spring Hotel: Temperature and pH for 2005/1/1 - 2021/5/1

- The water temperature of this feature has remained relatively constant since 2006.
- pH has remained in near-neutral conditions except for observations in 2018, where the pH was measured to be 5.
- Pool is often covered in organic debris and/or subaerial microbial mat communities, making it difficult to observe the water conditions.
- In 2021 a very large tree has fallen across the pool, with its trunk and branches acting as a partial roof.

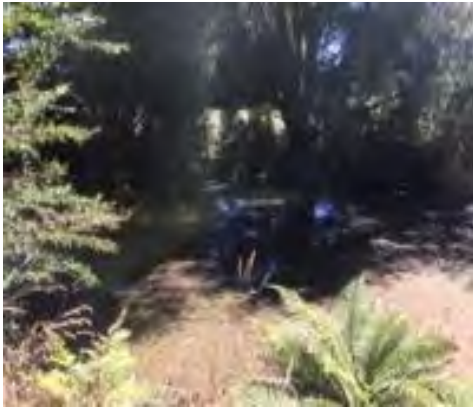
Fig.1 - taken on 2020-02-26 12:04:25"

Date	pH	Temp °C	Level (m)	Flow (l/s)	Clarity	Colour	Ebullition
2015/01/21	6.5	42.0			Murky	Green	Effervescing
Comments	Algal mats						
2016/01/12	7.0	41.3		None	Murky	Green-yellow	Effervescing
Comments	Water level: nd						
2016/12/01	7.0	38.8		None	Murky	Green-yellow	Effervescing
Comments	Water level: nd						
2017/01/27	7.0	41.0		None	Murky	Pale Green	Effervescing in centre
Comments	Algal mats covering most of the pool Water level: Overflowing						
2018/02/09	5.0	40.3		None	Cloudy	Green - Light	Effervescing
Comments	Less algal mats than usual Water level: nd						
2019/01/15	6.5	40.5		None	Cloudy	Green - Light	Effervescing in centre
Comments	Water level: nd						
2020/02/26	6.8	41.3	0.2		Murky	Green - Light	Effervescing in centre
Comments	Algae mats covering most of the feature.						
2021/03/25	7	42.9	0	N/a	Cloudy	Green - Murky	Constant ebullition
Comments	Surface covered in organic debris.

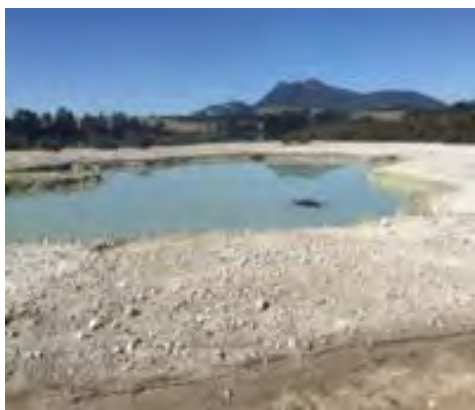
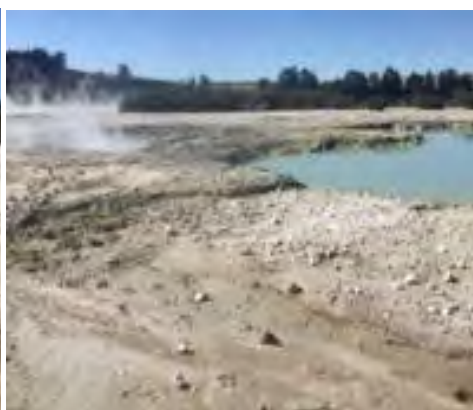
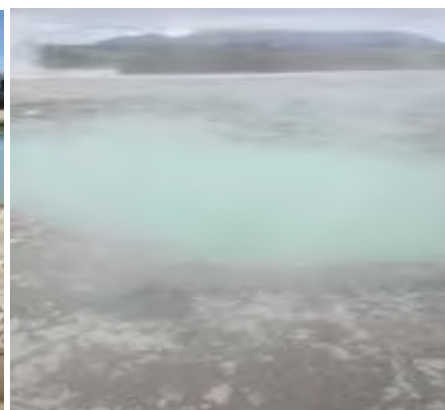
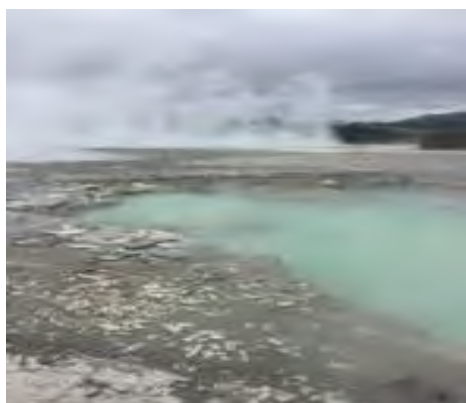
Comments	Ebullition on left, producing sulphur. Thick sulphur on ground next to pool. New outflow formed, currently dry. Soft ground. Two dead animals (wild pigs?) in pool. Couldn't access RKF4.						
2021/04/30	4.0	39.6	0.3		Milky	Blue - Light	None

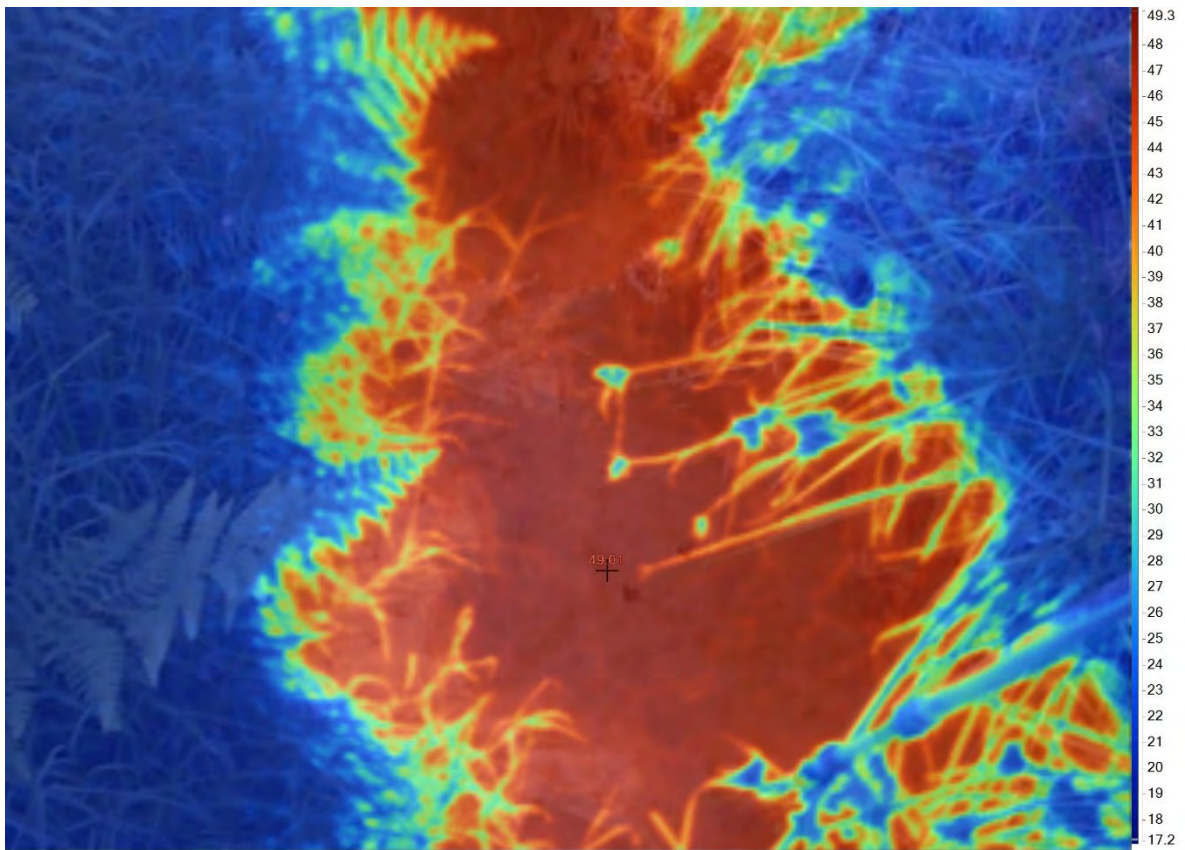
Fig. 3 Infrared image of Otumuheke Stream. Taken on 2020-03-25.

- Despite temperature fluctuations occurring until 2021, this feature has a decreasing temperature trend since at least 2009.
- Discharge rates of Otumuheke Stream has been decreasing according to measurements on WRC weirs, which could potentially influence the temperature changes occurring.
- pH measurements fluctuate without observed direct correlation to temperature.

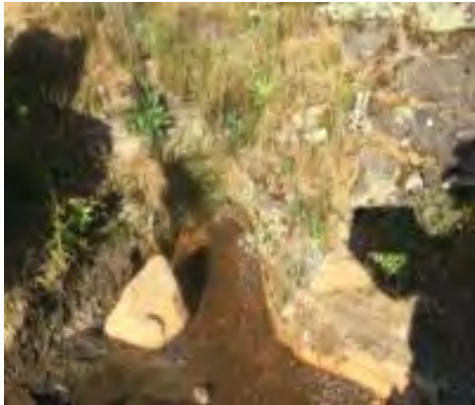
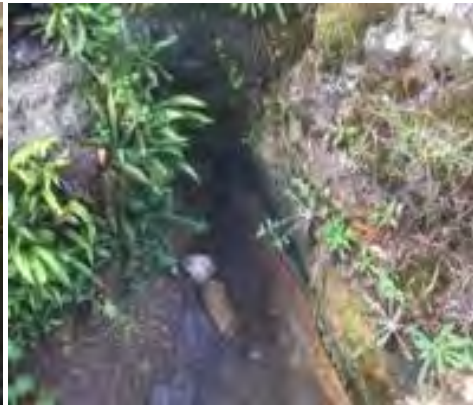
- The temperature conditions at Taharepa Springs are relatively stable since 2006.
- pH conditions consistently measure between pH 5 and 7.
- Orange staining affecting the water and surrounding rocks was observed in 2020 and 2021. It is possible that the orange colour is caused by mineral leaching.

Comments	Orange staining in some areas from mineral/soil.

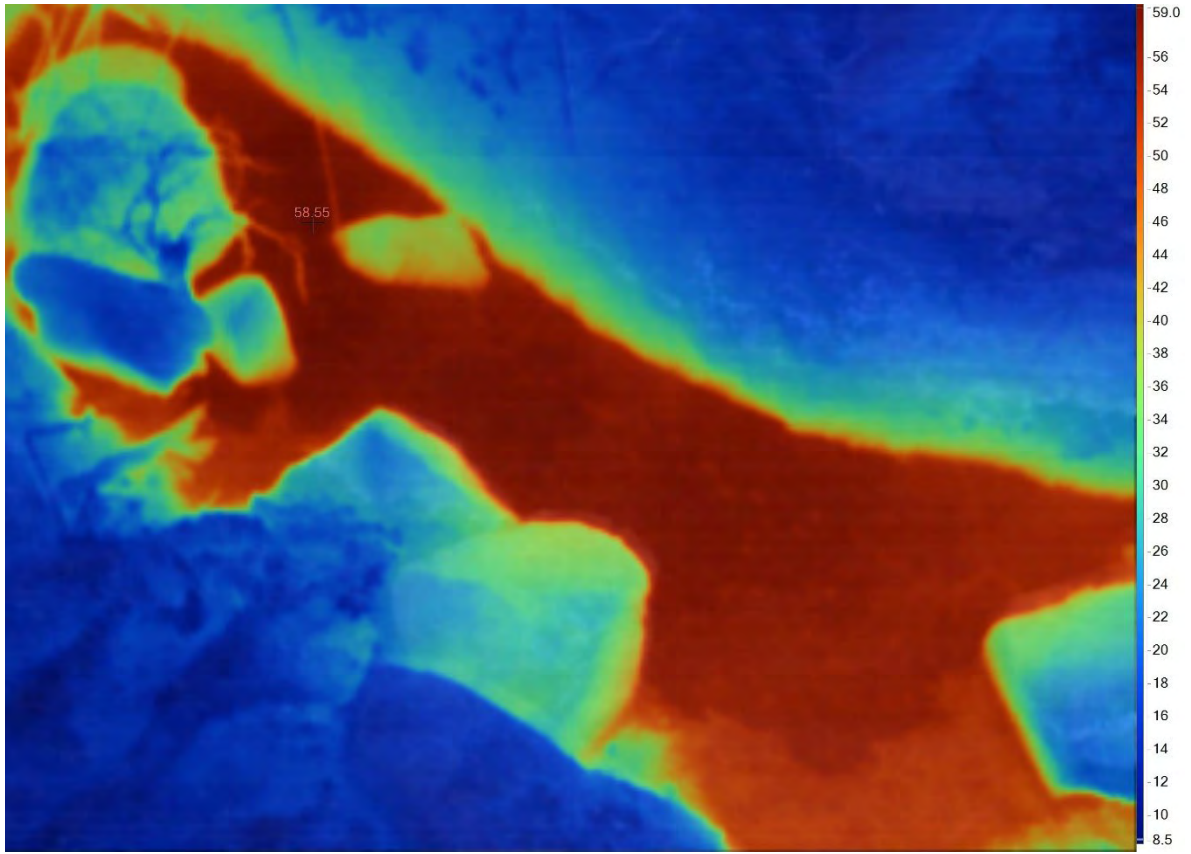
Fig. 9 Infrared image of Taharepa Spring. Taken on 2021-03-26.

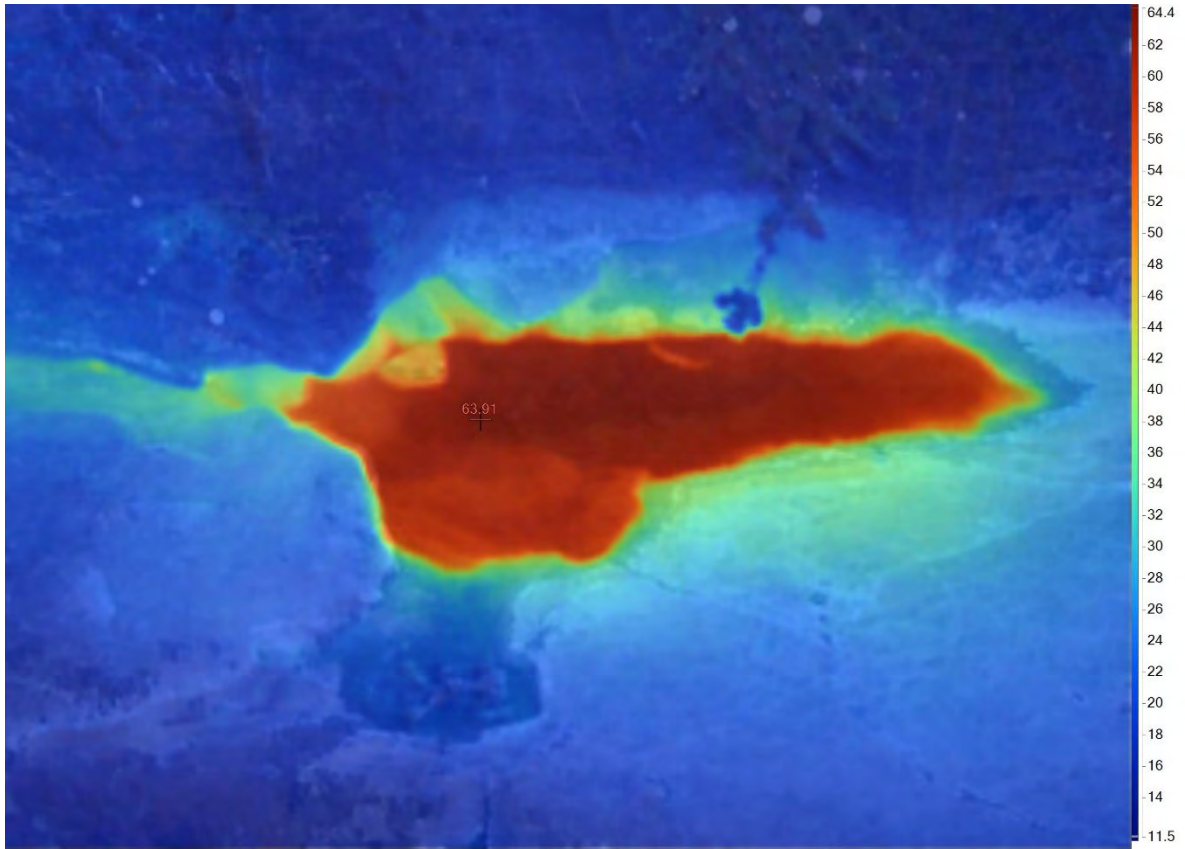
Fig. 9 Infrared image of Rocky Point Spring. Taken on 2021-03-26.

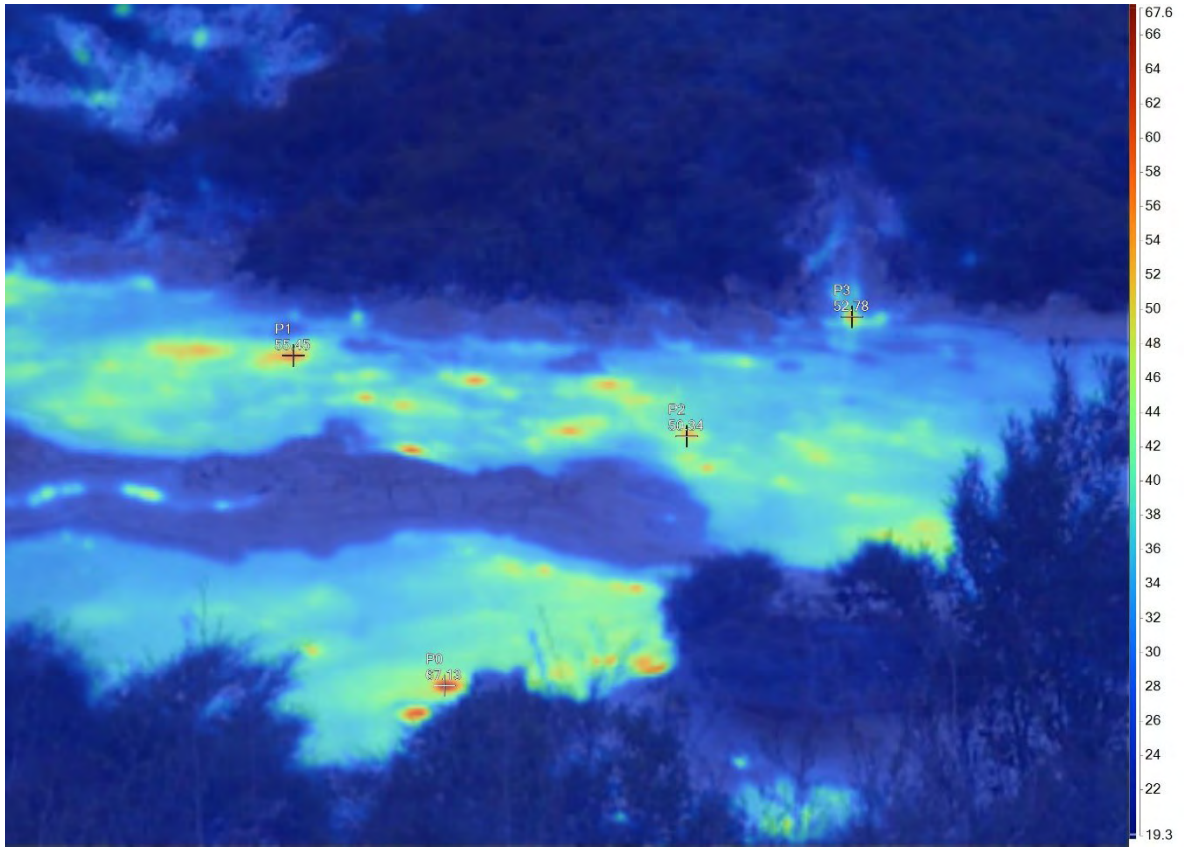
Fig. 3 Infrared image of Te Kopia mud pools. Taken on 2021-03-26.

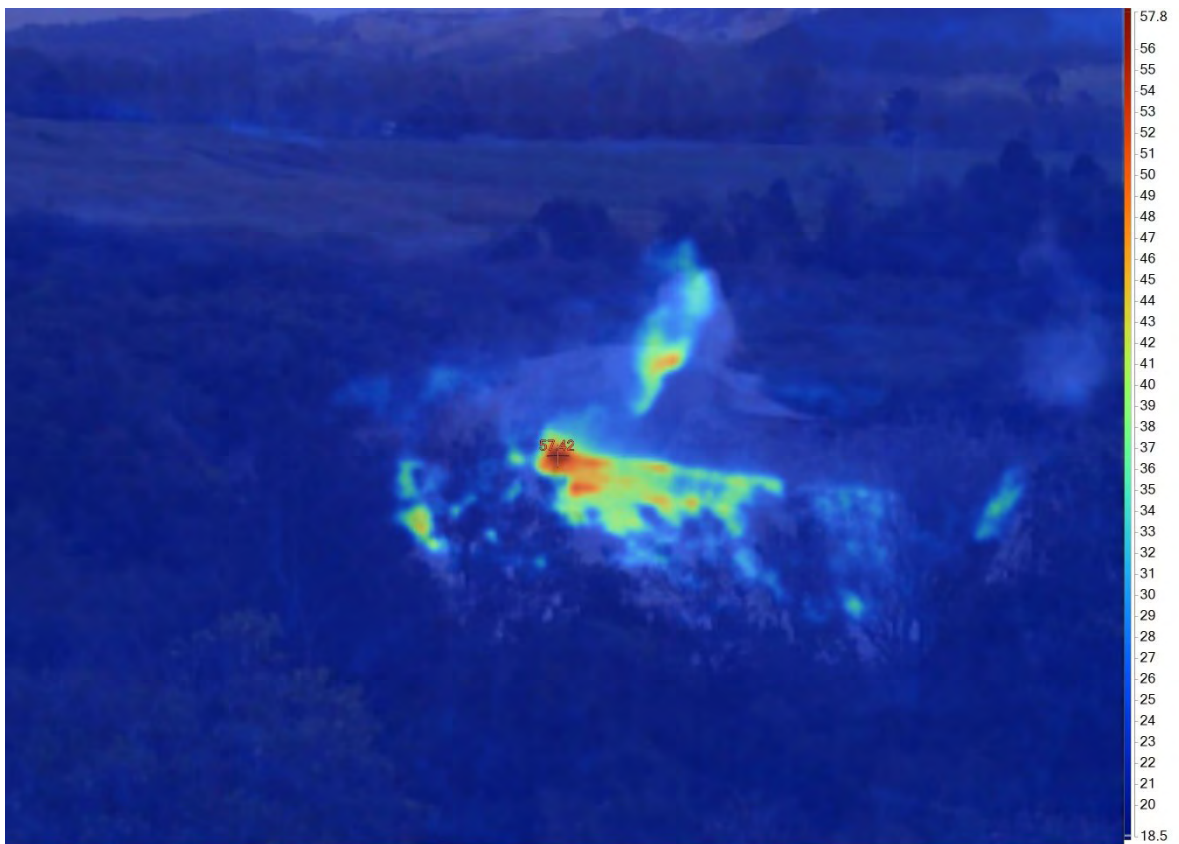
Fig. 4 Infrared image of Te Kopia mud volcano. Taken on 2021-03-26.

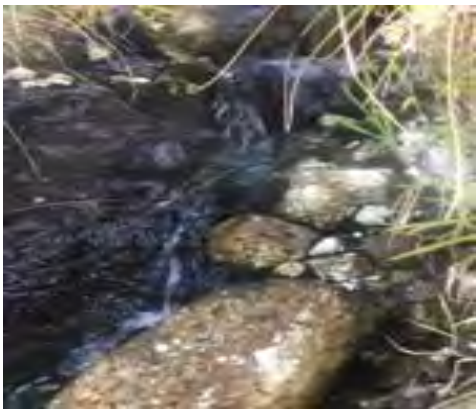
Fig.1 - taken on 2021-03-26 15:39:30"

- This site is not regularly monitored and is an area of multiple geothermal cascades. Images of the sampling trip on 26 March 2021 are presented on Fig.1 – Fig.3.
- There is a difference between the temperature and pH measurements taken in 2005 and 2021. However, as measurements were not collected at the water provenance, natural changes to temperature and pH may occur as the water was moving downstream.

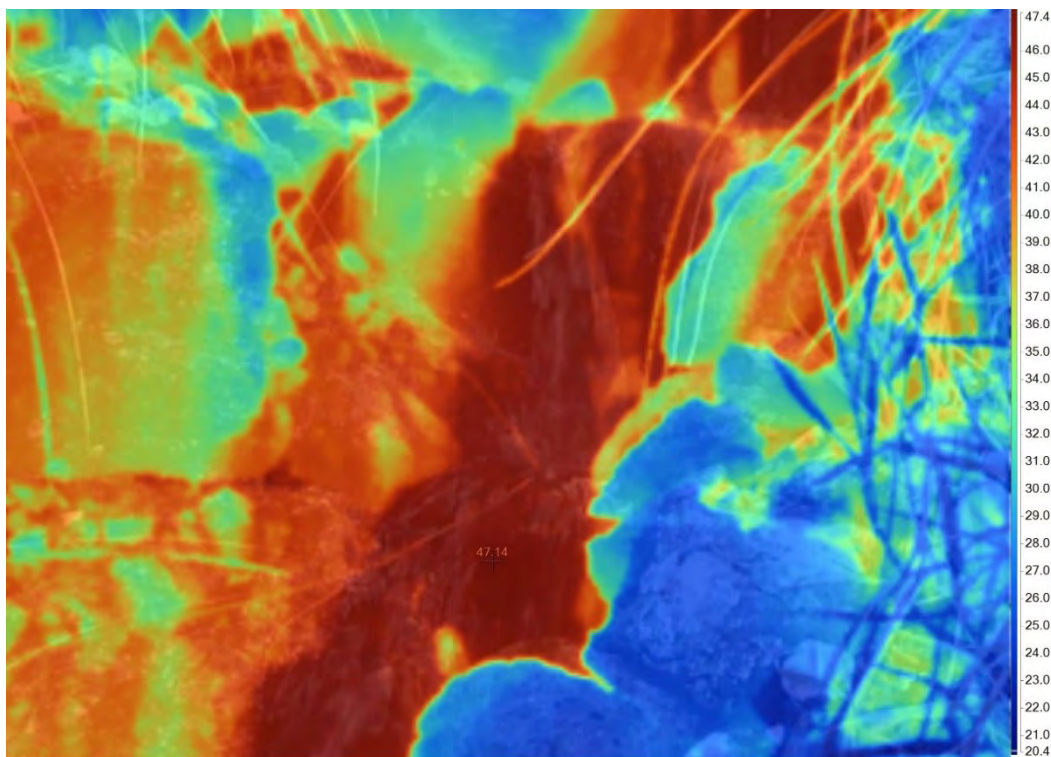
Fig. 4 Infrared image of the TKF100 falls. Taken on 2021-03-26.

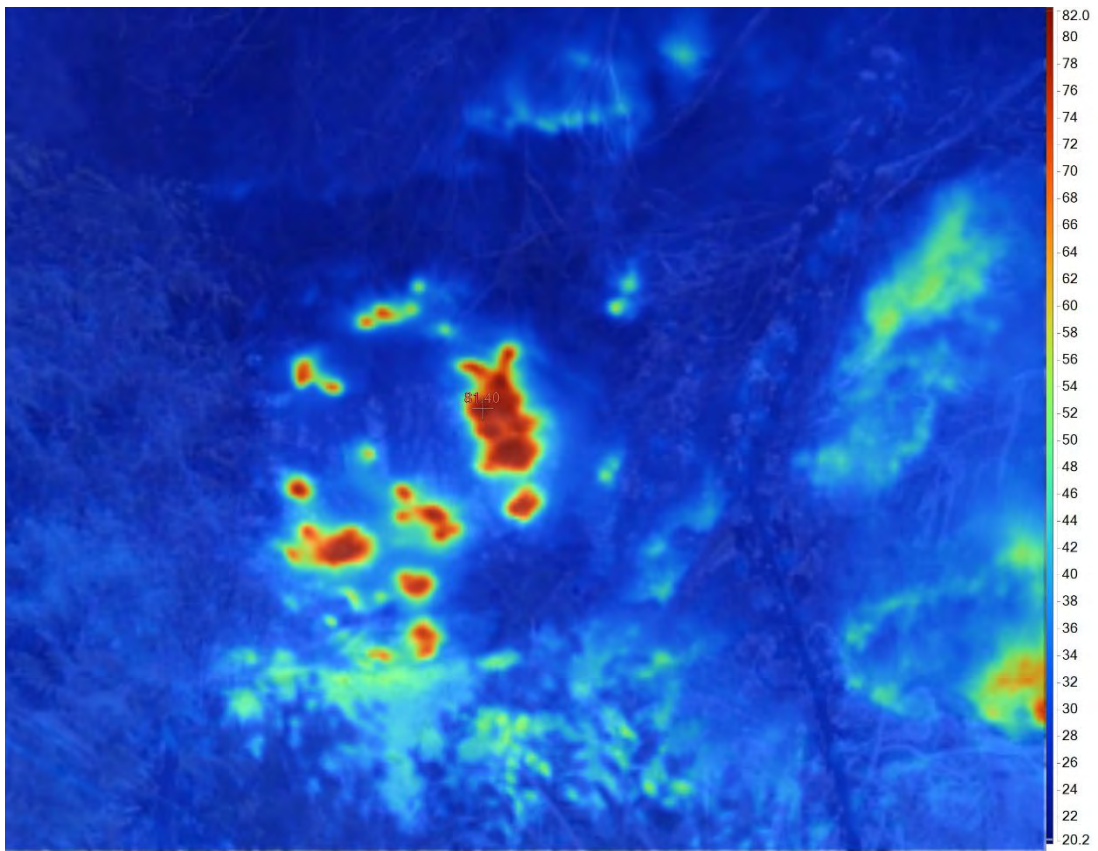
Fig. 3 Infrared image of Doom vent. Taken on 2021-03-26.

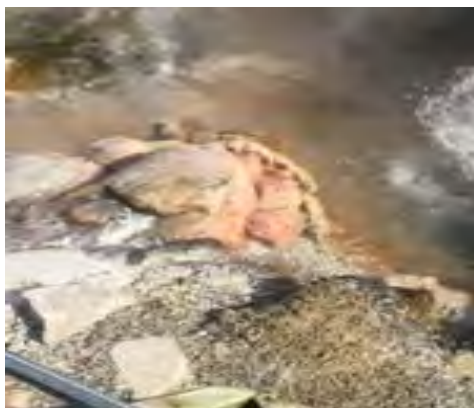
Fig.8 - taken on 2021-03-26 16:28:26"

- The overall temperature trend since 2005 is minor but visible temperature decrease over time and stays above 90 °C.
- pH conditions often fluctuate but remain within near-neutral conditions.
- Fresh geysers form around the pool within the splash zone (Fig.8).

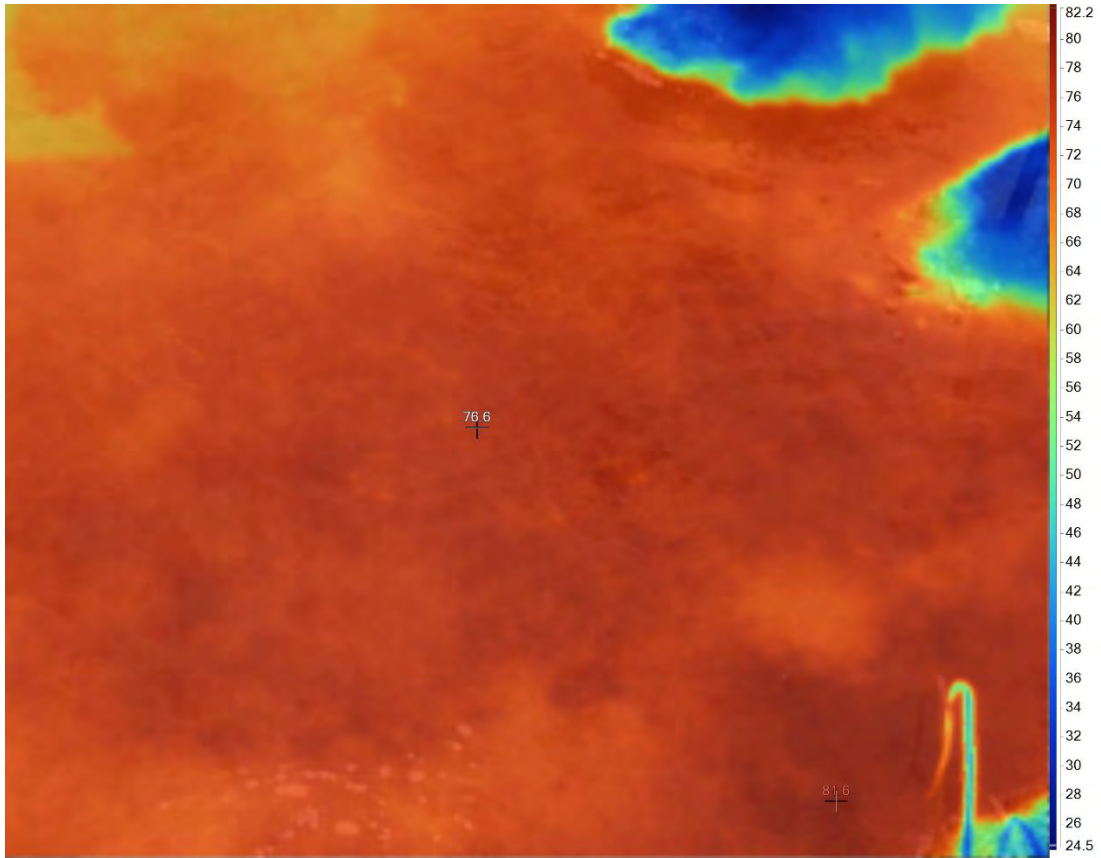
Fig.10 Infrared image of pool adjacent to Supply Spring. Taken on 2020-11-13.

- From 2010 to 2021, the water temperature of this feature has regularly varied between 60 and 90 °C. This is likely caused by relatively cooled waters from the outlet of Hot Pools Supply Spring (3073_107) entering into and cooling this feature.

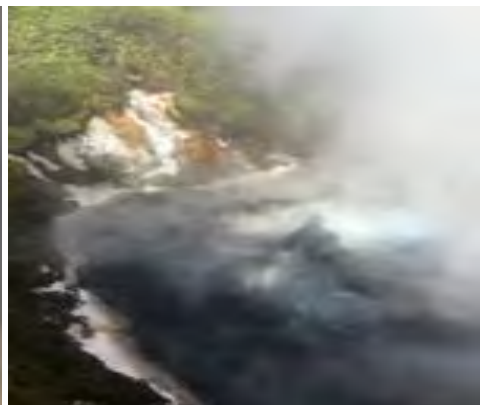
Fig.9 - taken on 2021-03-26 16:56:49"

2021/03/26	7.0	93.2	0	Clear	Colourless	Constant eruptive ebullition
Comments	Bigger radius of rupturing centre than usual

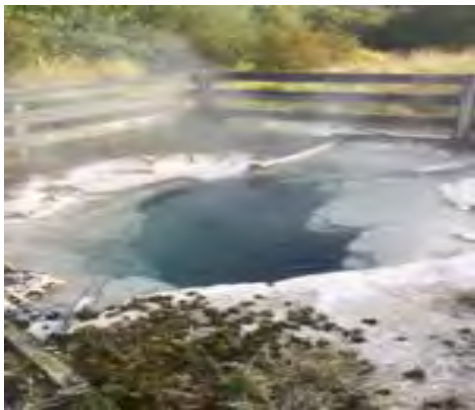
Fig.7 - taken on 2021-04-30 16:31:39"

2021/04/30	7.0	94.3	0	>5.0	Clear	Colourless	Constant ebullition
Comments	Constant ebullition near outlet, which is the hottest part of the pool.

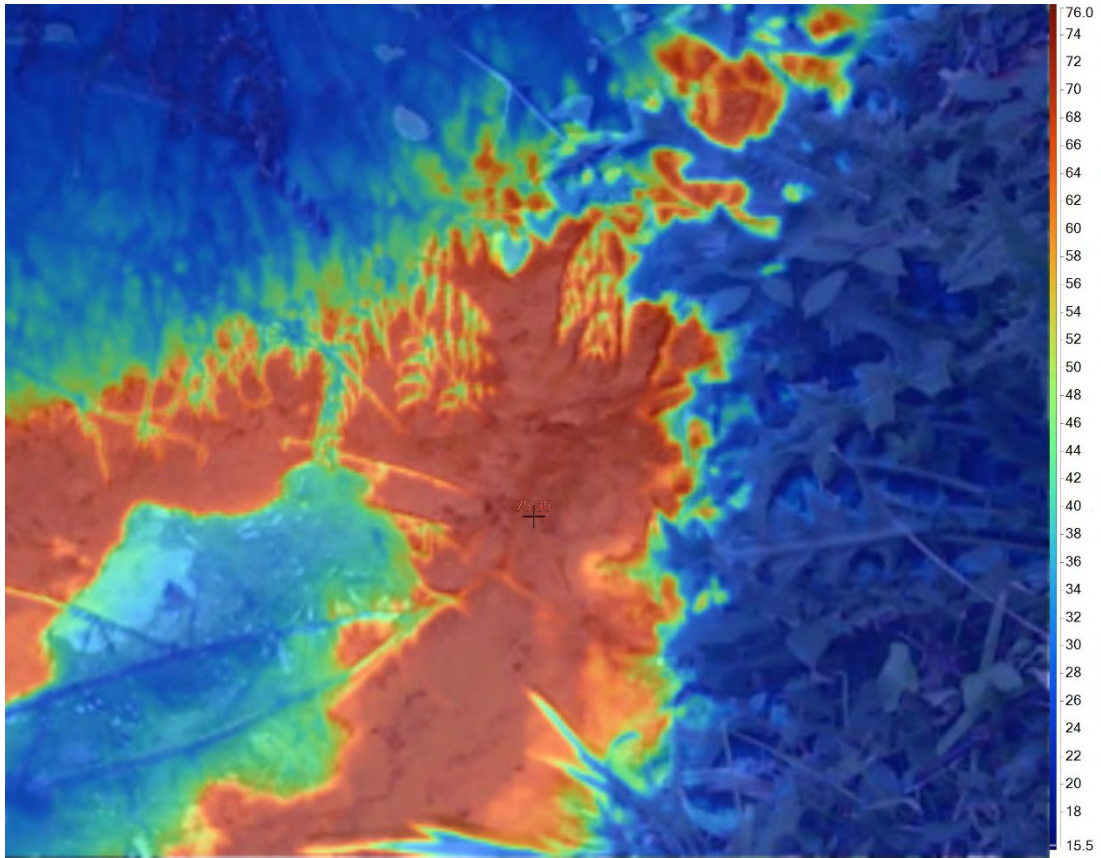
Fig.8 Infrared image of Waikite Scarp feature. Taken on 2020-08-05.

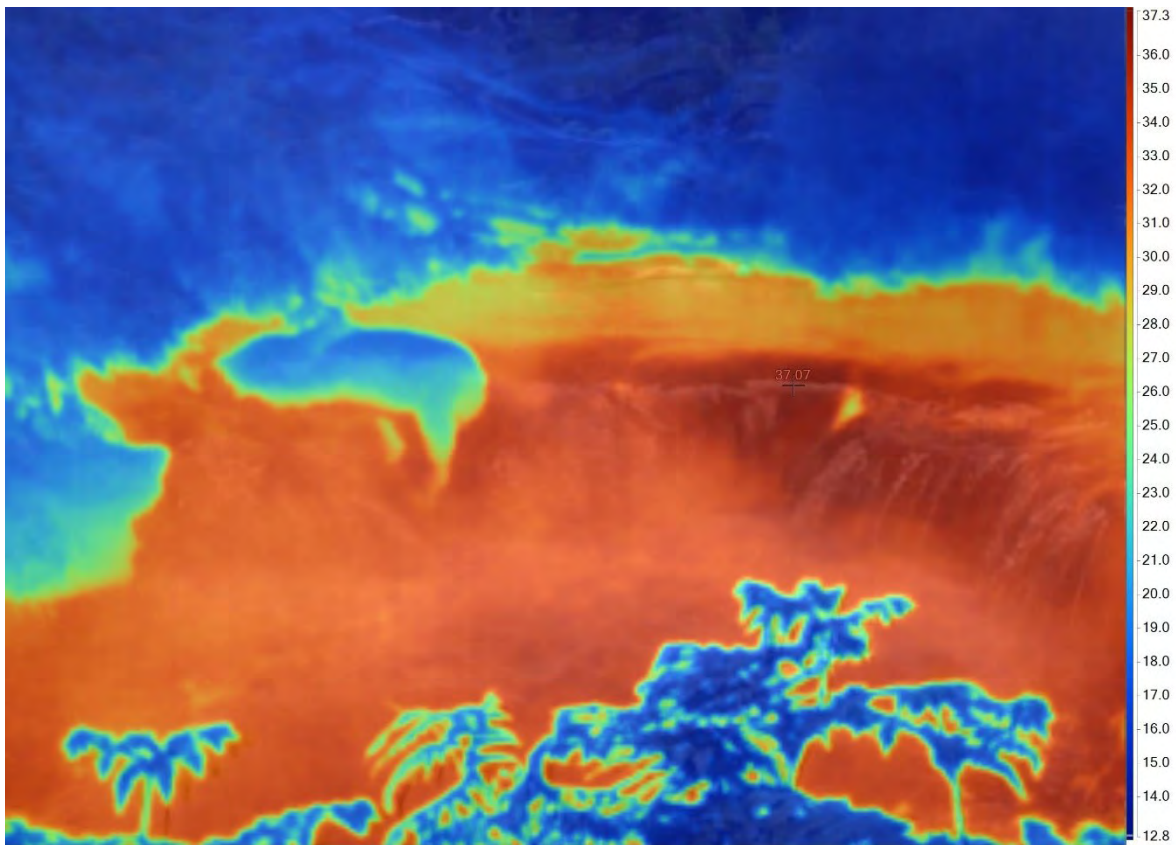
Fig. 1 Infrared image of Kerosene Creek sampling point. Taken on 2021-03-25.

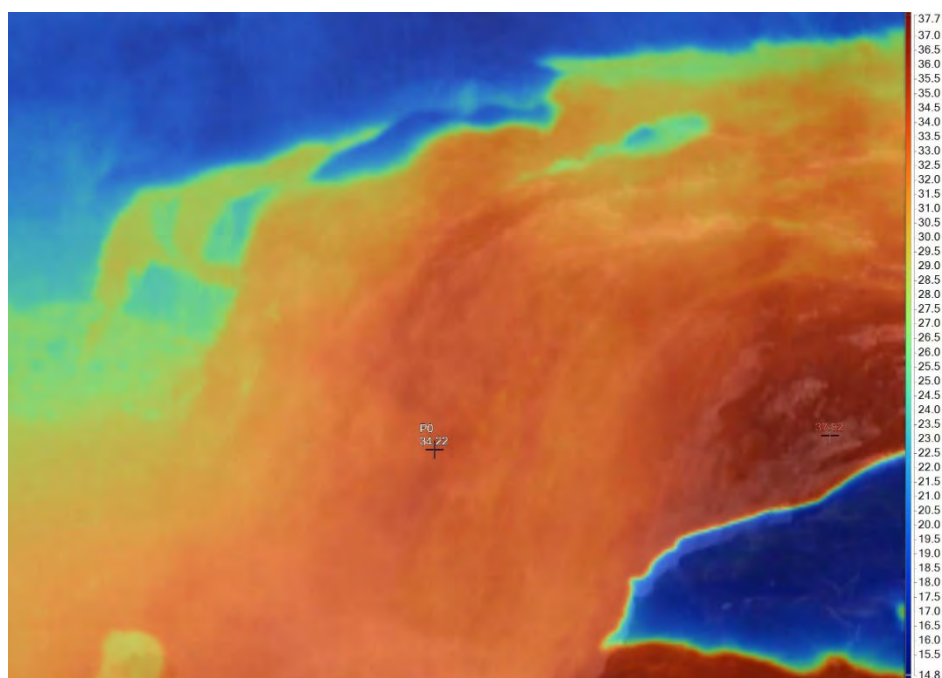
Fig. 4 Infrared image of Kerosene Creek Large Pool. Taken on 2021-03-25.

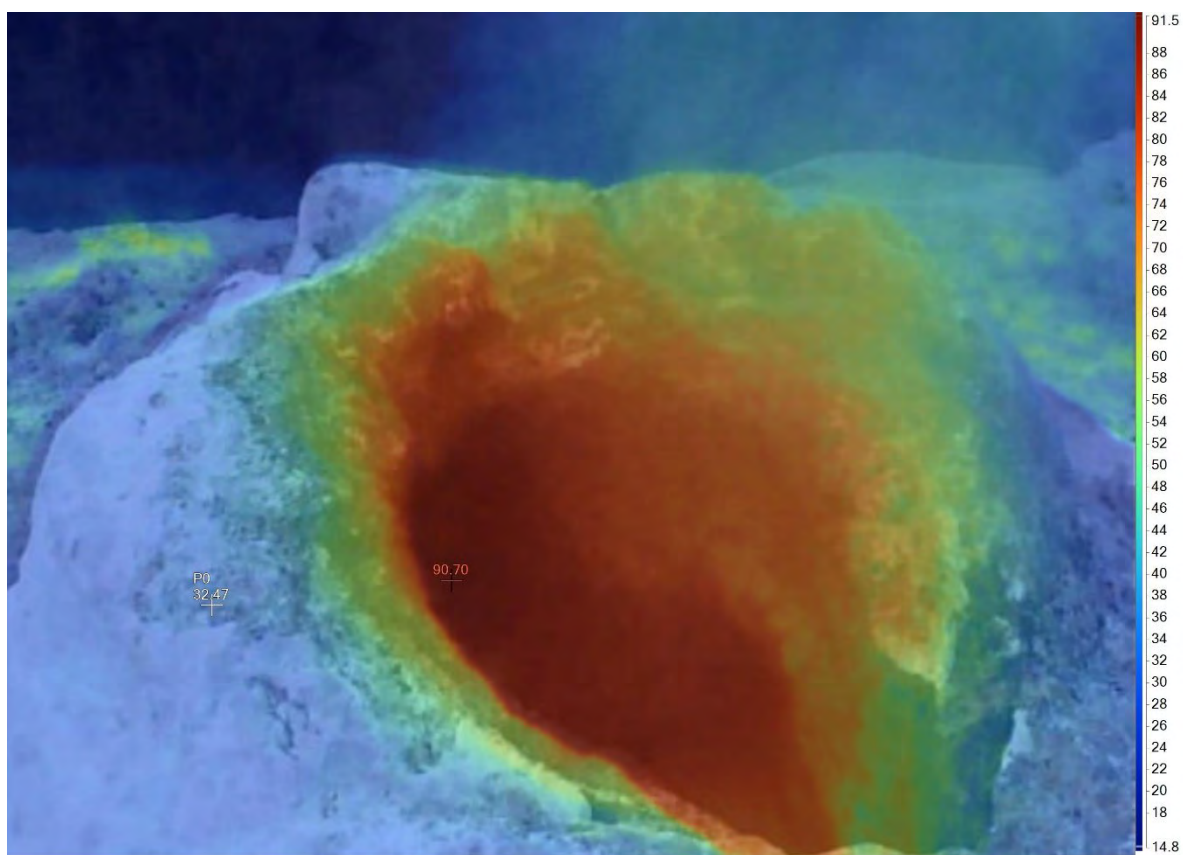
Fig. 5 Infrared image of Lady Knox Geyser. Taken on 2021-03-25.

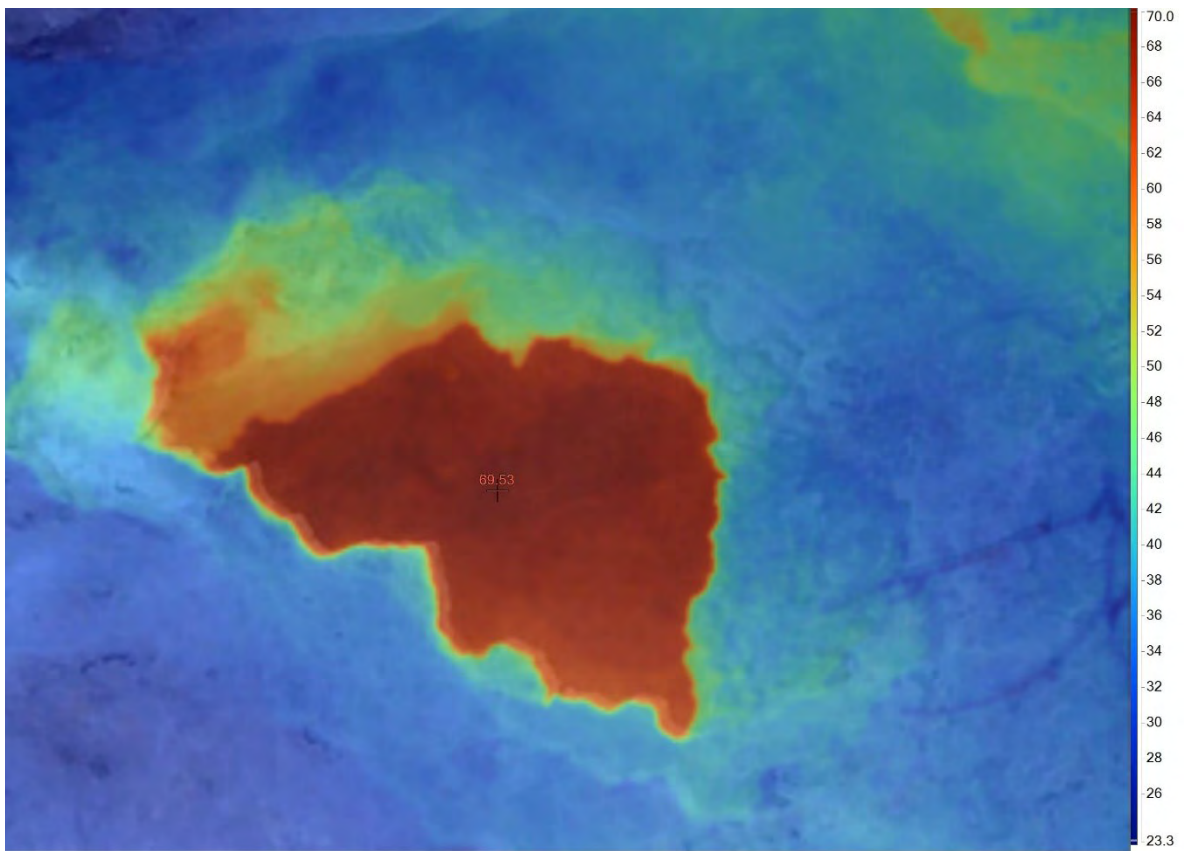
Fig. 2 Infrared image of Knox Hole spring. Taken on 2021-03-25.
