Geothermal features annual monitoring report – June 2021

August 2021

Document #: 21036557

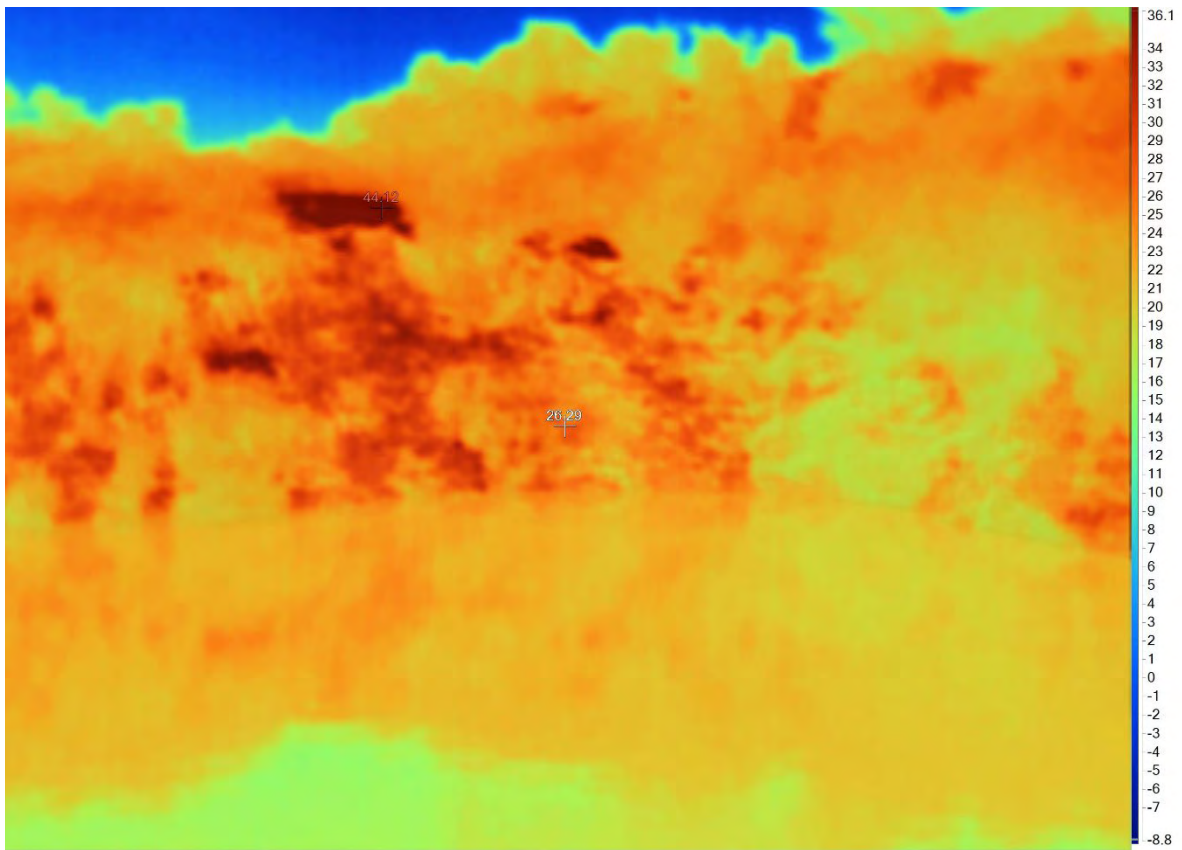
Fig. 3 Infrared image of Devil's Bath. Taken on 2020-12-03.

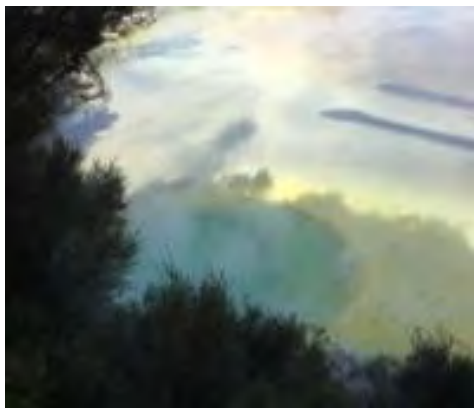
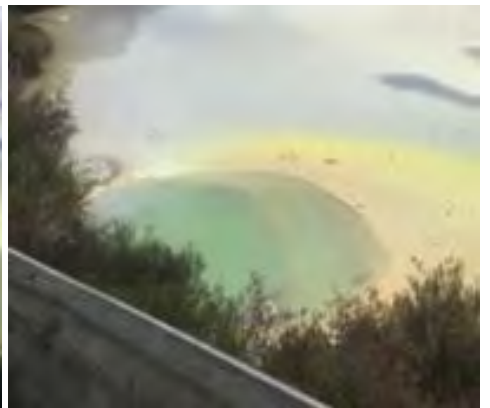
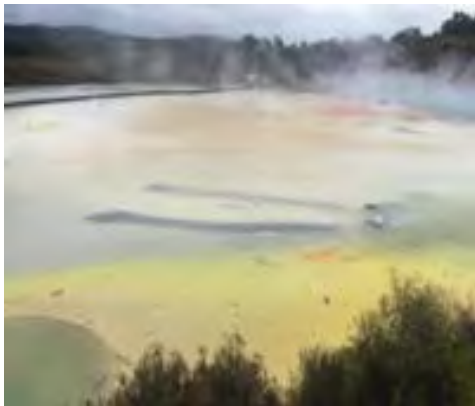
Fig.5 - taken on 2020-08-04 12:56:27"

- The average temperature conditions at this pool fluctuates between 40 and 70 °C.
- Two prominent black streaks were observed SE of the pool from late 2020 (Fig.5 – 7), but their nature and provenance are unknown.

Date	pHTemp °C	Level Flow (m) (l/s)	Clarity	Colour	Ebullition
2019/02/08	67.9	None	Murky	Green - Light	Constant bubbles
Comments	<i>Water level: Top of pool</i>				
2019/04/30	63.0	None	Cloudy	Green	Constant bubbles
Comments	<i>Water level: Overflowing</i>				
2019/07/25		<0.05	Clear	Yellow - Green	Constant bubbling
Comments	Very steamy				
2019/08/19	61.0	<0.05	Clear	Yellow - Green	Constant bubbling
Comments	Very steamy				
2019/12/05	70.4		Murky	Green - Light	Constant bubbling 10mm high
Comments	Colour and clarity have changed.				
2020/02/10	68.7		Murky	Green	Constant bubbling in centre
2020/08/04	55.0		Cloudy	Green - Blue	No bubbles
2020/12/03		Not flowing	Milky	Green – Yellow	Low ebullition
Comments	<i>Clarity: 0.5 m</i> 2 black elongate zones observed 7 – 8 m away from pool, possibly chemical fronts or algae.

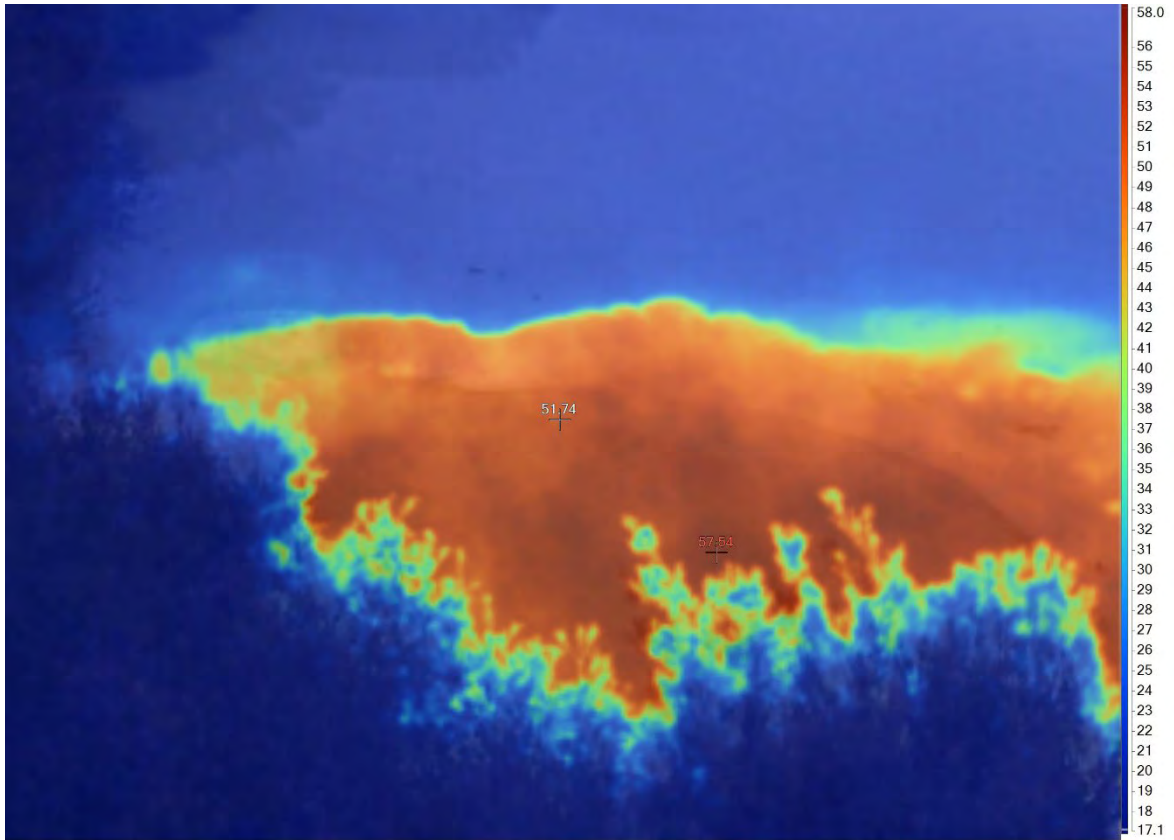
Fig. 8 Infrared image of Foreground Pool. Taken on 2020-12-03.

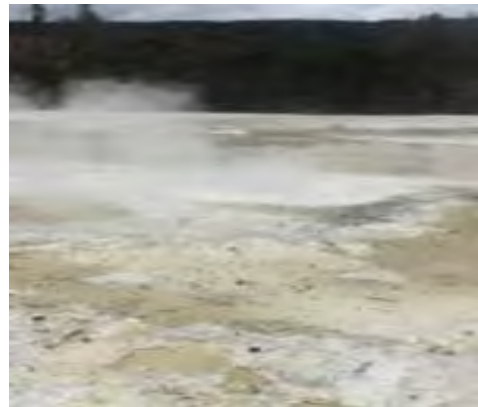
Fig.2 - taken on 2021-03-25 11:24:12"

2020/12/03		24	0		Clear	Blue – Grey	Nd
Comments	Area surrounding feature very dry.						
2021/03/25		27.1		None	nd	nd	nd
Comments	Could not get close to geyser as the ground appeared active and unstable. <i>Water level:</i> Below surface

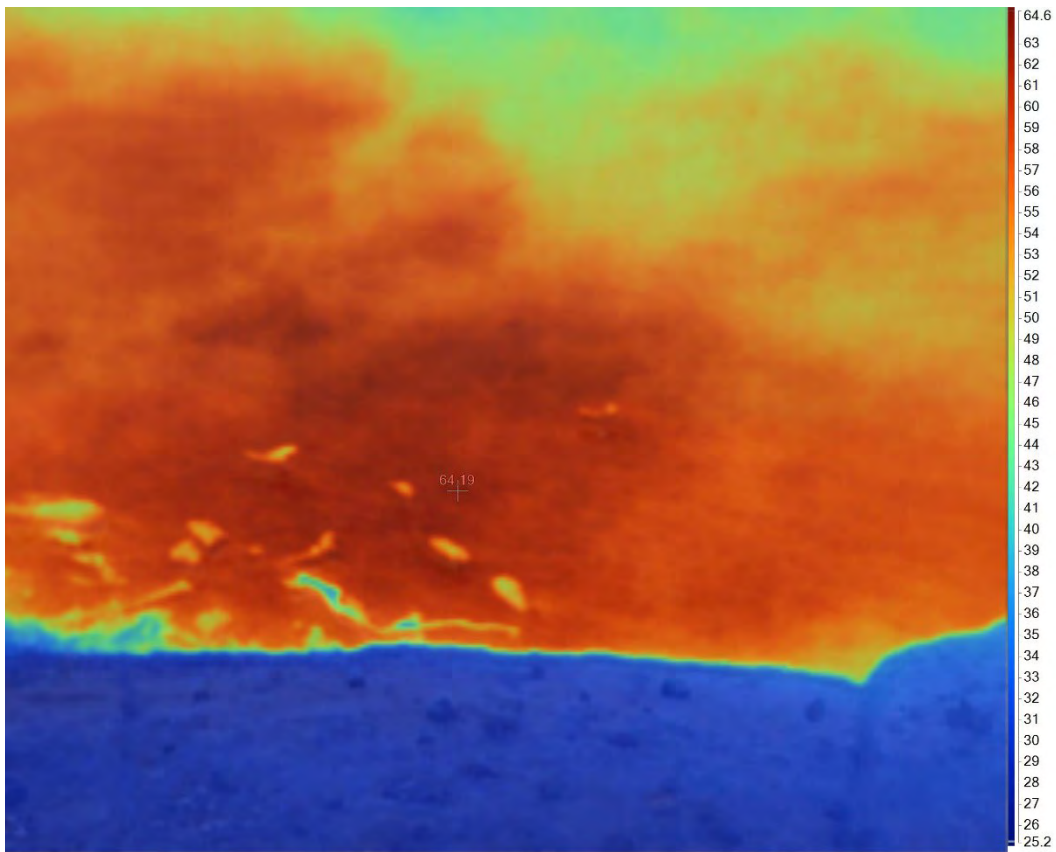
Fig. 4 Infrared image of Champagne Pool margins. Taken on 2021-03-25

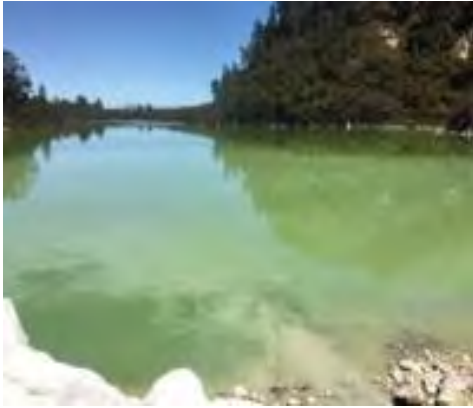
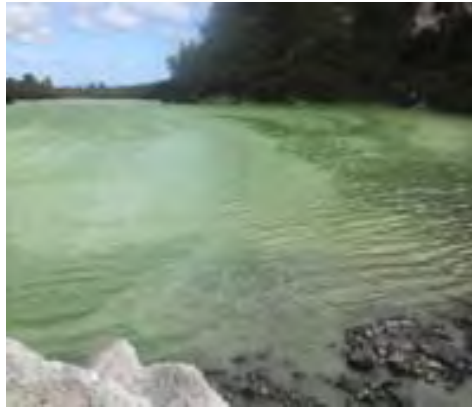
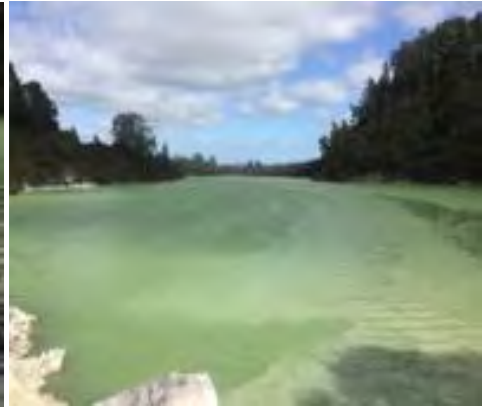
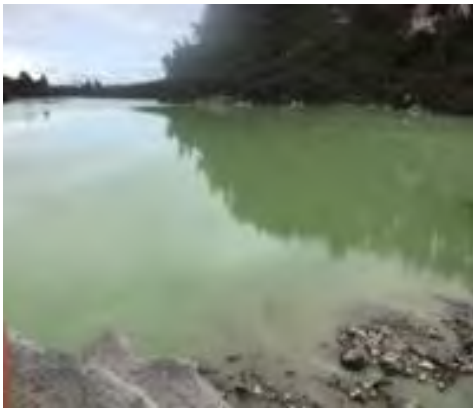
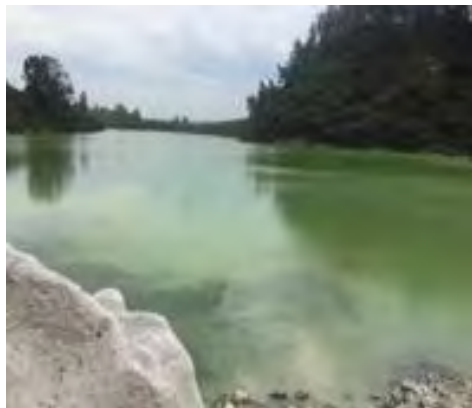
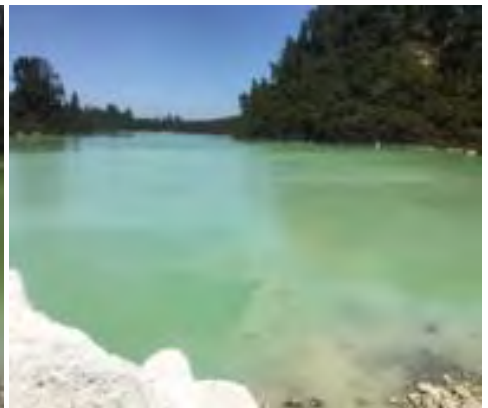
11.17 3074_212: WTF1088 Lake Ngakoro

- Water temperature conditions at Lake Ngakoro experienced an increasing trend between 2010 to 2013, before experiencing significant fluctuations to today.
- pH conditions remain relatively acidic, between pH 2 and 3.

Date	pH	Temp °C	Level Flow (m) (l/s)	Clarity	Colour	Ebullition
2019/02/08		25.0		Cloudy	Green - Murky	Effervescent just out from edges
Comments	<i>Water temperature: By outflow</i>					
2019/04/30			None	Cloudy	Green	nd
2019/07/25		19.0	None	Murky	Blue - Light	Calm
Comments	Small island that was forming has disappeared. <i>Water temperature: Temp 26 by waterfall</i>					
2019/08/19			None	Murky	Blue - Light	Calm
Comments	Small island that was forming has disappeared.					
2019/12/05		24.6		Murky	Green	Calm
Comments	Small Island has reappeared <i>Water temperature: 34 near outlet</i>					
2020/02/10		18.7		Murky	Green	Effervescent around edges
Comments	Water level is low, island visible.					
2020/08/04		13.0		Cloudy	Green	Constant bubbles
Comments	<i>Ebullition: Around the edge</i>

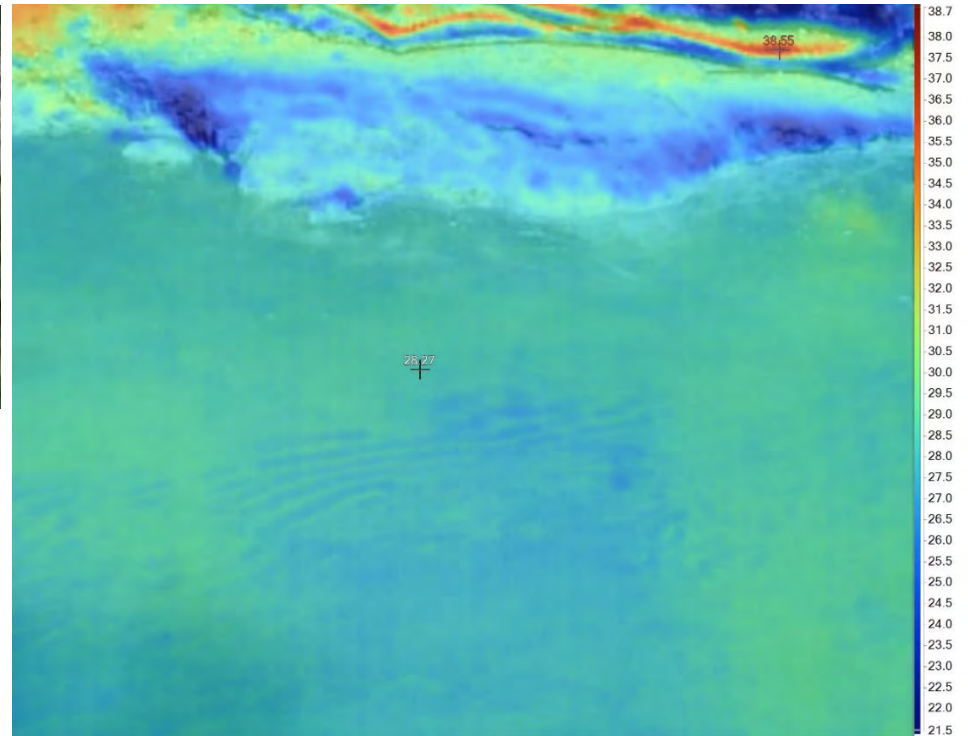
Fig.5 Infrared image of Loop Rd Pools. Taken on 2021-03-26.
